## Damages to masonry buildings during recent earthquakes in Turkey

Erkut Sayın<sup>1</sup>, Burak Yön<sup>1</sup>, Yusuf Calayır<sup>1</sup>

<sup>1</sup>Department of Civil Engineering, Fırat University, Turkey

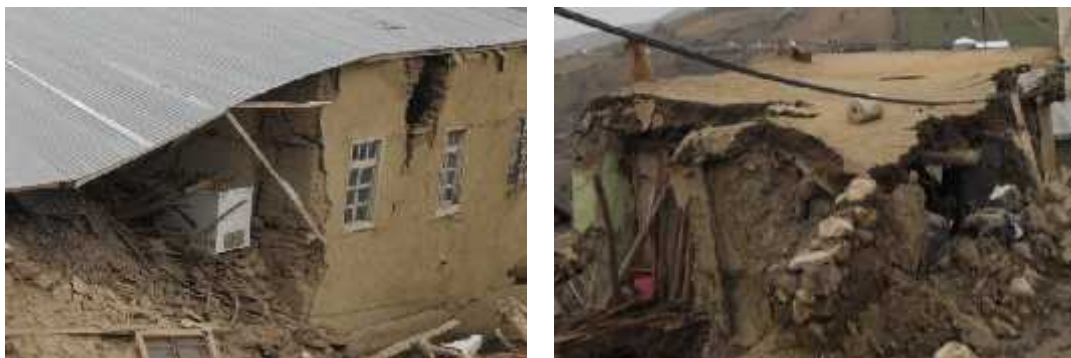
a) March 8, 2010 Elazı -Kovancılar earthquake

Adobe buildings were constructed by their own residents without receiving any engineering services in the earthquake regions. These buildings had heavy earthen roof placed on over wooden slabs which supported two walls of the buildings. These roofs were preferred by the residents because of heat insulation according to seasons. The thicknesses of the roofs were approximately 50-60 cm and wall to roof connection was poor. These heavy roofs increase lateral inertial forces on the walls during an earthquake. For this reason, TSC does not permit soil roofs in first and second seismic zones for adobe buildings and this thickness should not be more than 15 cm in third and fourth seismic zones. Some of the adobe buildings had two storey in the earthquake area. But TSC allow only one story for adobe buildings in all seismic zones. Also, TSC suggests to construct of horizontal wooden tie beams which may be prevent out of plane behavior and corner damage of the walls for these buildings. But many damaged adobe buildings had not horizontal tie beams or discontinuous tie beams had been used. Figure 4 shows damaged adobe buildings in the earthquake regions.

Figure 4 Structural damages in adobe buildings

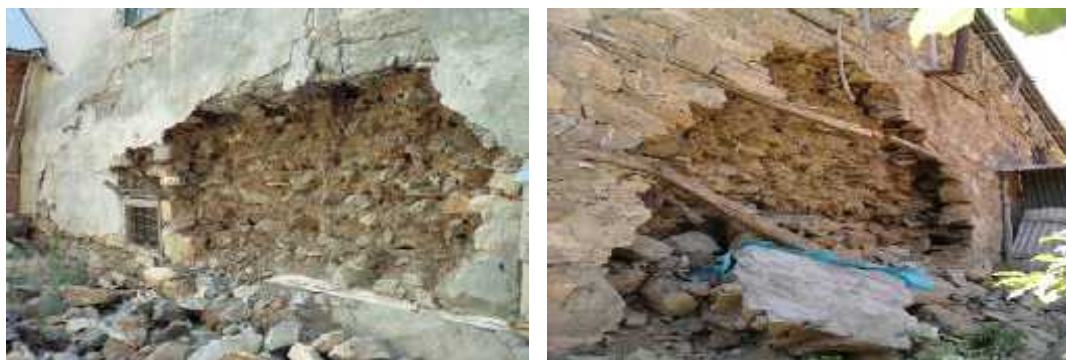
a) March 8, 2010 Elazı -Kovancılar earthquake

Important part of the stone masonry buildings were affected seriously in these earthquakes. Most of them had been constructed rubble stone walls. The thickness of the walls of these buildings was approximately 50-70 cm. These walls were constructed as two layers. The exterior layers of these walls were generally constructed large stones with relatively proper geometry. The void between the layers had been filled small rubble stones and mortar. Low strength mortar such as mud or lime mortar was used as binding material to joint stone. Therefore, the exterior and inner layers of the walls easily separated each other along the wall thickness during the ground motion. This situation was caused damages at these earthquakes. TSC requires that, lime mortar enhanced with cement (cement/lime/sand volumetric ratio=1/2/9) or cement mortar (cement/sand volumetric ratio=1/4) must be used in load-bearing walls. Some of these buildings had heavy earthen roof carried by wooden tie beams similar to adobe buildings. These ties beams were placed on the two walls which were perpendicular to these beams. In this case, the walls which are not supported with these beams are more vulnerable against out-of-plane mechanism than the other walls. Also, these tie beams are used for transfer the loads, limit the damage and increase the stability of the walls. But these wooden tie beams were either absent or discontinuous especially at the corners at most of the stone masonry buildings. Figure 5 shows damages to stone masonry buildings.

Figure 5 Structural damages in stone masonry buildings

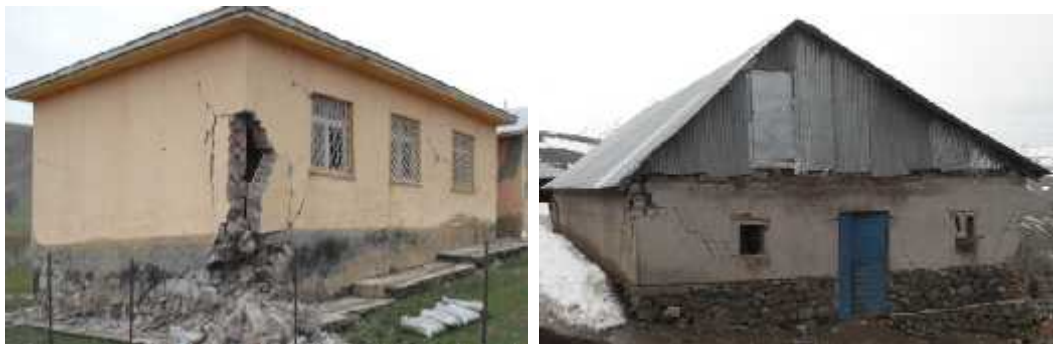
a) March 8, 2010 Elazı -Kovancılar earthquake

There were also brick and briquette masonry buildings which had generally one story in the earthquake regions. Foundations of these buildings were constructed using stones. Important parts of these buildings did not have vertical and horizontal R/C bond beams which ensure integrity and to increase earthquake resistance of buildings. Therefore, TSC requires R\C vertical and horizontal bond beams. The vertical bond beams should be constructed at the corner of the buildings, vertical cross-section of load bearing walls and on both sides of the openings. Cross section dimension of the beam which is perpendicular to wall length should be equal to thickness of the wall; the other dimension of the beam should not be less than 200 mm. Also, the horizontal bond beams should be cast monolithically with the slabs. The height of bond beams at least should be 200 mm and width of them must be equal to the width of the wall. But, R/C vertical and horizontal bond beams had not been constructed in the damaged buildings which observed in this paper. Thus, these walls had been subjected to out-of-plane behavior and the whole or the important part of these walls had been overturned during the earthquake. However, similar to stone masonry buildings mud mortar had been used between the masonry units at most of these buildings. Figure 6 shows damages to brick and briquette masonry buildings.

Figure 6 Structural damages in brick and briquette masonry buildings
