## **A Case Study For The Evaluation Of Total Quality Of Suburban Buildings In Turkey**

**Salih YILMAZ<sup>1</sup>, Hayri Baytan ÖZMEN<sup>1</sup>, Gulmustafa ŞEN<sup>2</sup>**

<sup>1</sup>*Department of Civil Engineering, Pamukkale University, Denizli, Turkey*

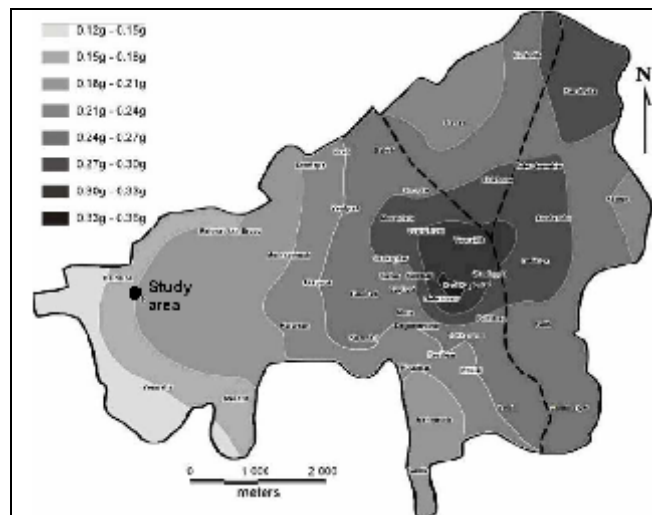
Earthquake is one of the major problems for many Turkish cities, like Denizli. City is on a region that is highest one of the 5 seismic zones of Turkey. Although, Adalet evleri is located on a hard soil layer, expected peak ground accelerations (PGA) at the area reaches up to 0.21g for a scenario earthquake of M6.9 as shown in the Fig. 2 [8].

Figure 2. Distribution of the expected PGA values for M 6.9 earthquake at Pamukkale Fault

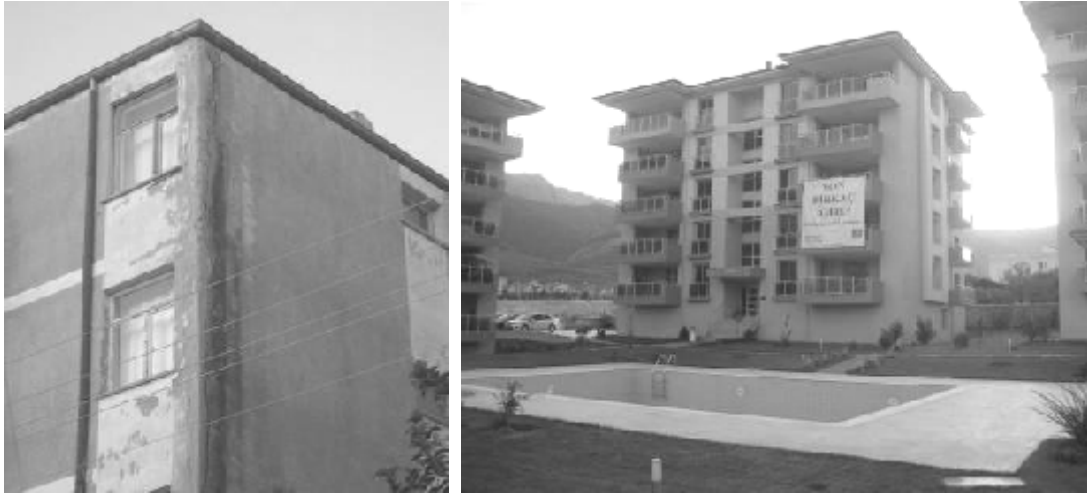
Especially the old buildings suffer from technical degrade (Fig. 5a). The outer paintings of these buildings are in poor condition and unseemly. The window frames are old with spoiled paints and ugly looking, railings at the balconies are rusted, some windows have

sunblinds and some do not. Non-uniformity of buildings' windows, balconies and overall appearance that belongs to different apartment levels is a common problem.

Besides these old buildings there are new buildings at the region. These buildings have very beautiful appearances with modern architectural features, nice colours, new window frames and aluminium railings (Fig. 5b).

Figure 5. a) Degradation of the old buildings and b) high technical quality of new buildings

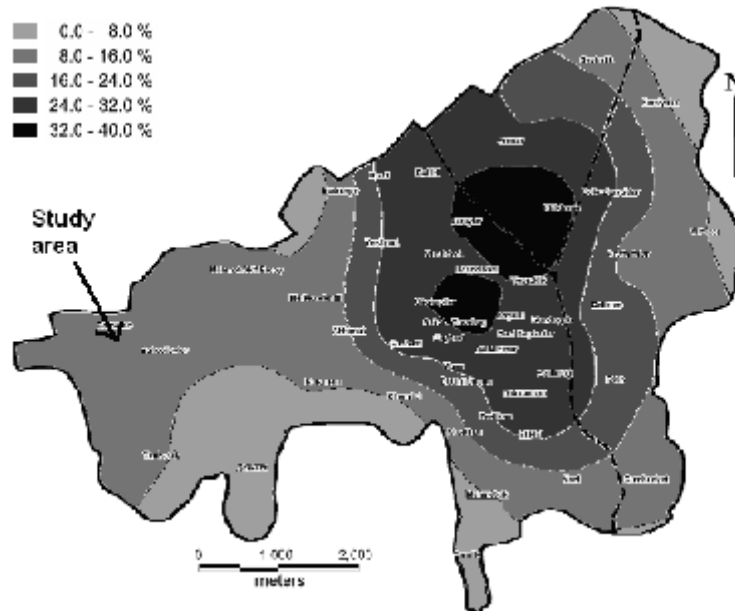
The distribution of unusable buildings after scenario earthquake for Denizli City is given in Fig. 6 [8]. As illustrated in the figure the expected percentage of the unusable buildings is between 0% and 8%. The values are highest in the city centre due to high number of old and deficient buildings in that area.

Figure 6. Distribution of unusable buildings for a M 6.3 earthquake at Pamukkale Fault.
