Repair the old concrete parts of the Hydro Plant

"LUMBARDHI" in Decan-Kosova

N.Kabashi¹, ; C. Krasniqi²,; R. Hadri³,; Q. Kadiri⁴,
University of Prishtina; Department of Civil Engineering, Prishtina, Kosova

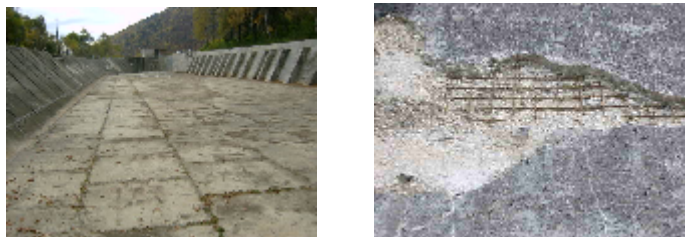
Fig.2. The view of the accumulations basin and degradation of concrete in concrete campades

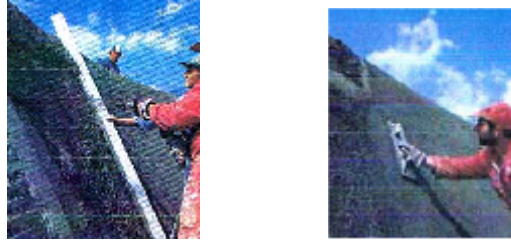
Fig.6. The cast in place and final smoothing the layer on the slope surface

The grout is cast in placed with compression in properly consistent for this kind of repairing works, especially but the surface was in slope position. In this case the applied grout is capable for excellent bond between existing concrete and grouts.

The thin layer was about 20 mm, in general. When we need for additional we apply the second layer.

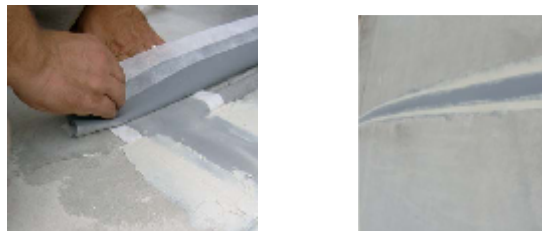
Fig.8: a/placing the PVC materials to protect the joints; b/the view of protected joints

The joints are protected with the polymer PVC materials , in this way this material are compatible for eventually joint movement in concrete. The methodology and placed this material is presented in fig. 8. a&b.
