## **Damages of Masonry School Buildings on 2010 Karakocan - Elazig Earthquake**

**N. Cetinkaya<sup>1</sup>, İ.Türkmen<sup>1</sup>**

*<sup>1</sup>Department of Civil Engineering, Inonu University, Turkey*

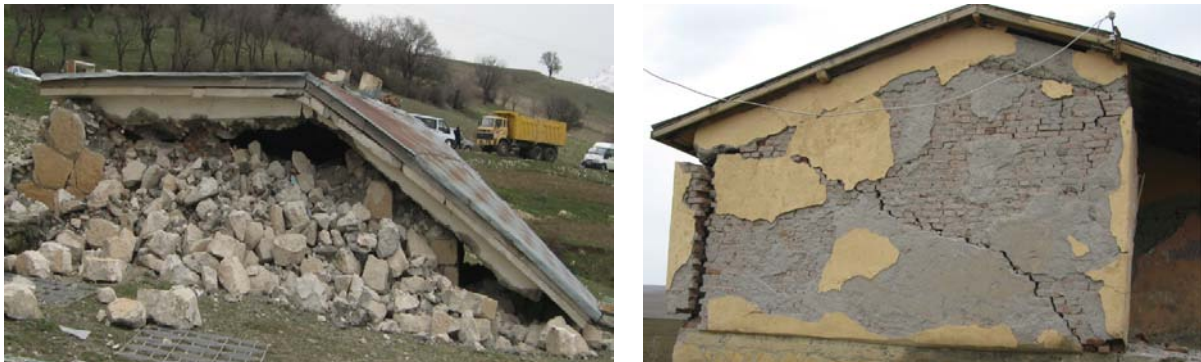
The masonry school buildings in the region affected by the earthquake were constructed by using stones collected from the river beds, soft natural stone blocks and lime hollow/solid blocks. Most of them were one-storey with a very heavy saddle shaped roof (Fig. 3). These buildings were not earthquake resistant according to previous or existing Turkish seismic codes [9]. Although the magnitude and spectral acceleration values of the Earthquake were not so high, many masonry school buildings were heavily damaged due to the above mentioned construction practice. The disaster area was surveyed and detailed studies were carried out on the damaged buildings to understand the reasons of the poor performance of the masonry school buildings. The main reasons are discussed in detail with the examples of damaged buildings.

Figure 3 Heavy -saddle shaped roofing systems

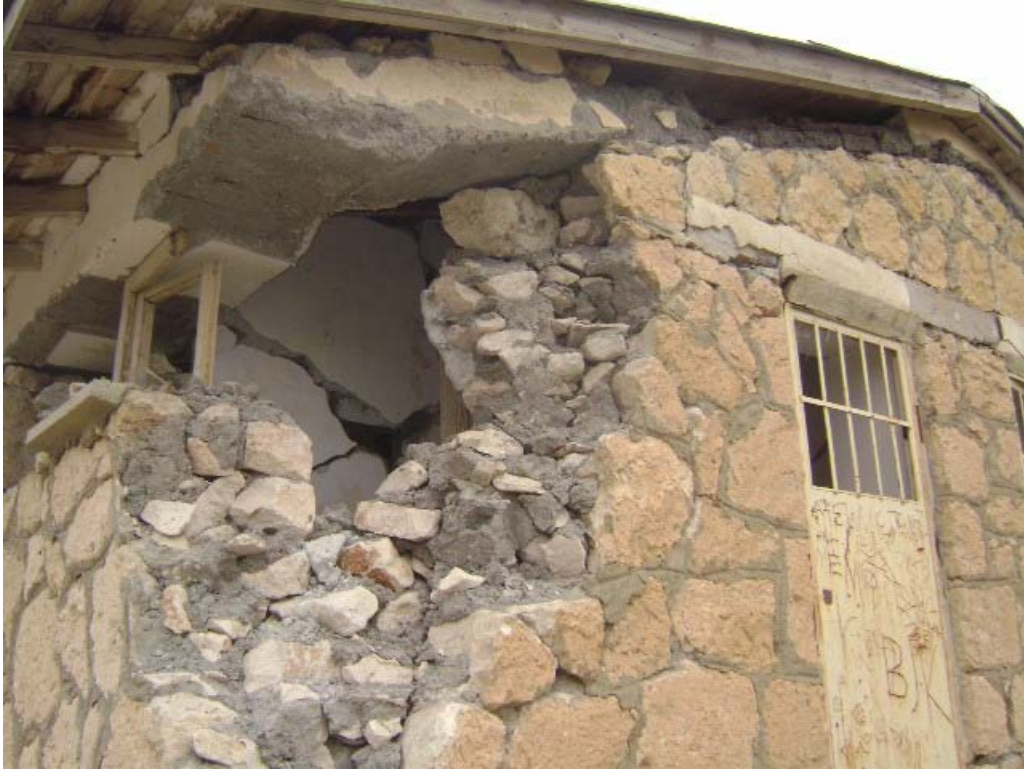
One of the most common reasons was the use of wrong material. Rubble stone and shaped soft stone blocks were the wall materials commonly used in the damaged buildings (Fig. 3 and 4). Soft stone blocks have low strength and ductility values. The rubble stone blocks selected from the river beds used as wall material do not have a proper shape for the use in the masonry walls. They have smooth and oval surfaces with irregular sizes. It is not possible to construct an overlapping wall section using this kind of material without cutting into proper sizes and shapes. Poor quality of bonding mortar as it is observed in most of the figures is another important reason for the damages.

Figure 4 Rubble stone and shaped soft stone blocks used as the wall materials

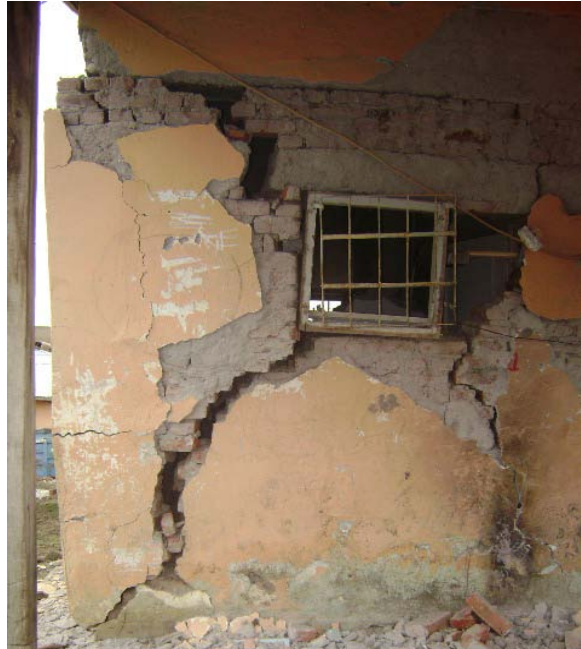
Figure 8 Wall opening close to the building corner

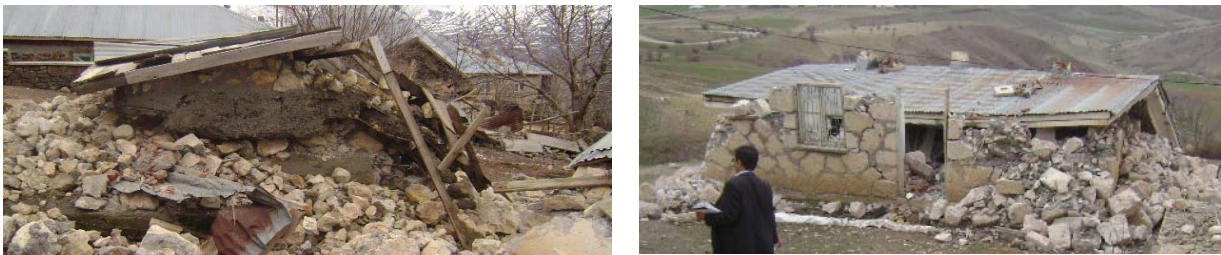
A heavy saddle shape roof which does not provide a proper rigid diaphragm effect is also important reason for the damages (Fig. 9). Interior walls and the walls in the inclined direction and the roof were not connected to each other to transfer the seismic loads. Therefore, the exterior long wall was subjected to the most of the seismic load coming from the heavy saddle type roof.

Figure 9 A heavy saddle shape roof

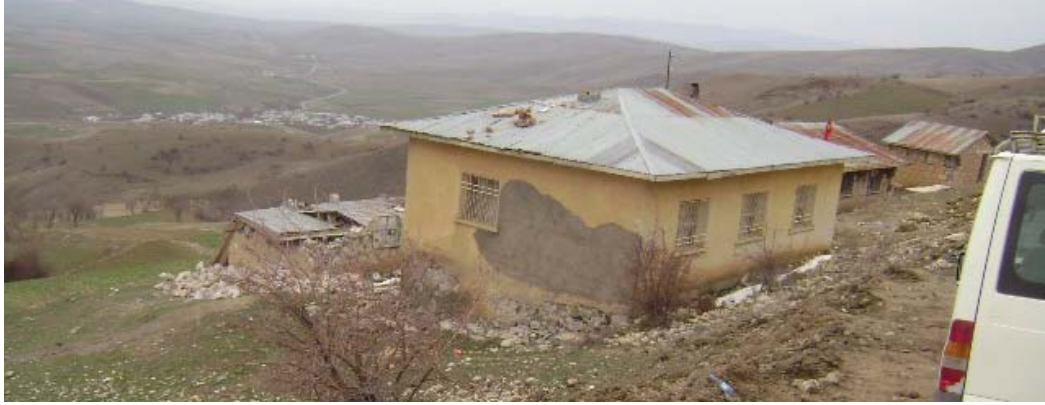
Topography of the region was also effective in the damages. Many of the damaged buildings were located on the hills with a high slope. According to Kramer topographical irregularities on ground surface may affect ground acceleration significantly [10]. Because of the amplified ground accelerations, the number of the damaged buildings increased significantly. The damages on the buildings located on a hill are shown in Fig. 10. Due to the concentration of seismic energy and amplification of the ground acceleration at the top of the hill, the damage level of the building becomes heavier than those located on the foot of the hill.

Figure 10 Many of the damaged buildings were located on the hills with a high slope
