Deficiencies Of Some Important Bridges In Albania

Erion PERIKU¹, Yavuz YARDIM¹

Keywords: Bridges; Defects; Inspection.

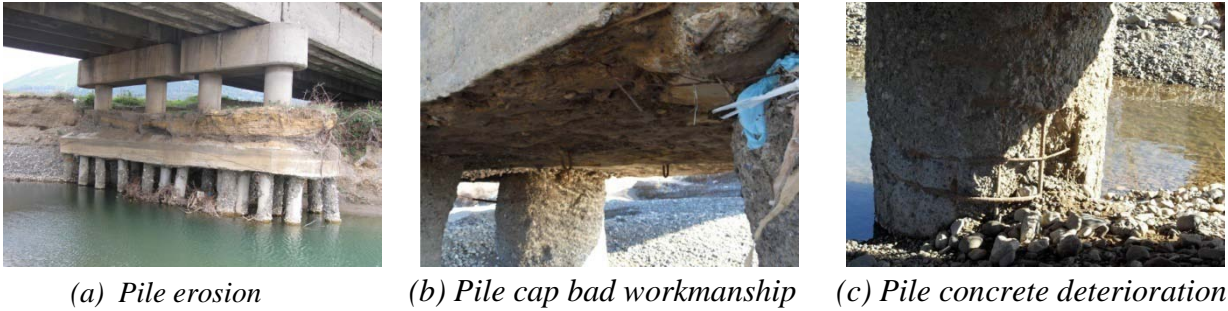
Figure 2 Substructure defects

Albania rivers have mass flow rate so scouring is one of the main concern for bridge substructure. Mat bridge passes over Mat river and foundation consists on piles connected with a pile cap. Almost all piles exposed and have some problems. Scoring were recorded with different severity level. Sever scouring were observed at some part of the foundation as shown in [Fig.2(a)]. Reinforcements of pile cap were exposed and rusted because of lack of concrete cover and poor workmanship. Moreover, considerable amount of soil was found in pile cap concrete as an evidence of poor construction supervision [Fig.2(b)]. The piles have concrete deterioration defects and very often steel bars are exposed to environment [Fig.2(c)].

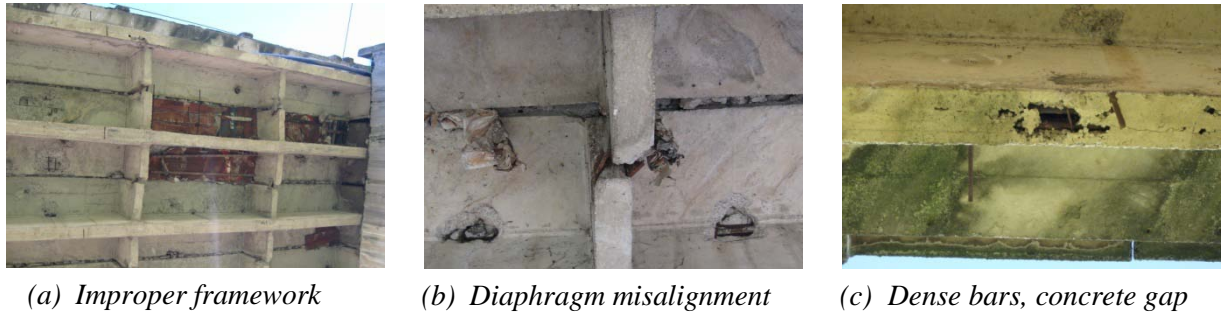
Figure 3 Deck defects

Bridge superstructure defects were seen in all three bridges. because of aging factor, more serious defects were seen on Mat and Vora Bridge compare to Sukth Bridge which was built after 1990. Workmanship problems such as improper frame work and inadequate concrete cover are very obvious in three bridges [Fig.3(a), Fig.4(f)]. Diaphragms that are very sensitive parts must align beams on correctly position. However the most of the diaphragms in these bridges were found out of position. The miss alignment were measured more than 5 cm on some of the diaphragms [Fig.3(b)]. Because of poor workmanship and design detail, reinforcement were placed so closely that does not allow the concrete enter between them so exposed reinforcement are widely seen [Fig.3(c)]. This problem was associated with improper concrete cover and water leakage and result with heavily rust on the reinforcement all over the bridges' structural members [Fig.4(a),(e)]. The reinforcement diameter was around 4mm at some rusty place. Chemical attack is widely seen on every superstructure element [Fig.4(b)]. Spalling and delamination were other two commonly defects seen all over the bridges' superstructures [Fig.4(c),(d)].
