Restoring the restoration: The Palaestra of the West Gymnasium of Kos

KEYWORDS: Kos, Hellenistic architecture, restoration of stone monuments, anastylosis, enhancement of archaeological site.

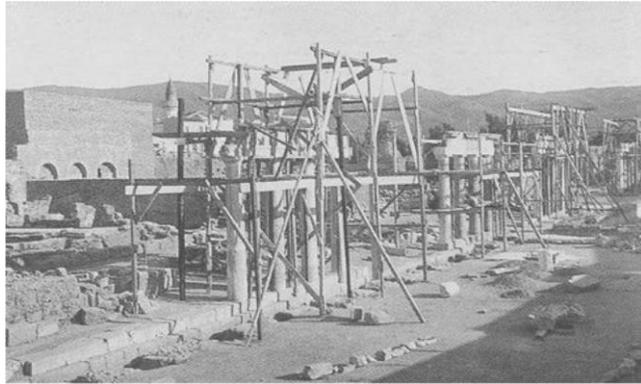
Figure 1: Kos, West Gymnasium. View from the North. Anastylis operation (G. Rocco, in Livadiotti, Rocco 1996, p. 148, fig. 342).

Anastylosis interventions proceeded in stages north-southern directed (SAIA, Archive Morricone, M 552-557) in order to rise the column shafts and the corresponding capitals (SAIA, Archive Morricone, M 570); only when a group of columns had been completed, it was carried on with the following section, starting from the bottom and taking into account the "*lower fragmented column drum found in situ*", respectively, "*three in the south and one in the north*" (Morricone 1950) and, in other situations, large portions of fragments were placed at the base of the "blue - black marble slabs having traces of columns" (*Ibidem*), in formworks with wooden slats, fastened at the base with more or less regular intervals and gradually built bottom up as a function of the necessary steps for concrete drying and hardening. During the restoration many blocks of the stylobate were replaced according to the alignment of the original ones and others were completely rebuilt in reinforced concrete (SAIA, Archive Morricone, M 512, M 515, M 579) (Fig. 1).

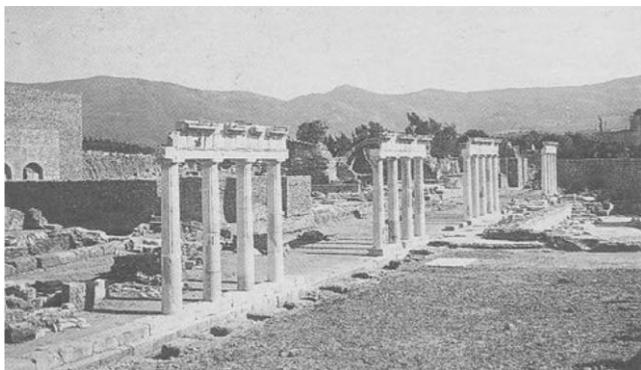
Figure 2: Kos, West Gymnasium. View from the North. The Monument after the restoration (G. Rocco, in Livadiotti, Rocco 1996, p. 148, fig. 343).

The columns were intentionally clustered in four consecutive sections spaced several meters, in order to suggest the volumetric development along the eastern branch of the only surviving peristyle, occupying in length the entire excavation area, meanwhile limited and accomplished (Fig. 2). Of course the vast working plan was interrupted, perhaps because of Second World War exacerbation, to the detriment of the fourth section of the higher colonnade that was subjected to a hurried restoration, inaccurate in the blocks replacing, in the joints treatment and in the exterior finishes, from then on intended to premature deterioration. Moreover, the numerous architectural recovered fragments, some prepared to hold metal armor and others already pivoted on (Fig. 3), show that the anastylosis site in the *Palaestra* of West Gymnasium was unfinished.

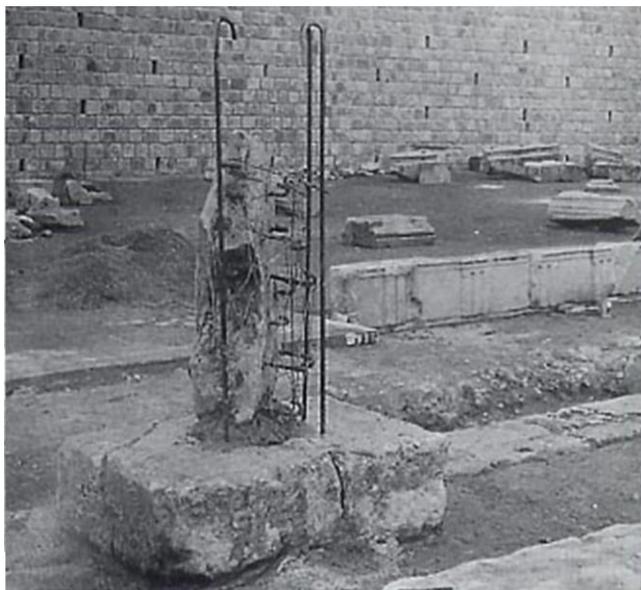
Figure 3: Kos, West Gymnasium. Detail of column restoration (G. Rocco, in Livadiotti, Rocco 1996, p. 147, fig. 341).

The relevant quantity of photographic material (G. Rocco in Livadiotti, Rocco 1996, pp. 144-148) and the presence of fragments in the site which are assumed to have been object of several anastylosis lead us to the following step: the interpretation of the restoration undertaken in 1938-43. We are dealing with pillars made with concrete artificially reproducing columns and girders simulating Doric beams. The columns reveal a core circular section made with concrete anchored to the stylobate. The iron reinforced bars vertically positioned are settled into two levels and in some pillars they are replaced by marble fragments. Moreover, the marble fragments contain cavities in which we find iron hooks, drowned in the concrete, functional to the stability of the fragment within the pillar (cfr. fig. 3).

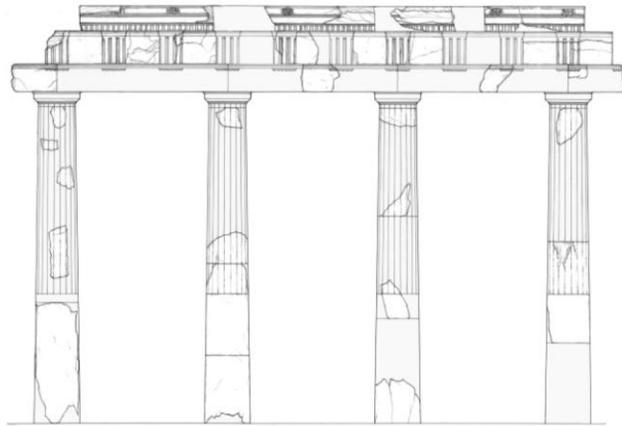
Figure 4: Kos, West Gymnasium. Identification of ancient fragments in the first section of the East Porch of the Palaestra (Drawing A. Fino).

ancient one, restoring the original fixing systems too. The de-restoring develops throughout a sequence of phases: the first one entails the identification of the ancient blocks (Fig. 4). Then it follows the second phase, namely the measurement, meant not only to observe what is visible but also relevant to the formulation of hypothesis about what we assume to find during the dismantling. It is possible to make assumptions about the preserved dimensions and to recreate the breach lines.

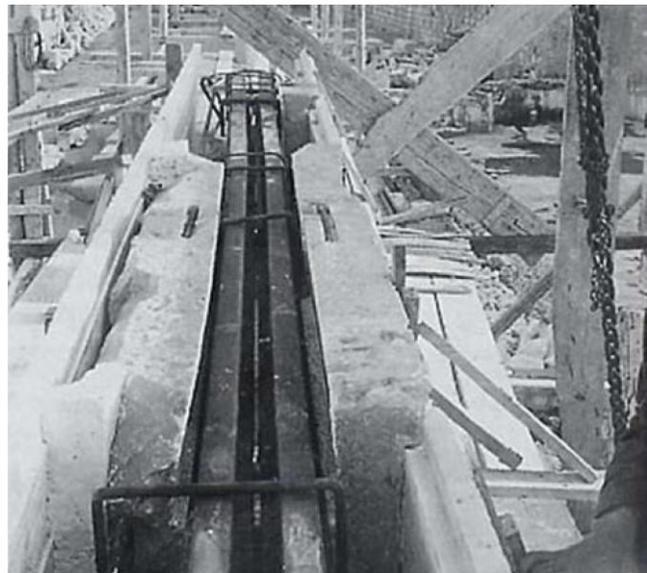
Figure 5: Kos, West Gymnasium. Detail of architrave restoration (G. Rocco, in Livadiotti, Rocco 1996, p. 147, fig. 340).

A long girder runs over all the columns linking them in a single frame. The marble beams reveal a cutting with a trapezoidal shape to hold the horizontal iron bars (Fig. 5). This horizontal iron structure is composed of vertical brackets which contain iron bars of different sections (the inferior ones with a bigger diameter) and instead of double -T section bars placed side by side, they used simple railway lines.

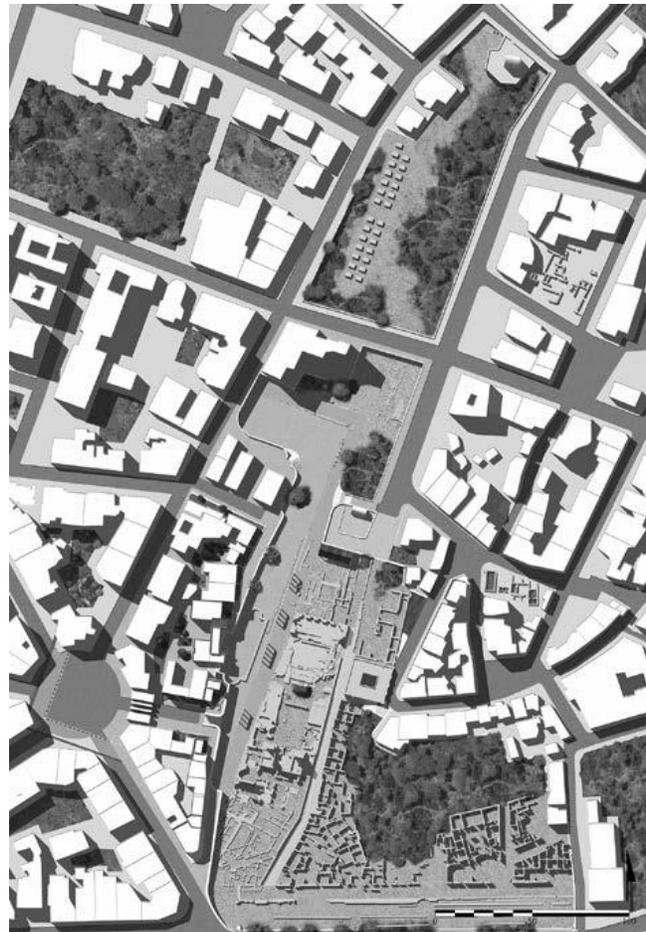
Figure 6: Kos, West Gymnasium. Plan for the accomplishment of the area (A. Fino).

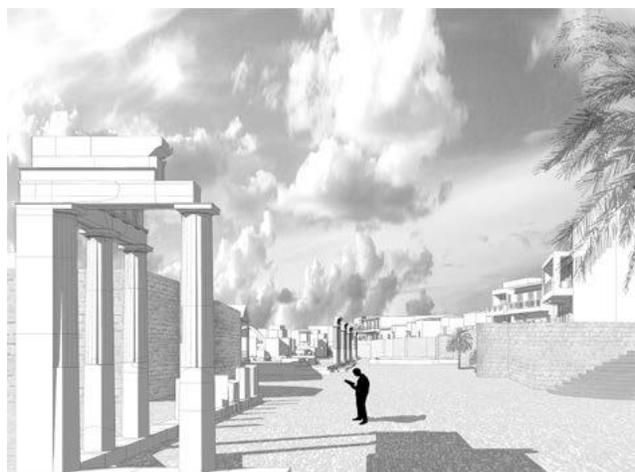
Figure 8: Kos, West Gymnasium. Perspective view of the accomplishment with the new anastylosis (A. Fino).

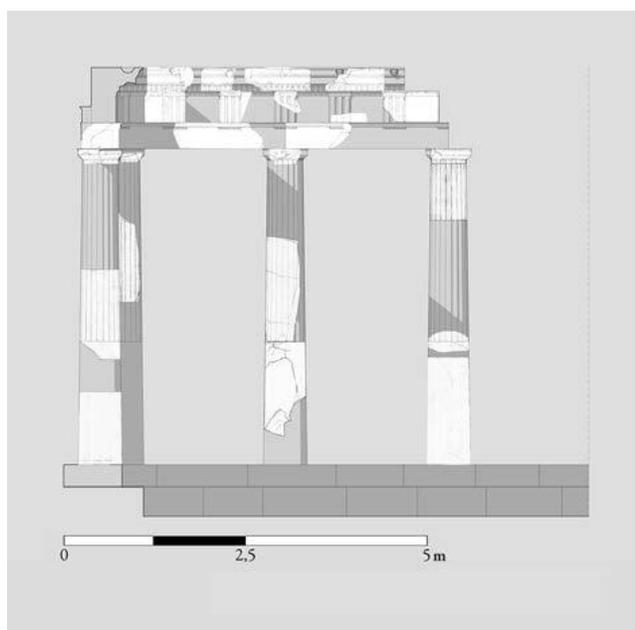
Figure 9: Kos, West Gymnasium. Anastylosis project, east elevation (F. Gotta).
