An Architectonic Recovery Plan over the North-East Historical Sector of Tirana, Albania

Klodjan Xhexhi

ABSTRACT

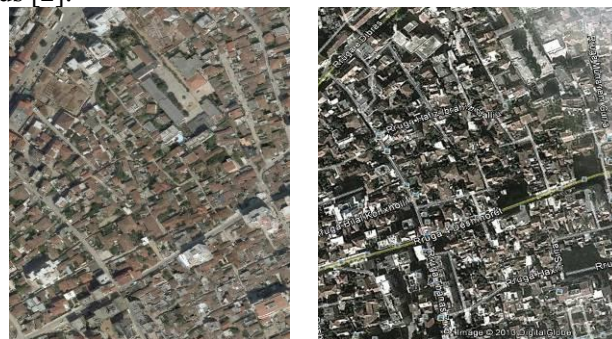
Figure 2: Left: Google earth (specification on roads designation). Right: Ortho photo of the area

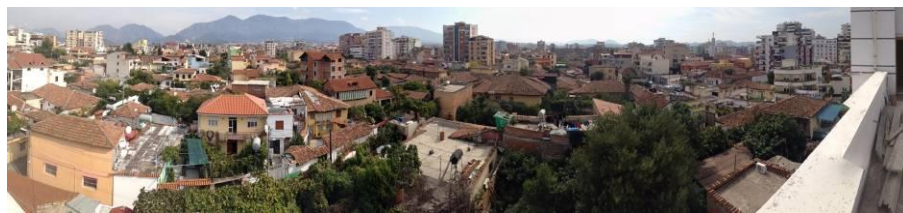
Figure 6: Existing situation, panoramic view of the area; (K. Xhexhi 2013)

Analyzing the existing situation of the panoramic view compared to the proposed view, one undoubtedly sees a great change. In the second view, the area calmness is evident. The buildings do not exceed the maximum number of two floors and the silhouette is unchanged. On the other hand, in the first view we have an interruption of this calmness due to the multi-floor buildings.

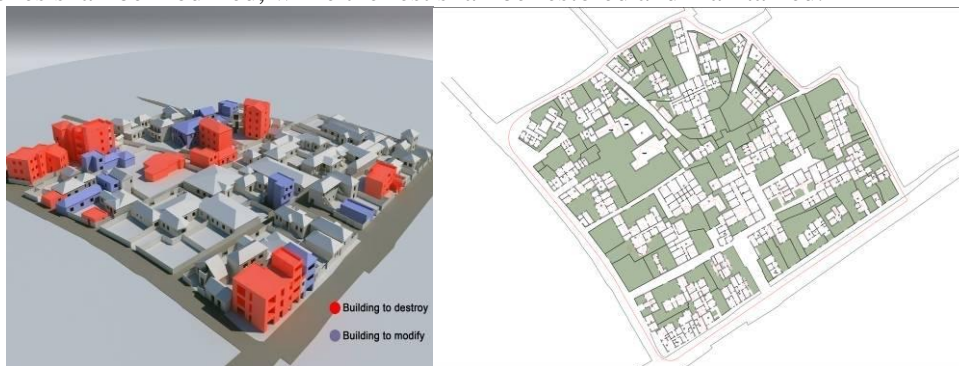
Figure 7: Intervention classification and existing situation plan (K. Xhexhi, 2013)

The logic of the intervention carried on in the area clearly defines the buildings which shall be demolished and the buildings which shall be modified. Respectively, the red building shall be demolished and the violet ones shall be modified, while the rest shall be restored and maintained.

Their modification shall be handled basically in various methods:

- Interventions concerning only the roof configuration (alternation from flat roofs to angled roofs, in accordance with the character of the area).

- Interventions concerning demolition or extension of the buildings, which is translated as minimal transformation, in order to create better urban conditions.

-Interventions concerning the reduction of a maximum of 2 floors and construction of angled roofs in the respective buildings.

-Interventions of restoration nature by demolishing the new buildings (lacking historical values) which have damaged the integrity of the historical buildings by bringing the missing parts back from the past in order to become part of the urban reality again.

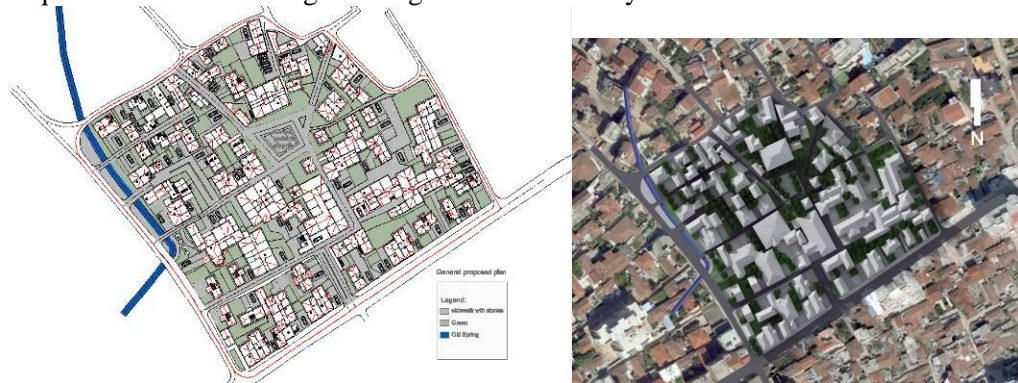
Figure 8: Proposed intervention (K. Xhexhi 2013)

The logic of intervention is easy. The buildings in contrast to the area shall be demolished. A part of them shall be modified and transformed and a part shall be newly built with the aim to achieve an acceptable building intensity and a considerable amount of compensation for the inhabitants who lose their homes due to demolition. The new buildings shall be built mainly in the south-eastern and north-eastern side, where there shall be more demolished houses. The use of certain type units which are repeated to provide a faster pace to the intervention makes the area more readable architectonically-wise, by creating more urban corridors. According to the new proposed intervention scheme, the technical-urban parameters have a slight difference. The territory exploitation coefficient is reduced to 35%, the building intensity to 1% and the density is also reduced to approximately 200 inhabitants/ha, which makes the area pleasant in many aspects.

In the north-western side was used the logic of the reflection of the buildings towards the main road axis which makes the scheme more interesting by respecting the existing boundary of the property. Meanwhile, in the south-western side, the 4-floor building is demolished and replaced with a 2-floor building which is identical with a group of existing buildings in the same parcel dating back from 1937. This block of buildings serves as a copy for another block of buildings on the other side of the road towards a well-defined symmetrical axis.

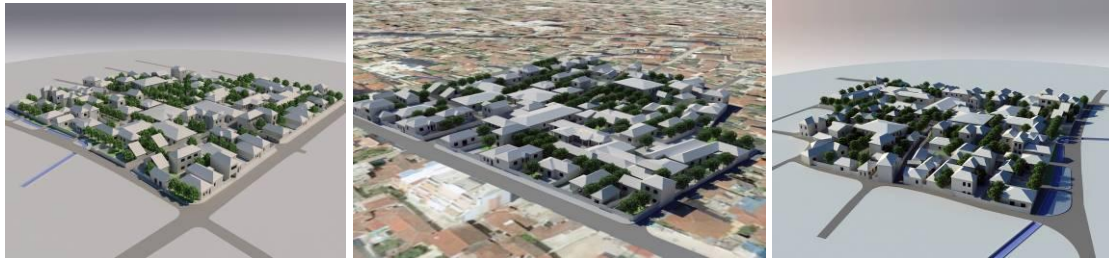
Figure 9: Proposed intervention; S-W angle; S-N angle; N-W angle (K.Xhexhi 2013)
