Usage of ferrocement jacketing for strengthening of damaged unreinforced masonry (URM) walls

Enea Mustafaraj¹, Yavuz Yardım²

¹Department of Civil Engineering, Epoka University, Albania

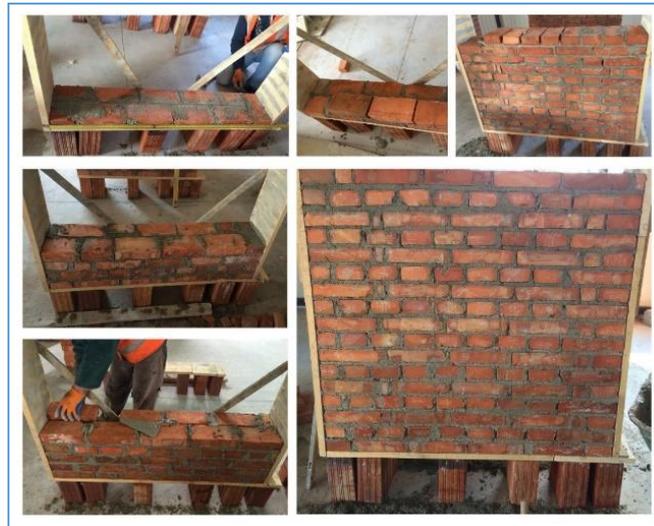
Figure 21. Construction process of plain walls.

All the panels, were built using two leaf, English bond and new clay bricks with typical nominal dimensions of 243.4 mm x 118.9 mm x 56.8 mm with 15 mm thick mortar joints made of hydraulic cement mortar of type "N" with a volumetric mix ratio of cement: lime: sand, 1:1:6 (Figure 21). The specimen are part of a wider experimental campaign conducted by the authors for a research project at Epoka University.

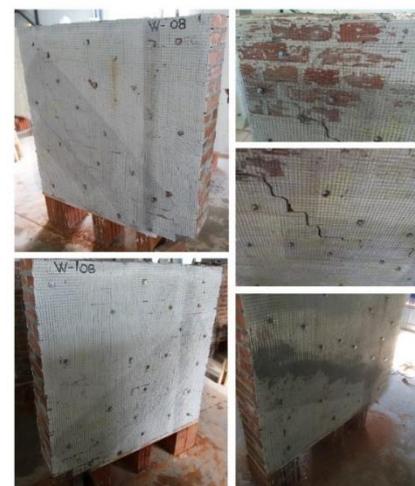
Figure 2. Plastering process with ferrocement jacketing (FC) (schematic view and application) (left) and repairing with ferrocement (right).

W-10-FC, W-11-FC and W-12-FC panels were reinforced using ferrocement jacketing; attachment of a double-layered galvanized steel mesh on both sides of the plain wall (**Error! Reference source not found.**). The mesh is fixed to the wall by means of mechanical anchors and common mortar. The dimensions of the steel mesh are equal to the plain wall (1.2 m x 1.2 m). Allowance of 1.5-2 cm on each side shall be made in order to have a proper jacketing of the wall. The galvanized steel mesh is fixed using anchors (threaded bolts of diameter 8 mm and length 70 mm with washers, mounted on previously drilled holes, having 10-mm wall plugs on the bricks at a distance of 30 cm). The spacing of the connections was slightly changed depending on the brick arrangements, in order to make sure that the connection was done on the brick and not on the mortar joint. The process of mounting the steel mesh on the faces of the wall should be done carefully in order to lay the layers properly, as well as to provide a 5-10 mm allowance between mesh and the bricks for plaster mortar. The mortar mix is prepared using cement: sand 1:4, by volume and water/cement ratio of 0.4.

The procedure of repairing of the damaged walls with ferrocement is the same as strengthening of the plain walls. The only difference is application of an extra layer of galvanized steel mesh along the diagonal cracks of the damaged wall (Figure 2). This layer is fixed using extra anchors drilled every 30 cm along the diagonal.

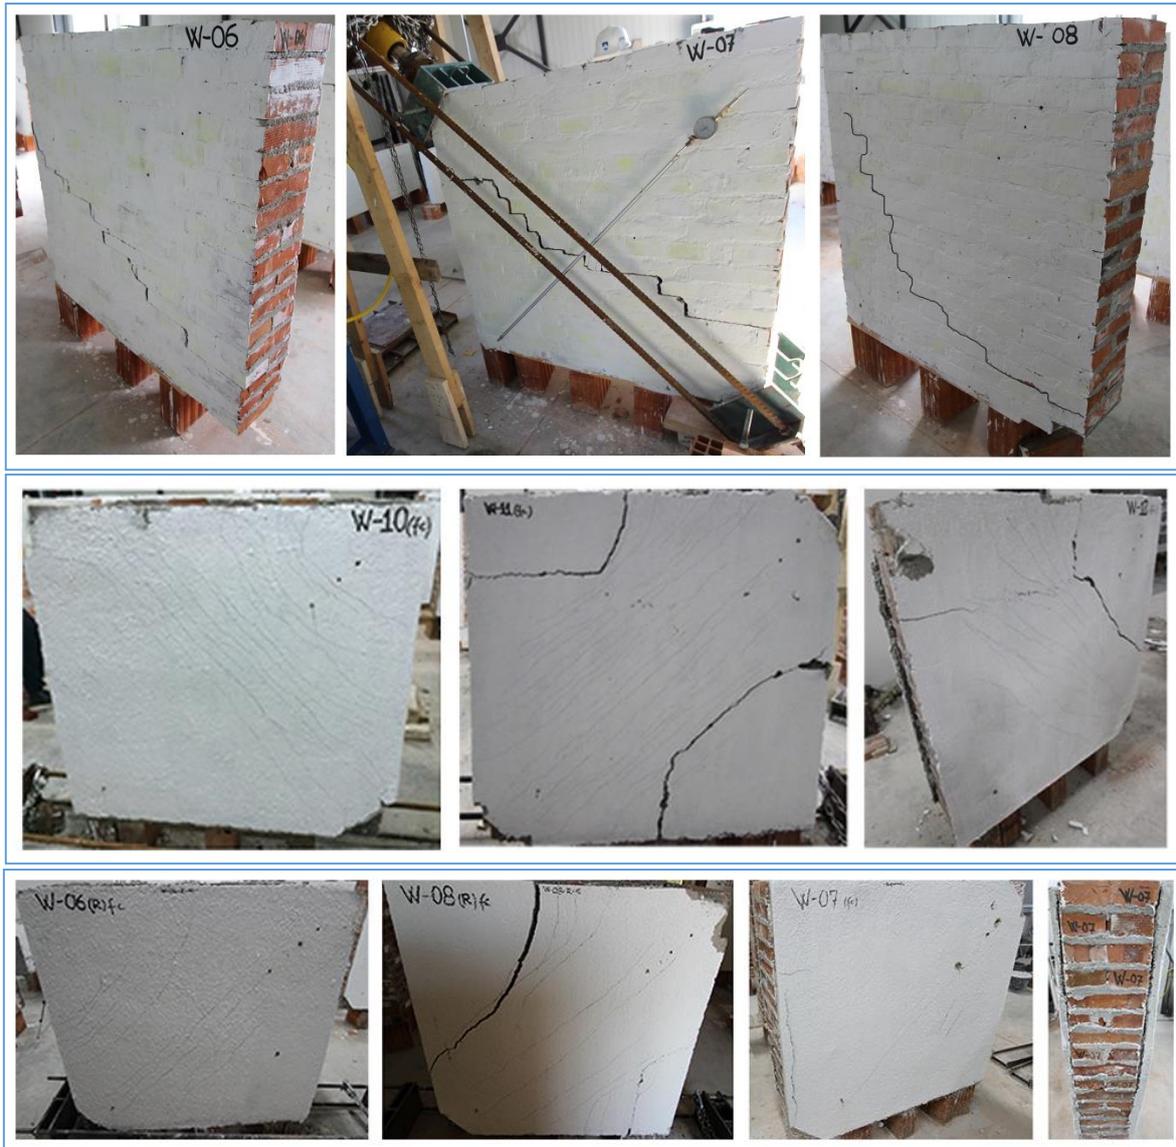
The plain wall panels had a similar failure mode; it was observed that cracking occurred along the compressed diagonal, predominantly through the mortar joints. Nevertheless, in some cases, sliding along the mortar bed joints, following by diagonally extended cracks was observed (Figure 6). The overall failure mode can be categorized as tension failure followed by shear-sliding along the compressed diagonal in a step-like pattern.

The plain panels (W-06, W-07, W-08) exhibited similar failure modes; a step-like pattern along the compressed diagonal. The cracks occurred in the mortar joints.

Figure 6. Failure mode of plain, ferrocement strengthened and repaired panels.

In the ferrocement jacketing reinforcement panels while loading, hair-like cracks were observed, mainly in the compressed diagonal. From the tests, it was observed no splitting in the head or bed joints. The total failure of the wall after the reinforcing ferrocement-plastering layer yielded, is attributed to the loss of bond between the plastering layer and the wall (Figure 6). The connection failure is the main cause of loss of adhesion of the strengthening layer that caused the overall failure of the panels.

In W-11-FC apart from the diagonal and hair-like cracks that were developed in the plaster layer, after exceeding the materials' resisting capacities, due to high tensile stresses, connection failure was observed, which resulted in thick radial cracks around the unloaded upper and bottom edges of the panel. In W-12-FC, connection failure resulted in debonding of the mesh reinforced plaster layer.

The crack pattern of the ferrocement jacketing repaired panels of both series were similar to the corresponding W-FC reinforced panels. Before failure, after unloading, the diagonal cracks were not visible to the naked eye. Because of this reason, during testing stage, all the developed cracks were marked with a graphite pencil at various loading stages. Apart from the usual cracking mode, debonding of the repairing plaster layer was observed.
