Non-Destructive Damage Detection and Retrofitting Techniques on a Historical Masonry Tower

Dora Foti¹, Mariella Diaferio¹, Marilena Venerito²

The aim of the paper is to detect the damage of the bell tower of the Church “Santa Maria della Natività”, Noci (Bari, Italy) that in 2012 was hit by a lightning and to propose a retrofitting solution. The solution must be designed to improve the constructive regularity, the strength and ductility of the structure, especially on the more resistant structural elements or on the mechanisms of collapse so as to transform them from brittle to ductile ones. The tower is 35 m tall and it is structurally connected to the Church for about one third of its height; the remaining part of the tower is totally disconnected from the structure of the Church. The results of the experimental tests have been analyzed in order to estimate the modal parameters of the tower and to calibrate a 3D finite element model of the tower in order to design *ad hoc* improvement interventions.

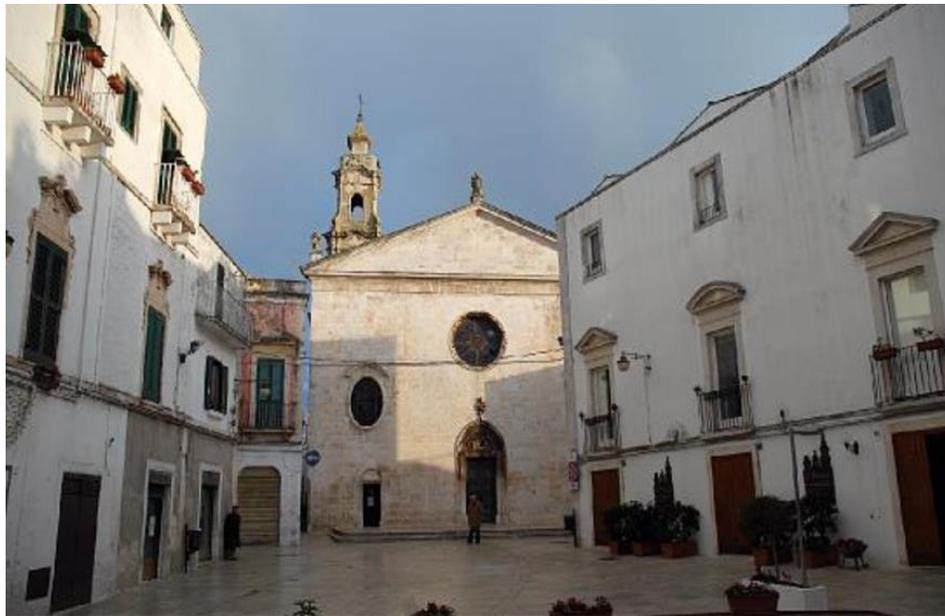
Figure 1 Church of “Santa Maria della Natività”, Noci (Bari, Italy).

In this paper a series of in-situ tests have been performed in order to detect the damage of the bell tower of the Church “Santa Maria della Natività”, Noci (Bari, Italy) that in 2012 was hit by a lightning (Figure 1). The aim is to propose a retrofitting solution to improve the constructive regularity, the strength and ductility of the structure, especially on the more resistant structural elements or on the mechanisms of collapse, so as to transform them from brittle to ductile ones.

The bell tower was built, in substitution of the existing one, between the 1758 and 1761, by architect Magarelli from Monopoli (Bari). It is 35 m tall and is structurally connected to the Church for about one third of its height; the remaining part of the tower is totally disconnected from the structure of the Church.

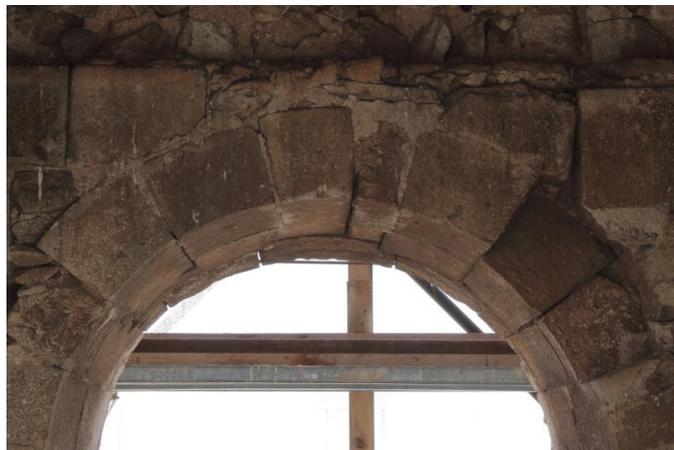
From the analysis of related endoscopic inspections, integrated with 2D and 3D radar tomographies, it has been possible to reconstruct the masonry stratigraphy; it is everywhere composed by a layered masonry, interspersed with cavities of a reduced thickness formed by little altered material.

Figure 2 Internal disconnection of the keystone of an opening in the belfry.

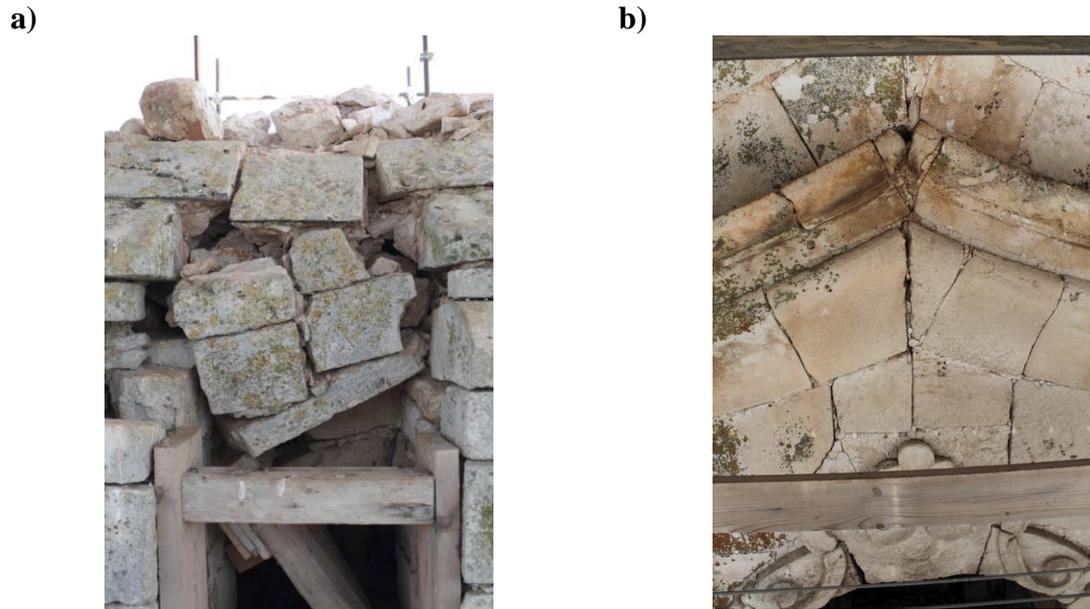
The application of the verification method assumed the analysis of the local mechanisms significant for the construction, identified considering the wide crack pattern that affects the masonry of the bell tower of the Church.

Figure 3 Disconnection a) at the basement level of the spire collapsed because of lightning; b) at the level of the keystone of an opening of the belfry.

- On the cantonal connection between the dividing walls, in correspondence of the vault pressure (lower zone) and at the base of the spire, at the base of the third and second level (higher zone) it is expected to insert the wooden bars connected by threaded steel tie rods with external anchor; the utilized mixture will be made of premixed mortar based on hydraulic lime.
