STRUCTURAL BEHAVIOR AND ASSESSMENT OF BAJRAKLI MOSQUE
IN WESTERN KOSOVO

A THESIS SUBMITTED TO
THE FACULTY OF ARCHITECTURE AND ENGINEERING
OF
EPOKA UNIVERSITY

IN PARTIAL FULFILLMENT OF THE REQUIREMENTS
FOR
THE DEGREE OF MASTER OF SCIENCE
IN
CIVIL ENGINEERING

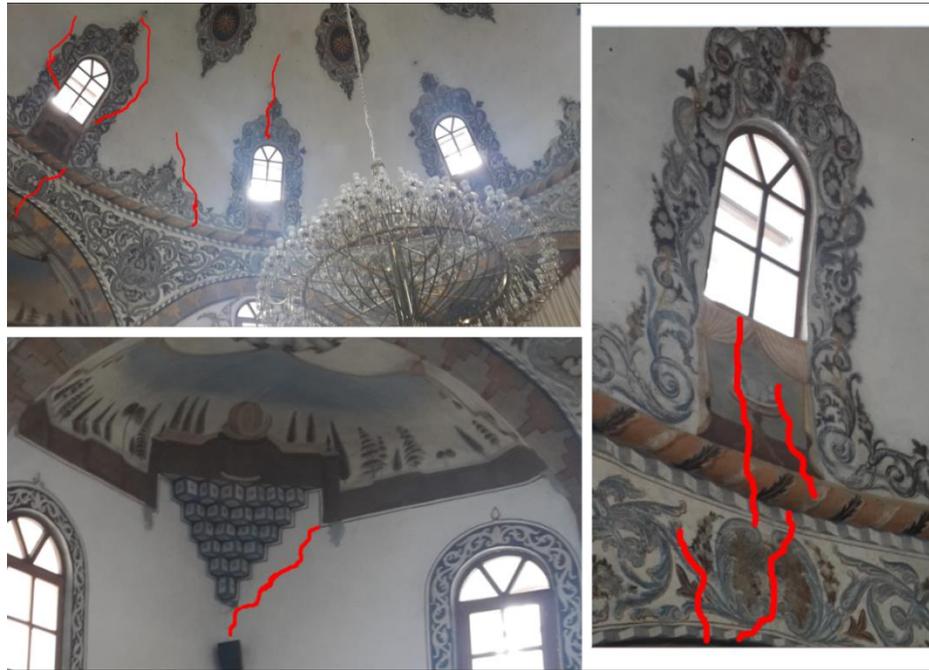
Figure 10. Crack inspection at domes, arches and pendentives.

While checking in the interior of the structure, there are found some cracks in the domes, pendentives and arches. Considering the fact that those cracks can not only be plaster cracks but structural cracks as well, it is important to identify them as structural deficiencies. Cracks may have been development from different factors such as bad maintenance, aging of the materials, weather conditions, improper isolation, moisture, earthquake loads. The following figure show the interior cracks of domes, arches and pendentives.

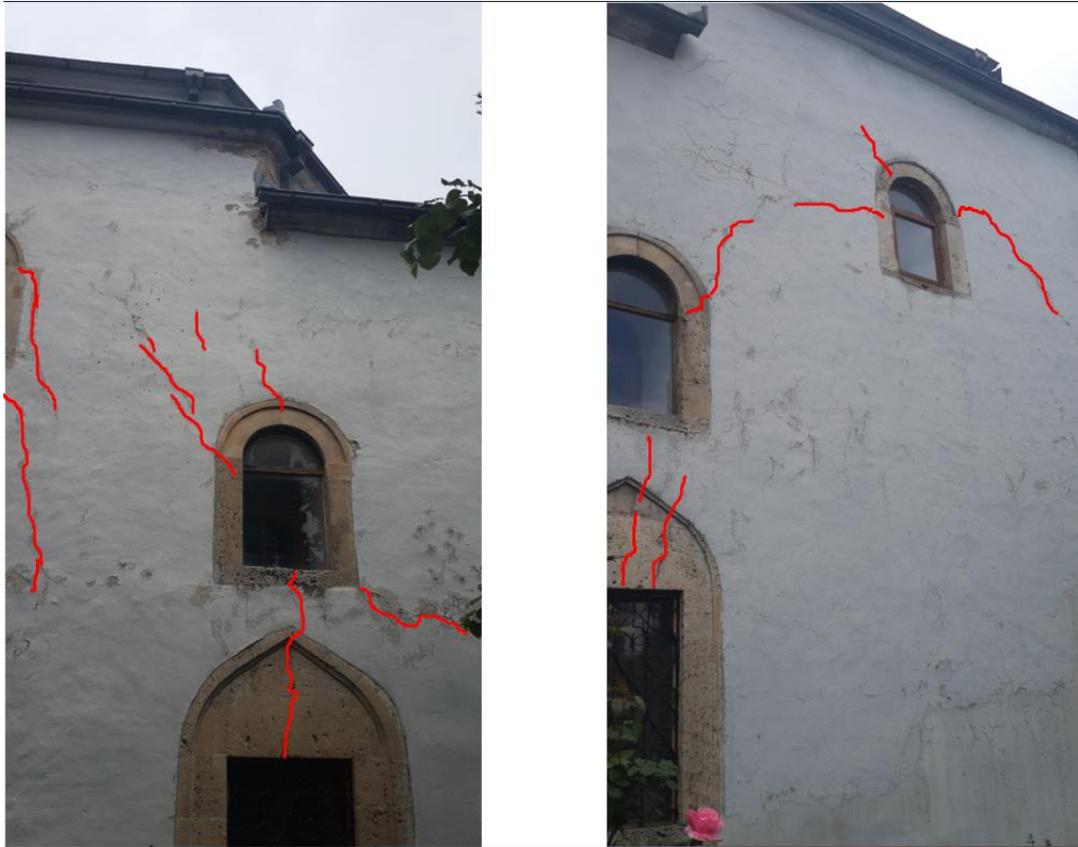
Figure 11. Crack inspection at load bearing walls.

Generally, damages in masonry structures occur in the main body of load bearing systems. From site inspections, many cracks can be identified in the load bearing walls of the structure. All of the façades of Bajrakli Mosque suffer from structural cracks. Many of the cracks can be seen close to the edges of the windows, and extending along the walls. Some of the reasons for the cracks developed in load bearing walls are such as, the compressive stress as a result of vertical loads, shear stress as a result of lateral force, tension forces, cracks due to earthquake forces etc. The following picture shows the cracks on the bearing walls of the structure.

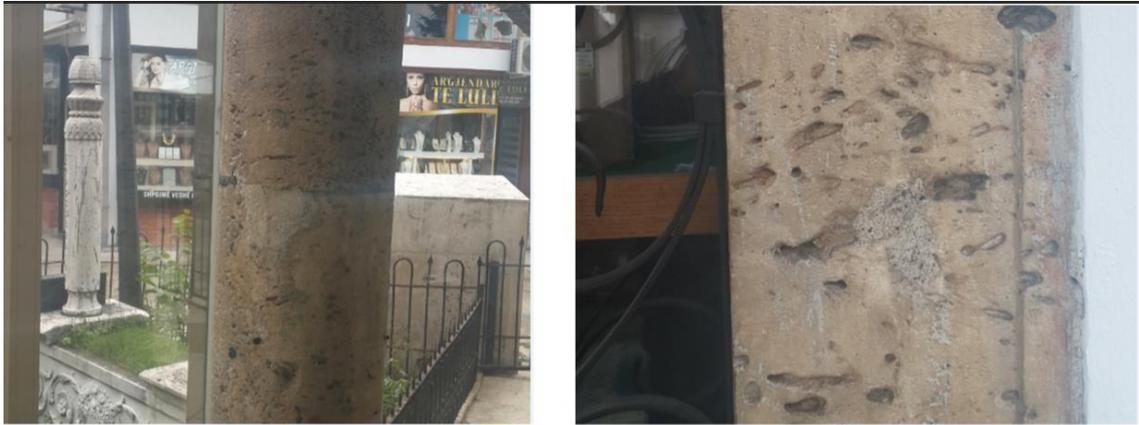
Figure 12. Stone porosity inspection.

Material properties are the basic general parameters in FE modeling of structures. The selected parameters are selected considering the literature survey method from the previous chapter. Some initial information on the material can be also perceived visually. During the site investigations, it is seen that stone masonry blocks used for building the Bajrakli Mosque show high porosity. Figure 12 is a picture taken during site visit.

Porosity of materials is an important factor affecting the stony masonry. It is one of issues that lead to some property changes in the material. Environmental conditions are one of the causes that cause changes in the masonry block, because of high porosity. The pores present in the masonry may allow amount of water to move through the stone. Thus, such process may cause changes in the durability of stone. With the water moving through the stone, there may be some problems such as frost attack, and/or the transported salt through the pores with moving water.
