Architecture, identity and phases of construction of the Byzantine church of St. Mary Vllaherna – Berat/Albania

Klodjana Gjata, Marsela Demaj, Ronela Çuku

This article is the result of a research study on the Byzantine Church of St. Mary Vllaherna. It aims at the study of the architecture, phases of construction and transformations in time of this church. Today St. Mary Vllaherna presents an unusual architectural plan, an infinity of material traces testimony of its transformation in time and an outstanding interior frescoed by Nicholas Onufri in 1578. For the above reasons St. Mary Vllaherna is chosen as a case study for this research.

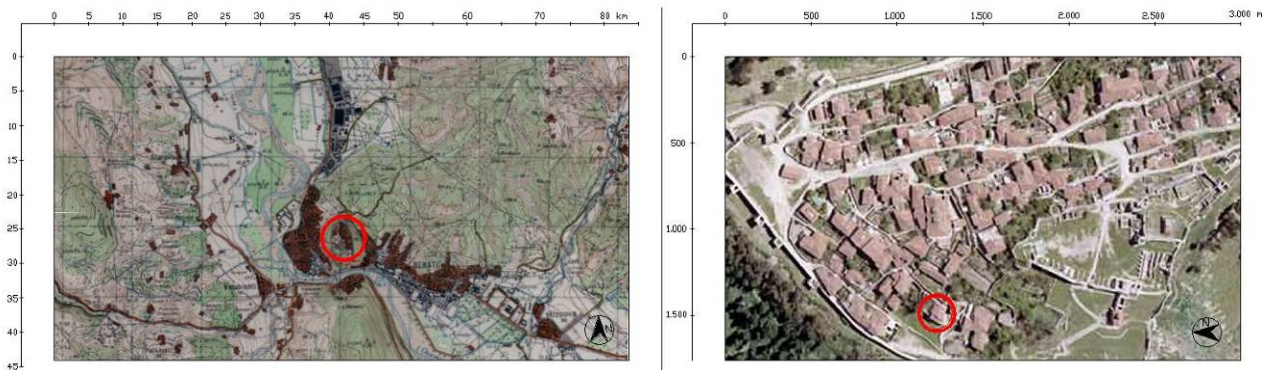
Fig. 1: Location of the castle in the city of Berat (left) and location of St. Mary Vllaherna in the castle (right)

The church of St. Mary Vllaherna is located within the inhabited historic district of the castle of Berat. Precisely it lies in the western part of the castle, on a steep terrain surrounded by the houses of the Kala district. According to oral testimony it is the oldest church in Berat. The name of the church, St. Mary Vllaherna in iconography is closely linked to the Byzantine Empire. No other medieval church in Albania is dedicated to St. Mary Vllaherna, so it is assumed that this name is brought from outside, probably from Constantinople. The earliest usage of this name dates back to the 2nd century. In the 6th century it was

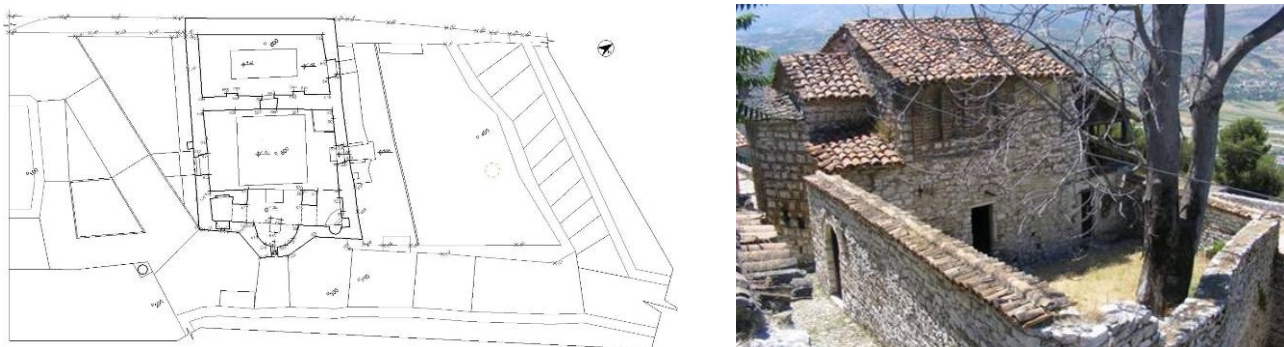
Fig. 3: Gen-plan of the church (left) and view from the north

The rectangular shaped naos of the church is preceded by a narthex and in the southeast it ends with an slightly raised semicircular apse, which is concave in the inside and polygonal in the outside. In the north it faces a small courtyard enclosed by walls with an entrance from the east (fig.3).

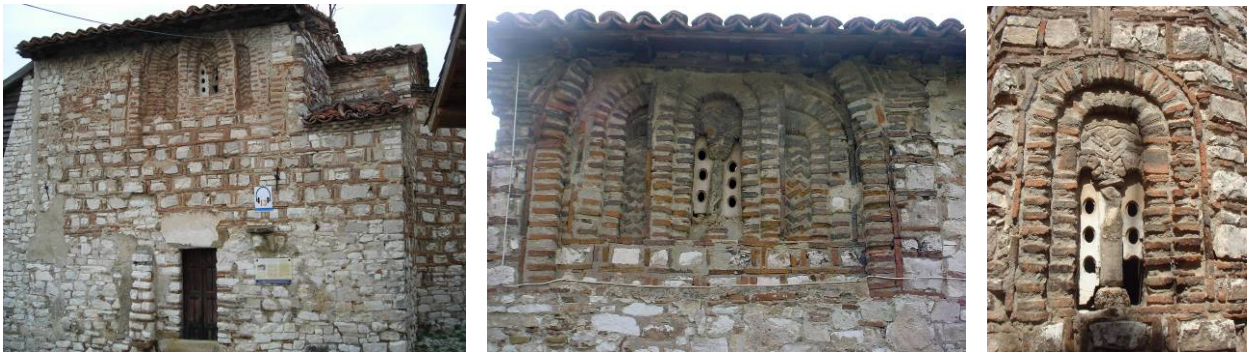
Fig. 4: View of the windows respectively in the south, north and est elevation

Two robust pillars divide the naos into two main areas: the central hall and the altar. The apse is located at the centre of the altar area while to the sides are the diaconicon, separated from the hall by a wall with rectangular bays and the prothesis, with rectangular and semicircular bays, both of which are vaulted. The naos has windows in all sides. The windows of the altar, north and south walls are biforate decorated by two lateral semi-archs and a double central arch in bricks. In the north and south wall the outer arch in bricks that decorated the windows is non complete in height (fig.4).

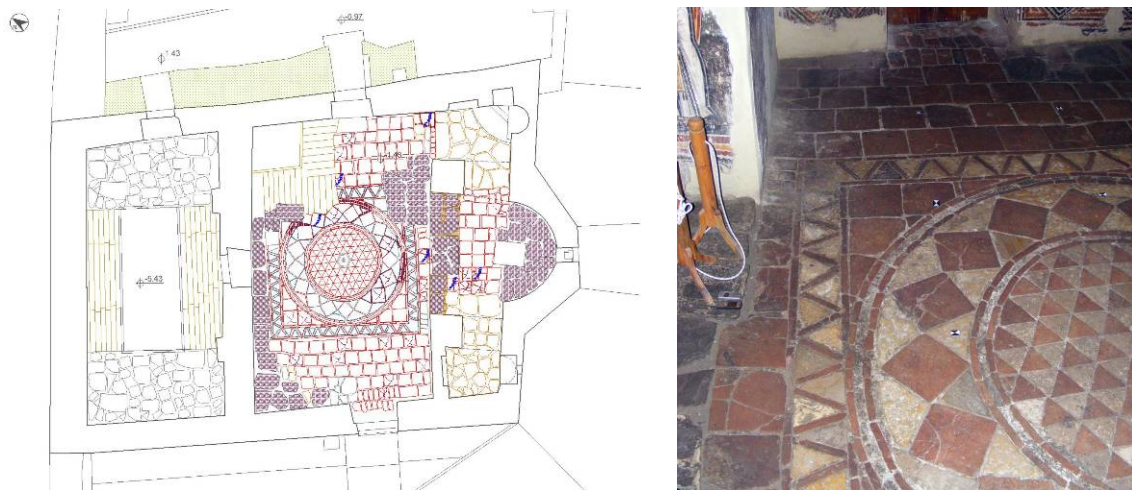
Fig. 5: Plan of the church-different materials and patterns on the pavement (left), Partial view of the pavement (right)

The pavement of the central hall is decorated by a square earthenware tile carpet with an inscribed circle. The rest of the church area is paved with different materials (stone, brick tiles and wood) showing a superimposition of different phases (fig.5).

The pavement of the narthex (the area around the cistern) is in stone slabs in the north and south and wood material in the east and west sides of the cistern (fig.5).

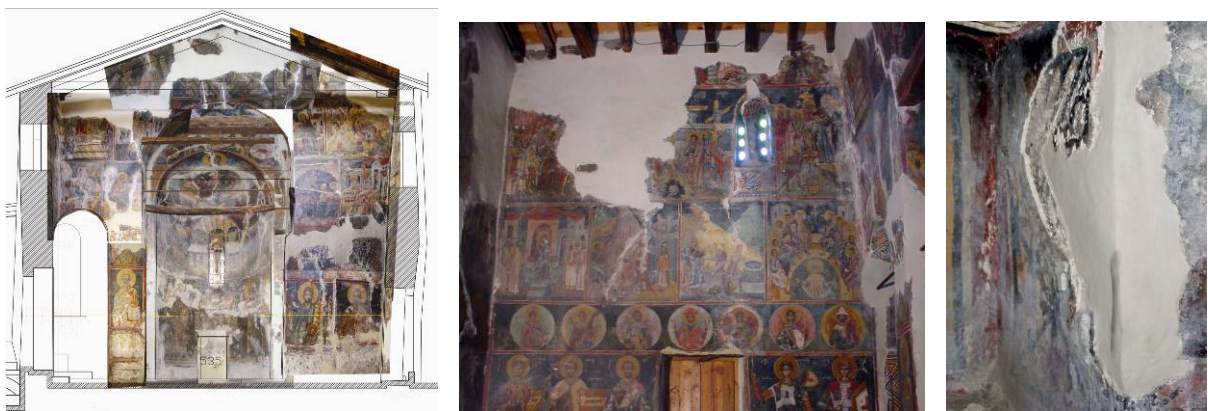
Fig. 6: Section B-B facing altar-frescoes rendered in photographic relief image (left), Frescoes in north elevation, Two layers of fresco (right)

In the interior the walls of the church are entirely frescoed with paintings signed by Nicholas Onufri and dating back to 1578, as it can be seen in an inscription located over the door that connects the naos with the narthex. A superimposition of two layers of frescoes can clearly be seen in the niche on the left of the apse. The layer beneath dates back to an earlier phase of decoration of the naos (fig 6).

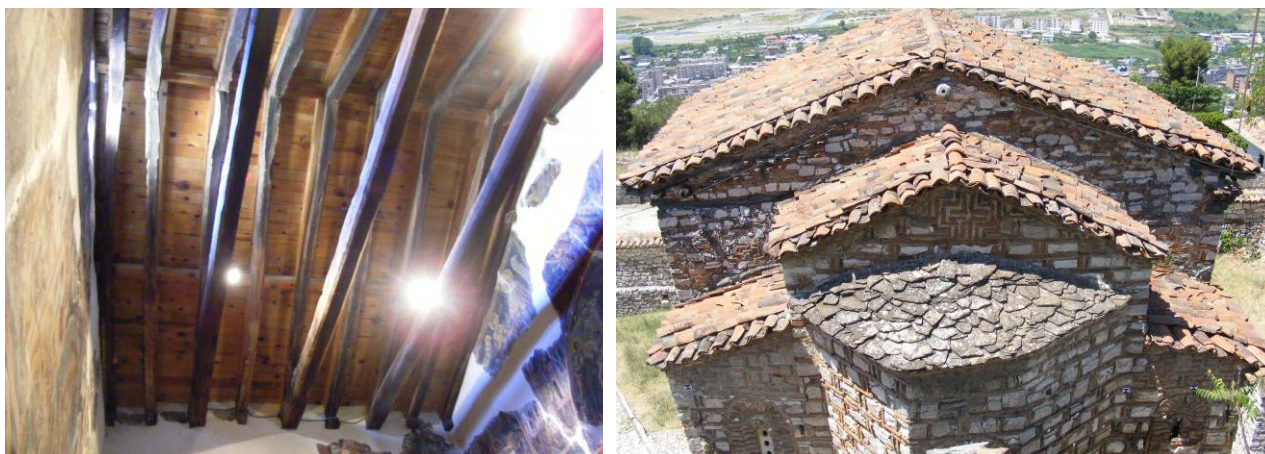
Fig. 7: View of the structure of the roof (left) and view of the roof (right)

The naos is today covered by a structure of timber frame trusses, covered with tiles, while only the apse is covered with stone slabs (fig.7).

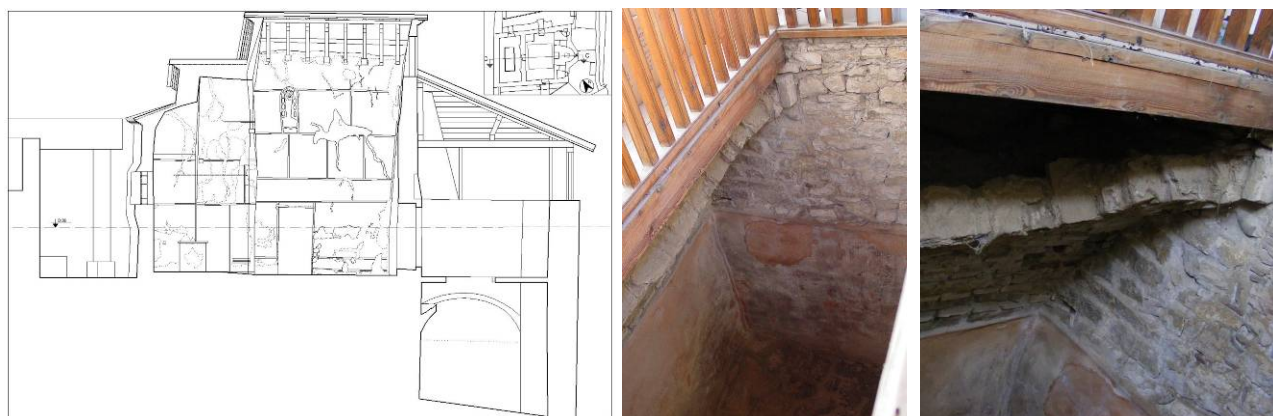
Fig. 8: Section C-C showing the location of the cistern (left) and views of the remaining structure of the cistern (right)

The walls of the narthex reach the level of the door architrave. In elevation these walls are covered by a wooden structure (constructed during the restoration works in 1978). A cistern is located beneath the narthex. It was covered by a barrel vault, of which today only the points of attachment remain (fig.8).

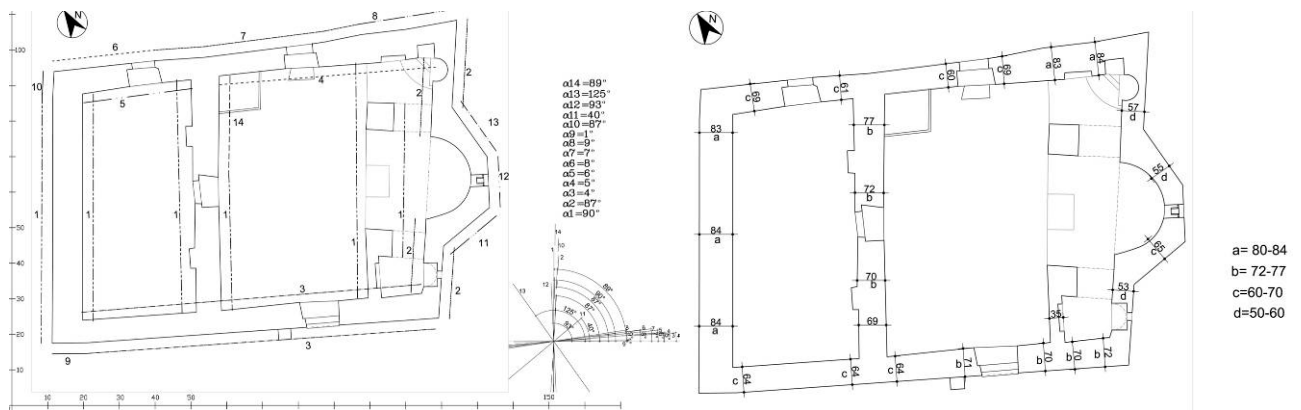
Fig. 9: Study of wall alignments (left), Range of the wall thicknesses (right)

The density of wall stratifications in St Mary Vllaherna can be seen in the varied thicknesses, from 53 cm on the apsidal side to 84 cm at the north west head, and through the uncertain course of the walls, conditioned by being out of plumb and unbalanced but also by an initial adaptation of the plan to the evident urban and morphological constraints of the area (fig. 9). Nonetheless, a proportional reading of the edifice reveals yet more design criteria that can be used to understand the original layout; basing the depth of the naos on the size of the apse (in a ratio 3:1), with the former corresponding to the size of the presbitery. Less precise is the

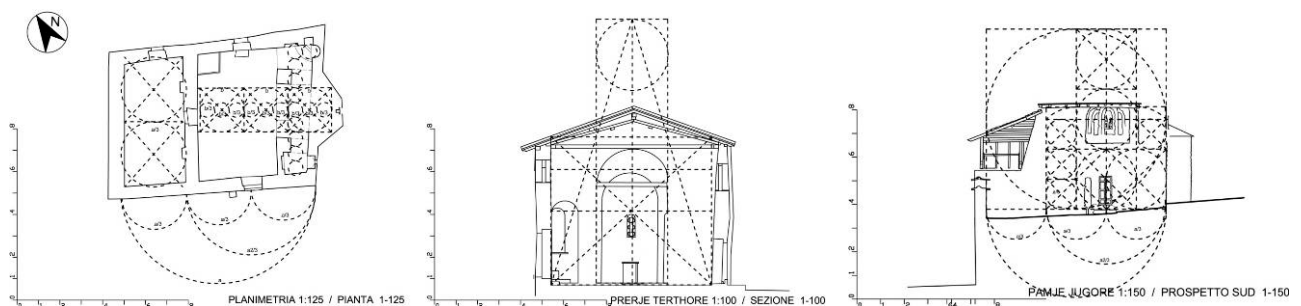
Fig. 10: Geometrical-proportional study in plan, section and elevation according to the "harmonic section"

ratio between the dimensions of the narthex and those of the naos; while comparison of the elevation shows that with the loss of the roof due to a probable collapse of walls and pillars towards the north west, the structure has remained irreversibly compromised (fig.10).

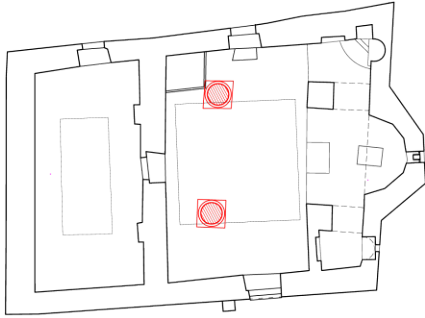
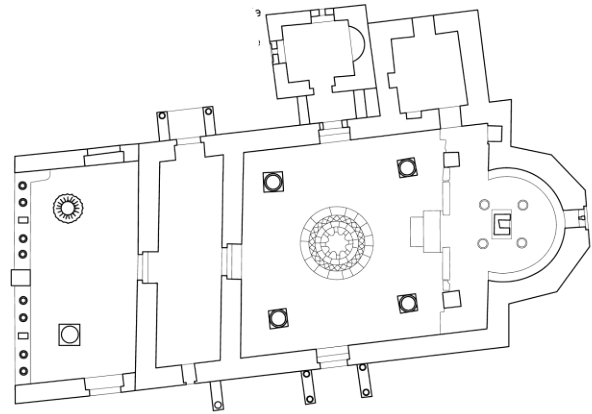
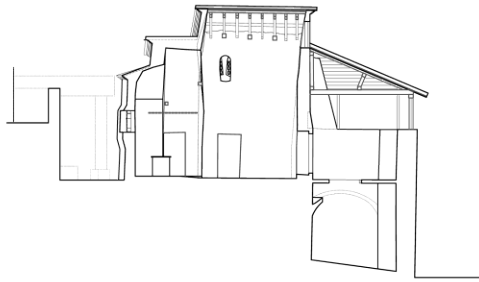
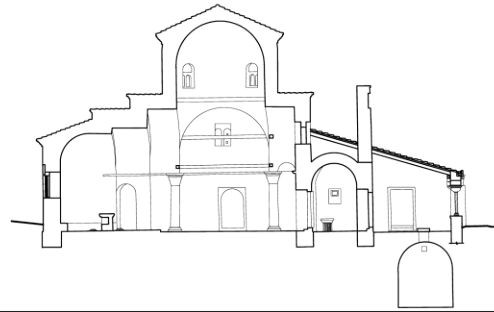
Fig. 11: Comparison in plan and section between St. Mary Vllaherna and St. Mary in Apollonia / Albania

The plan of St. Mary Vllaherna has a rectangular shape slightly rotated (towards south) around the longitudinal axis. Although this is a common feature in byzantine architecture, this configuration could be also due to the sloped terrain in which the church is located. Comparison made with the 11th century church of St. Mary in Apollonia/Albania show high similarities regarding the deviation of the plan around the longitudinal axis. Both churches are composed by a naos and a narthex and St. Mary of Apollonia has a cross shape with central dome. Traces found in the north elevation of St. Mary Vllaherna show the presence of an auxiliary space in this side, as it can also be seen in St. Mary in Apollonia. In section, both churches have a cistern area underneath the narthex (fig.11). Comparisons with other churches show clear similarities in the altar area. Based on the structure of the bema, presence of two pillars on the east, and the found traces of the two other pillars on the west, the identification in St. Mary Vllaherna of an inscribed-cross plan with a central dome is possible. Eventhough today there is no trace of columns, based on the observations made in site and on the comparison made with Holy Trinity Church in the castle of Berat, it is assumed that the dome rested, probably, on two pillars and two columns (fig.12). The areas on the right and left of the apse were covered with barrel vaults, as can be seen today in the prothesis. Similarities in the central part of the naos and apse are evident also from the comparisons in elevation with St. Mary in Kakome and St. Mary in Malçan in Saranda. Comparisons made in the elements of the facades show that in general the windows and the walls of byzantine churches were framed by rows of bricks put in saw-teeth shape as it can be seen in St. Jovan and church of Peribleptos in Macedonia. In St. Mary Vllaherna, this type of frame is partially preserved in the east wall and windows.

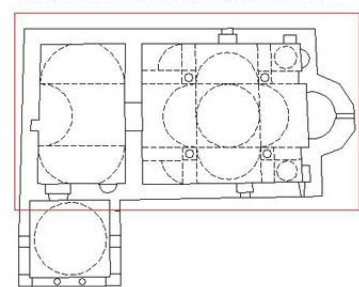
Fig. 12: Comparison in plan between St. Mary Vllaherna, St. Mary in Kosina / Saranda, Holy Trinity in Berat and St. Mary in Saraqinisht/Gjrokastra - Albania

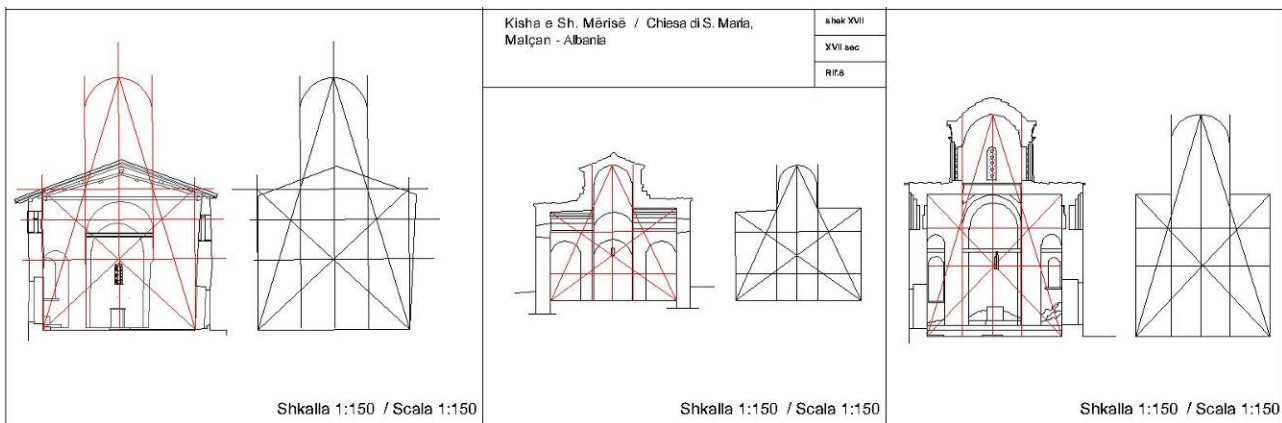
Fig. 13: Comparison in section between St. Mary Vllaherna, St. Mary in Malçan / Saranda and Holy Trinity in Berat – Albania

However, it might be of interest to reconstruct the internal section of the original collapsed church through a system of "harmonic section", taking in comparison for example the church of St. Mary in Malçan, near Saranda or Holy Trinity church in Berat.

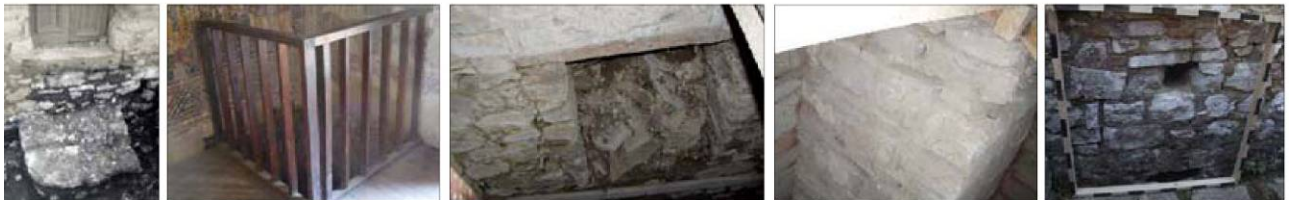
Fig. 15: 1-level of entrance in north elevation, 2-view of north-west corner where surveys were made in the interior, 3-pre-existent masonry found below the pavement level, 4- 3rd pillar found in the western part, 5-type of masonry of this phase

A major restoration was carried out in St. Mary Vllaherna in 1980's by the specialists of the Institute of Cultural Monuments. During the restoration works in 1980, excavation surveys were performed inside the church area. From the surveys it was discovered that the type of masonry below the level of the pavement (northwest corner of the naos) was different from the masonry above. Also it was noted that the two walls identified under the pavement level do not bind to each other. In fact, the west wall abuts the north wall. Based on the difference of masonry it can be assumed that the area below dates back to an earlier phase. This phase is identified from the traces of the walls below the pavement level (which have also an opening – probably a window) and the discovery of an early Christian cross carved under a stone in the north wall. Based on these traces the preexistence of a church (probably paleochristian) can be assumed. Excavation surveys carried out in the courtyard discovered some tombs that indicate that probably the level of the ground was lower. The cistern area was filled up and excavation surveys in this part discovered that in a previous phase the cistern was used as a cemetery area. The excavation surveys done in the central hall of the church discovered a foundation of a pillar (or column). The stone pillar has a different masonry from the other discovered traces of walls (fig.15).

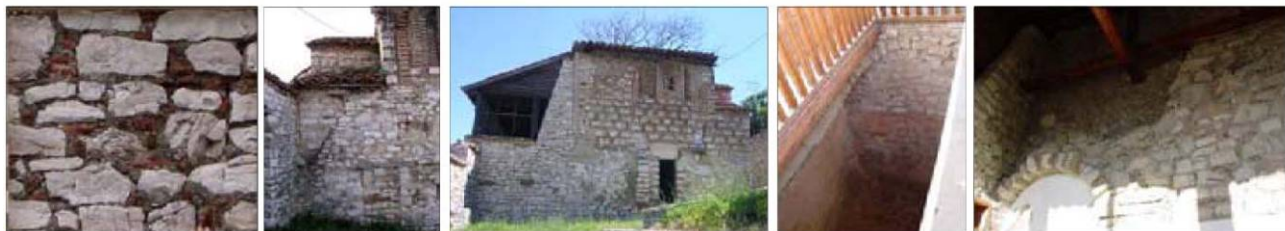
Fig. 16: 1-type of masonry of this phase, 2-traces of walled-up door in the north elevation, 3-south elevation, 4- view of *cocciopesto* plaster in the cistern area, 5-traces of three arches in the west elevation of the naos

The identification of different range of masonry types as well as the differentiation of older parts of walls from the more recent ones was done by visual inspection of the facades. The observations focused on the identification of materials and construction techniques used. The presence of the technique of cloisonné (combination of stones and bricks) was noticed in north, east and south wall. During the comparative study of the types of masonry, similarities were found between the masonry used in the castle walls (north entrance gate) and the east front of the church (base). This type of masonry is characterized by irregular stones and pieces of bricks and is coeval to the cloisonné.

In the north wall, there are traces of a door (now walled), visible from both outside and inside. Above these traces, from the outside, the wall is set a little behind the overall front and has a curved shape. These traces as well as other observations and data on the fresco of the naos, suggest the existence of an auxiliary room to the naos. Two layers of fresco, one above the other can be observed in the niche on the left of the apse. Art historians are of the opinion that the underlying layer, based on the simple technique used and in the almost primitive way of painting the clothing of the saints, can be dated to the middle or end of the 13th century². The fact that the north wall of the naos is attached to the north wall of the narthex suggests that the church already had a narthex in this phase. Traces of three arches found in west elevation of the naos, strengthen the hypothesis that this area was covered by two barrel vaults, and a central dome on pendentives (the same structure of the church of Holy Trinity).

The plaster in *cocciopesto* of the water cistern under the narthex, is a technique seen also in the other byzantine cisterns in the castle. This is an important element for the datation of this phase (fig.16).

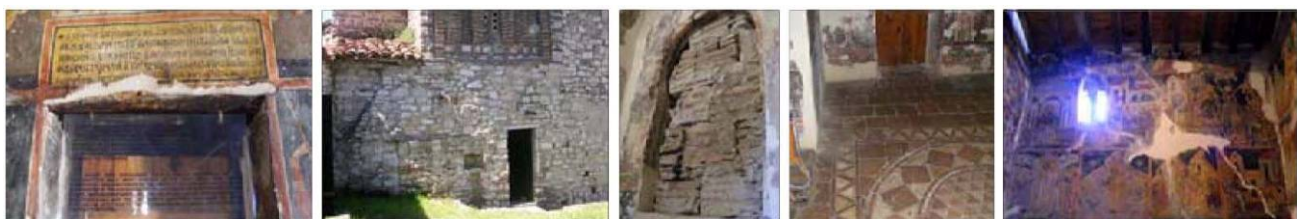
Fig. 17:1-inscription in the upper part of the door connecting the naos to the narthex, 2-traces of walled-up door in north elevation, 3-traces of walled-up entrance to the diaconicon, 4-view of pavement in stone and bricks, 5-view of the upper frame of frescoes

This phase is identified by the datation of the mural painting of the church. As it can be seen in an inscription left by the painter Nicholas Onufri in the upper part of the door connecting the naos to the narthex, the interior of the church was entirely painted in 1578. Observations in the interior determine that the church was already covered with a wood structure in the time of painting, which means that the coverage with wooden structure (after the crolling of the dome) is either coeval or preexistent to the painting. The collapse of the dome some time before this phase is probably due to an earthquake, a landslide in the west or the big load of the dome etc. The upper and lower frame of the paintings as well as the placement of wooden beams of the roof are strong elements that support this assumption. By the mural paintings and by observing the traces in the outer masonry, it can be clearly understood that the walling of the door in the north wall and opening of the present door in the same wall dates back to some time before 1578. The pavement in stone and earthenware bricks seems to be coeval to the painting of the interior. This can be verified by the frames of fresco in the upper and lower part (fig.17).

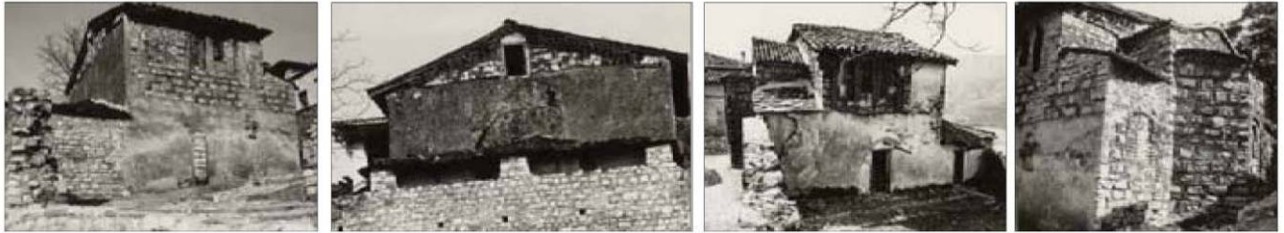
Fig. 18: Archive photos that show the state of the church prior to restoration (Archive of the Institute of Cultural Monuments 1970s)

The church was proclaimed “Monument of Culture of 1st Category” in 1948. A general survey of the church and the documentation of its state of conservation was done in the ‘70s by the Institute of Cultural Monuments. As it is seen in the archive documentation the church in this period was plastered in the south, west and north fronts. The present cracks in the frescoes are verified in the archive photos of this period. They are probably caused by the great reported earthquake of 1751, which caused much other damage in the historical inhabited centre of Berat. The narthex in this period was covered by a low hip roof. The entrance door in the south front and the window openings in the east were walled. The diaconicon covering structure

was sloped to the east instead of the classic slope of byzantine architecture to the south. The apse and prothesis were covered by stone slates while the rest of the roof was in tiles. The datation of this phase is assumed to some time after 1751. It presents minor interventions to the church, probably with the intention of reinforcement of the structure after the earthquake (fig.18).

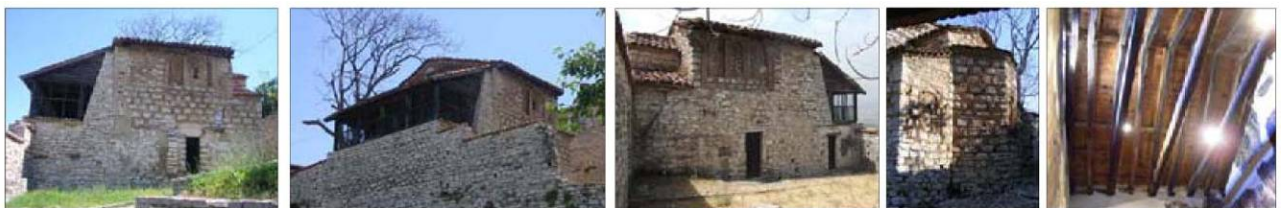
Fig. 19:View of present state of conservation of the church (elevations and structure of the roof)

The church was subject to restoration in 1980. The restoration works focused on:

1. Removal of the plaster visible in the archive photos of the '70s in the south, west and north fronts. In some parts the older plaster found beneath was left visible.

2. The walled door in the south front was opened.
3. The slope of covering structure in tiles of the diaconicon was changed to towards south (based on the byzantine typology).

4. Since the roof of the naos was damaged it needed a restoration. This was done by conserving the three wooden beams of the 1578 structure and by constructing over these beams a light weight wooden truss structure.

5. In the south-east corner the access to the diaconicon was found walled, and the entire area of the diaconicon was filled prior to 1578 probably to reinforce the whole structure. During the restoration works this area was freed by the fillings and re-opened to access. Traces of frescoes were discovered inside the diaconicon area. Its datation is not clear but based on its technique it is not attributable to Nicholas Onufri. Some hypothesis date it to a phase before 1578.

6. Based on the traces found in the west front the roof of the narthex was changed from hip roof to a light weight shed roof.
