TRANSFORMATION IN HISTORIC SITES: THEIR PRESERVATION  
THROUGH DIGITALIZATION OF INFORMATIVE INSTANCES REGARDING  
CULTURAL HERITAGE

CASE STUDY: G'JUHADOL/SHKODER

A THESIS SUBMITTED TO  
THE FACULTY OF ARCHITECTURE AND ENGINEERING  
OF  
EPOKA UNIVERSITY

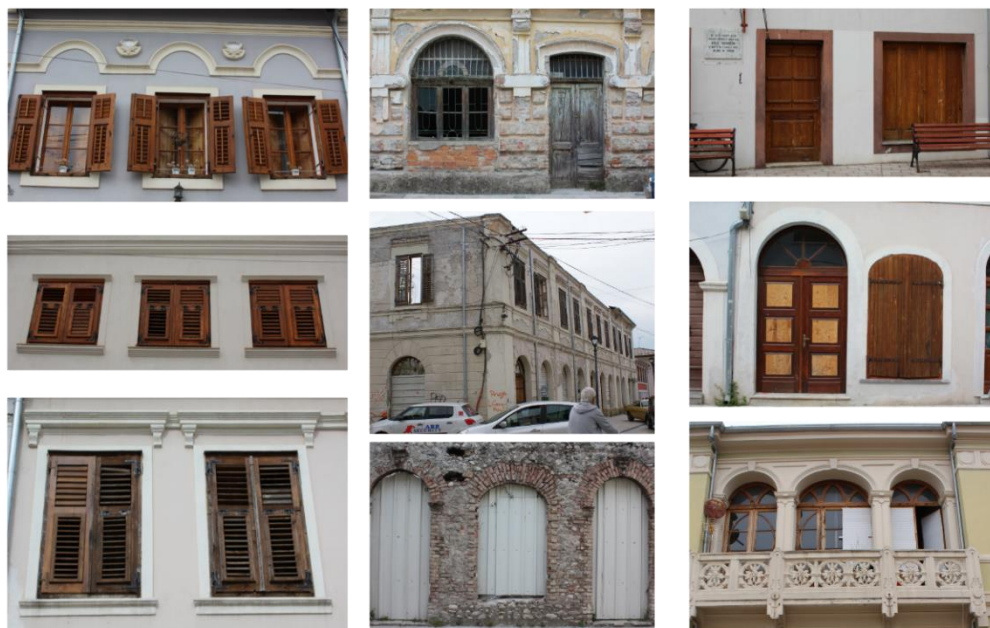
*Figure 8* Photos of the architectural elements of buildings located in G'juhadol, courtesy of the author

the exterior of the ensemble not uniform in architecture and volume, however this does not affect the compositional unity of this ensemble.

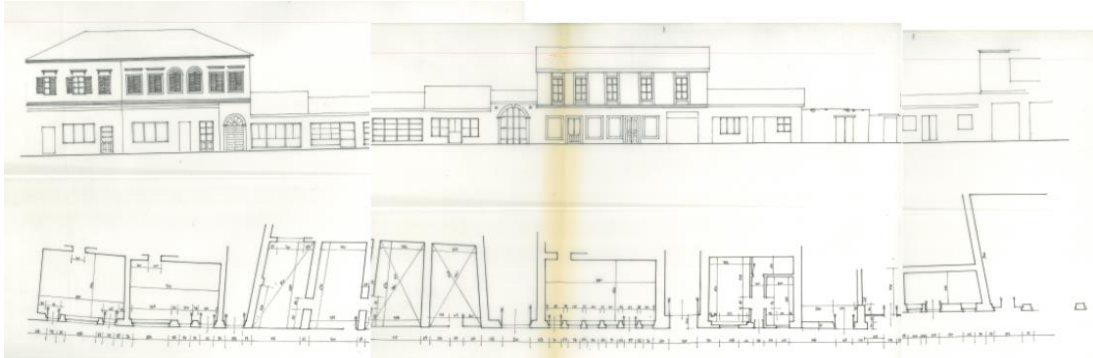
**Figure 14** one of the wings of G'juhadol

Another building has been completely transformed, leaving in place the existing traces of windows which would be better evidenced by stripping new plaster by defining exactly their dimensions. The type of windshield has been extracted from the photographic documentation. In addition to the placement of windows and complete plastering, the construction of decorative frames has been done and has been painted with oil paint.

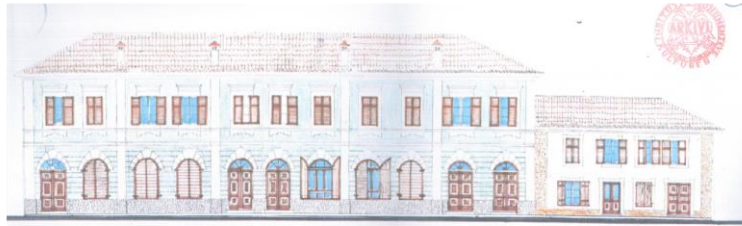
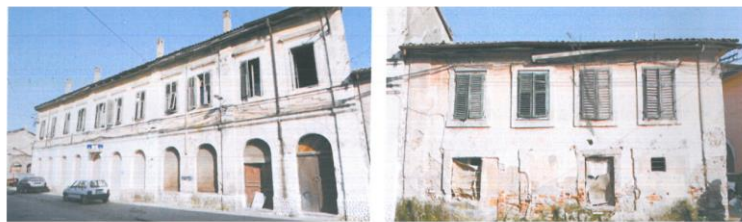
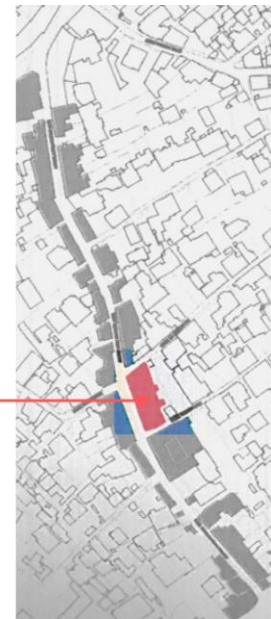
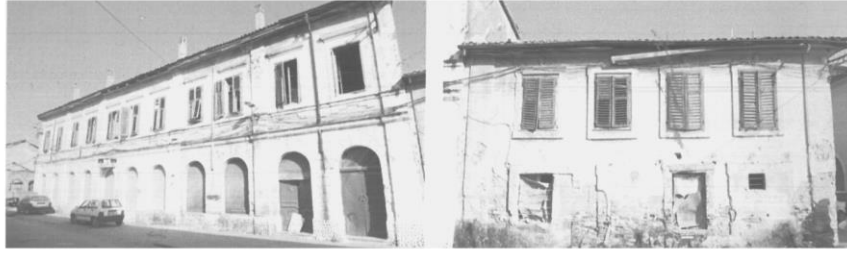
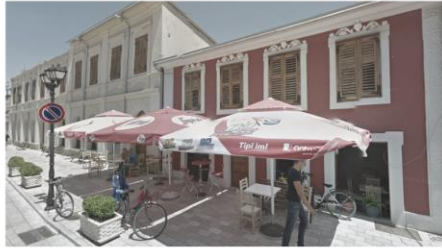
*Figure 15* comparison before-after (2011 reports, courtesy of IKTK)

restoration of:  
roof, plaster, shutters, windows,  
decorative frames, gutters,  
decorative painting of the building..

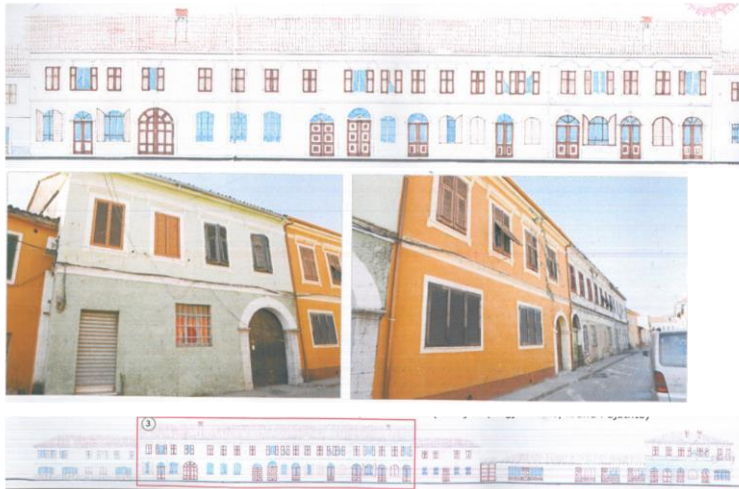
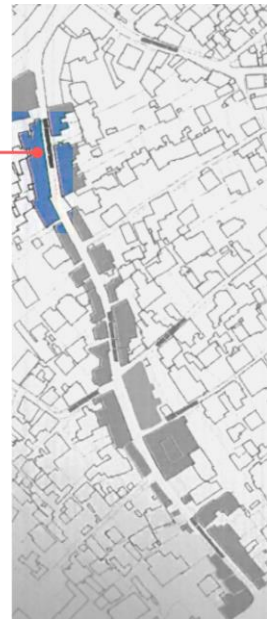
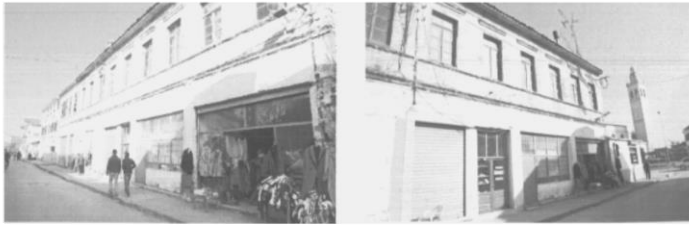
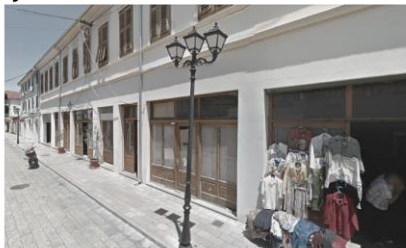
*Figure 18* comparison before-after (2011 reports, courtesy of IKTK)

restoration of:  
roof, plaster,  
shutters, windows,  
decorative frames,  
gutters,  
decorative  
painting of the  
building..

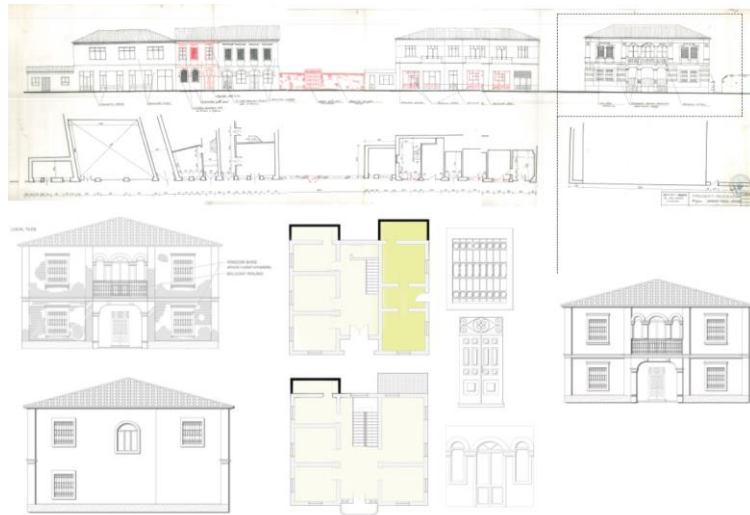
*Figure 35* Dr. Prelas house, drawings- courtesy of Lida Miraj, and IKTK archive

- *House construction is based on load-bearing wall. Walls are durable and stable due to their structure, so the villa doesn't need constructive reinforcements. To remove humidity it is important to verify its cause. If the humidity is as an outside phenomenon, because of the age, we remove the plaster under 'sicknesses' and then, after doing analysis how the plaster was made, put another plaster composed with the same components. If the humidity is in the ground floor, is important to clean around foundations and to do their hydro isolation.*
- *In order to remove stains caused by the humidity we will interfere with toothbrushes from sorghum.*
- *Where spots appear severe, they can be treated by washing.*
- *Restoring all the damaged parts.*
- *Painting with the original color each element of the façade*
