DOCUMENTING RURAL ARCHITECTURE IN BËNJA VILLAGE:  
RECONSTRUCTION SCENARIOS FOR HOUSES DESTROYED IN WWII

A THESIS SUBMITTED TO  
THE FACULTY OF ARCHITECTURE AND ENGINEERING  
OF  
EPOKA UNIVERSITY

JUNE, 2024

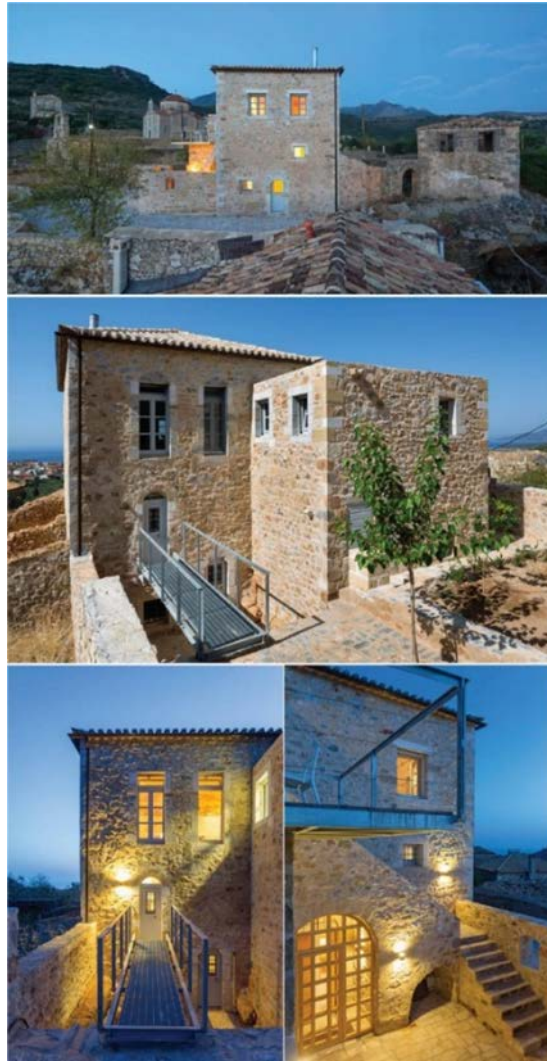
*Figure 11.* Stone house in Mani by hhharchitecs

Stone House in Mani by hhharchitects: In reconstructing this traditional house in Mani, hhharchitects aimed at preserving its existing stone shell while clearly differentiating new interventions. They used a lightweight steel construction to create visual contact between different levels and highlight the new interventions. The staircase, made from both marble and metal, connects the house's three levels. The 'outbuilding,' in direct contact with the main house, was reconstructed into a bedroom. The kitchen on the

upper level communicates with the dining room and sun terrace, which was expanded to create an outdoor seating area. The reconstruction maintained the integrity of the old wooden gate and connected various levels of the house through external staircases.

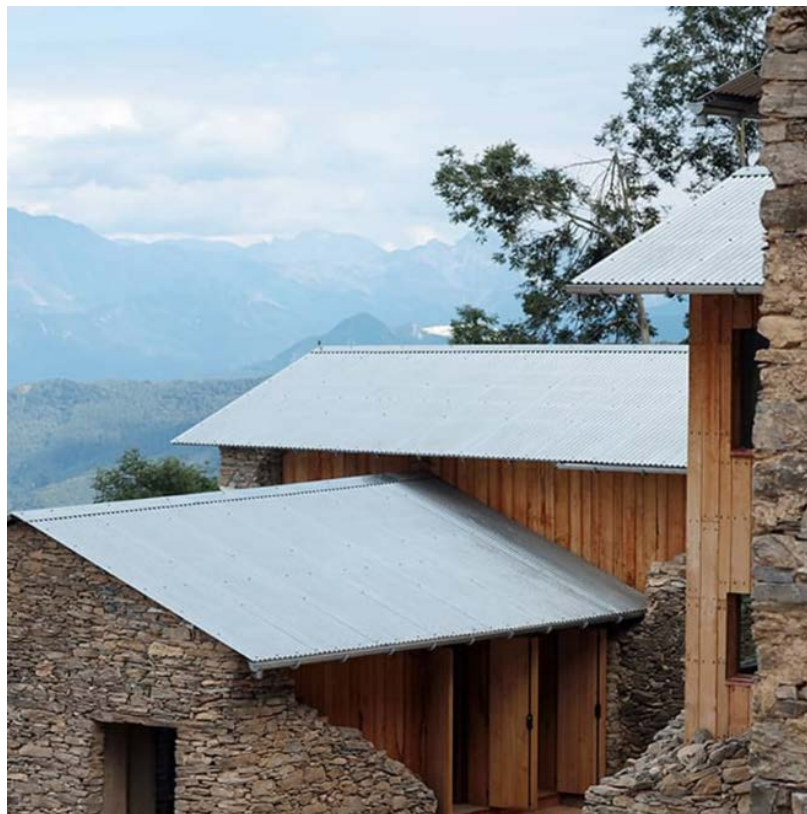
**Figure 12.** RECUPERO DELLA BORGATA PARALOUP  
Daniele Regis, Dario Castellino, RealyEasyStar

Recupero della Borgata Paraloup by D. Castellino, V. Cottino, G. Barberis, and D. Regis: This project revived the abandoned village of Paraloup in Valle Stura, highlighting the dialogue between historical heritage and contemporary architecture. The recovery preserved the site's identity, sustainability, environmental, and social quality, conserving and enhancing the architectural and landscape heritage. The project maintained the original layout and pedestrian paths, consolidating the ruins while recognizing and reconstructing the original volumes and geometries. Using traditional materials like untreated local chestnut and modern, invisible technologies ensured the intervention's recognizability and respect for the site's historical fabric. The project also integrated modern sustainable practices, such as photovoltaic systems and local wool insulation, ensuring the village's long-term viability and cultural activities.

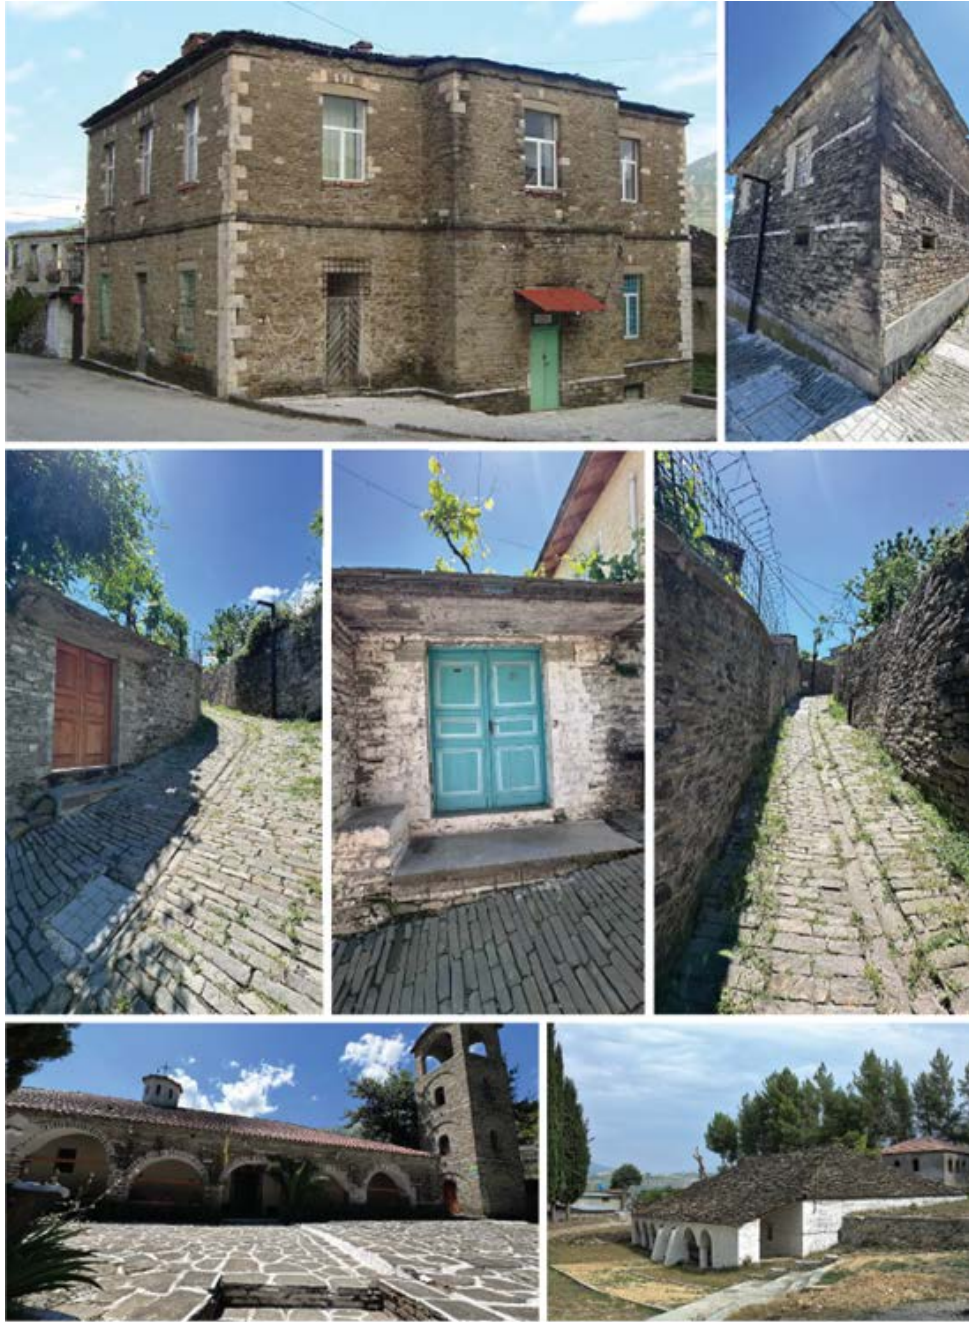
In Përmet there are characteristic houses, albeit transformed, arched gates and perennial cypress trees. The cemetery, which usually included the dwellings outside the fortresses, those under the foot of the castle, over time was known as the neighborhood of Shënkolli, since this neighborhood began to stretch under the foot of the Bolënga bank, from the end of the which the castle was located. his neighborhood, built almost from the southern side of Bolënga, went down to the other neighborhoods, over which it dominated as a position and had a wide view. The streets are paved for the most part with cobblestones made of limestone and river stones. In each stretch of road there was a central line for the passage of water, which was opened almost daily by the mills to guarantee the cleaning of the streets, gates and gardens. The houses of this neighborhood are built almost next to each other, with small yards or gardens and with a slight slope that is dictated by the terrain itself. The enclosures of the courtyards are mostly enclosed by high stone walls and sheltered wooden gates. Most of the houses are two-story with stone walls and stone-slab roofs, but there are also one-story or three-story houses.

*Figure 17.* Buildings from the early 20th, streets with cobblestones made of limestone and river stones.

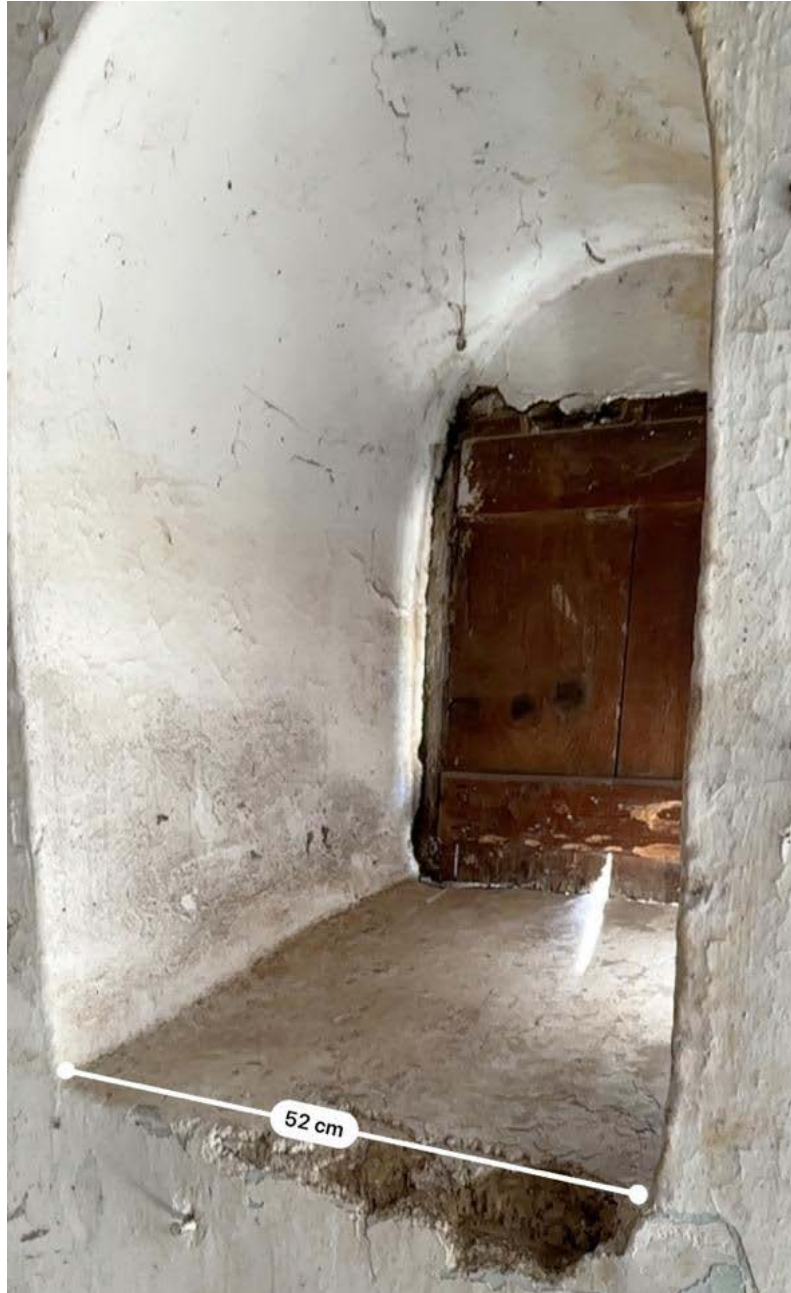
**Figure 26.** Electronic laser window measurements

Used innovative software systems to conduct precise measurements and scans of the selected houses. This innovative approach increased the precision and efficiency of data collecting, allowing for a thorough examination of architectural characteristics and details. The utilization of these advanced tools contributed to a more comprehensive understanding of the studied village.

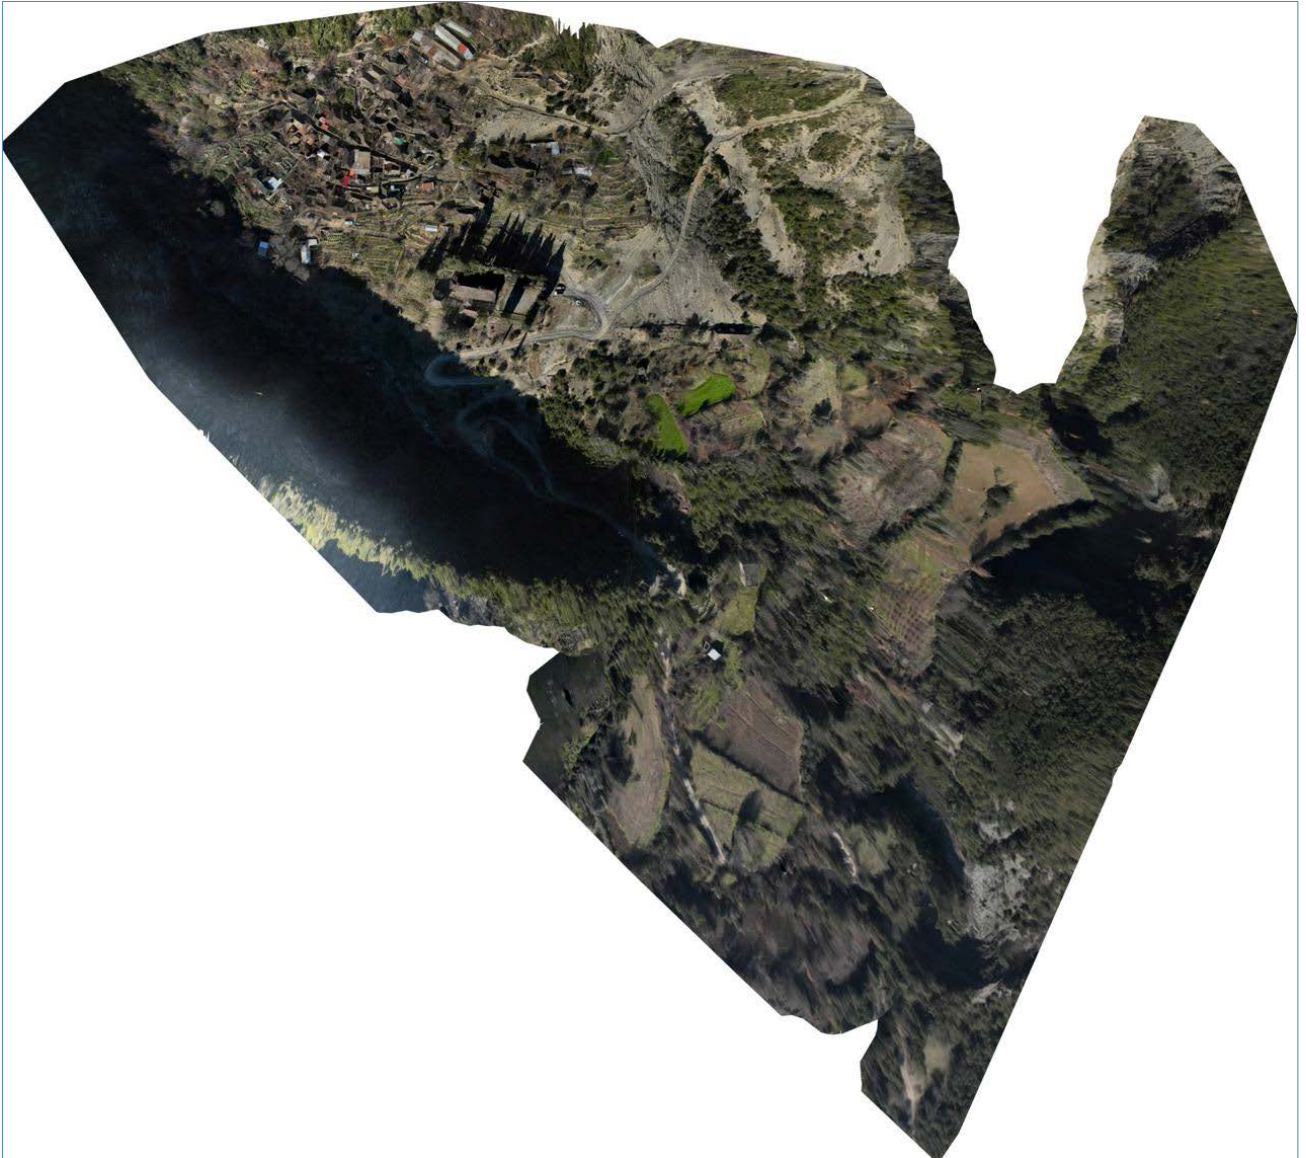
*Figure 28.* Aerial imagery depicts the village

Utilized drone technology to capture high-resolution images of the village, providing a detailed aerial perspective for further analysis.

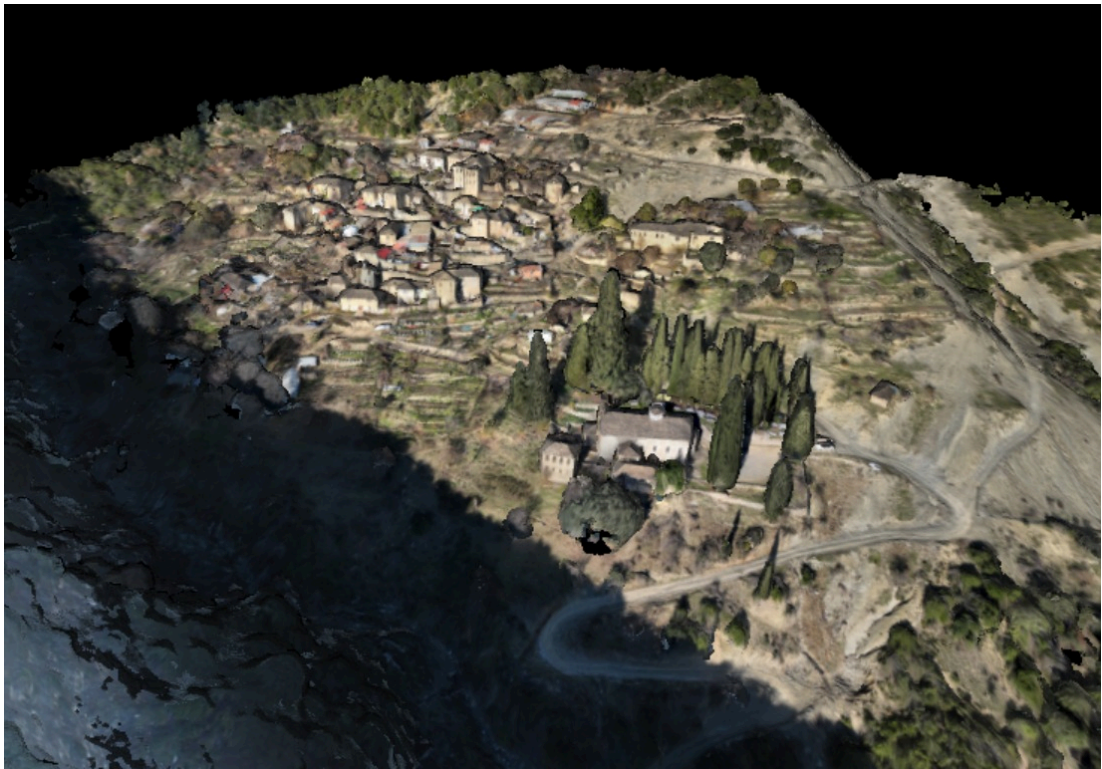
*Figure 31.* 3D developed via a drone

The collected drone materials aimed to create 3D images of the village by utilizing advanced software systems. This involved a thorough analysis of the dataset, involving the extraction of valuable information to enhance the precision of the visual representations. The detailed examination of these 3D images contributed significantly to a comprehensive understanding of the architectural and topographical aspects of the studied village.

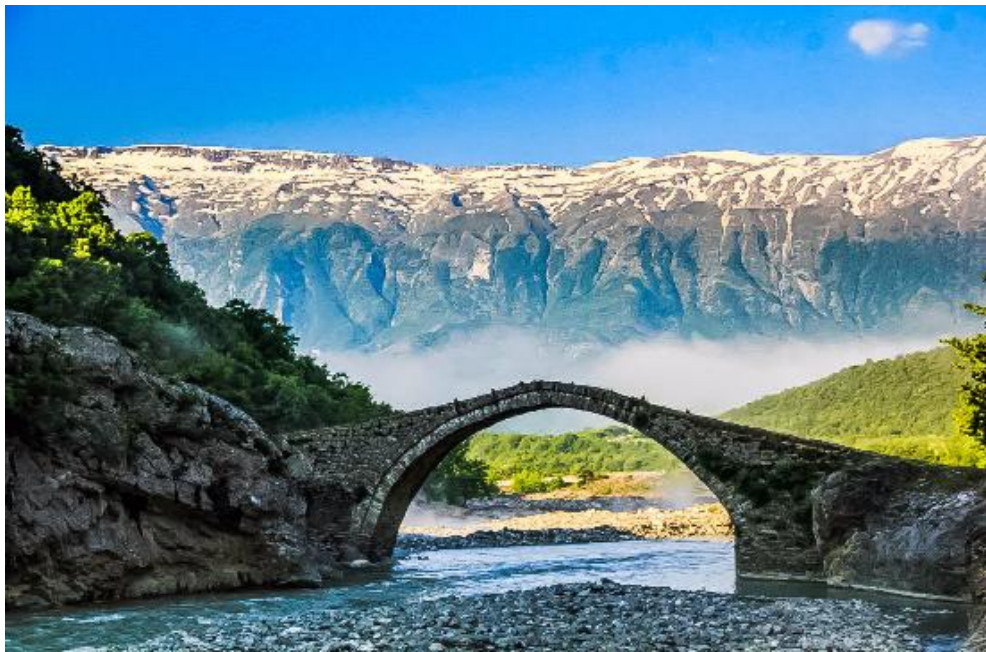
*Figure 36.* Katiu Bridge, surrounded by natural thermal springs

A few kilometers upstream from its confluence with the Vjosa River, precisely at the thermal baths, lies the Katiu Bridge, a structure of notable interest and relatively well-preserved. Built upon rocky cliffs, it presents architectural composition and constructional solutions of interest. At the center of the bridge's composition is the main arch in the form of a circular segment, with a span of 15.5 meters and a height of 6 meters above the water level. Including the arch ring, the thickness of the arch is 1 meter and is constructed with slab-shaped limestone blocks. At the lower end of the bridge, two metal hooks are still preserved for anchoring the spring stones. The bridge's pavement, with a length of 2.65 meters, is built with flat limestone blocks laid in a herringbone pattern. On both sides of the key, two concentric rows of river stones are raised above the pavement, facilitating ascent over the bridge's crest.

The Katiu Bridge, a humpbacked bridge, characterized by horizontal emphasis, with a larger main arch and a smaller one on either side, is a well-known type in Albania in the 18th century.

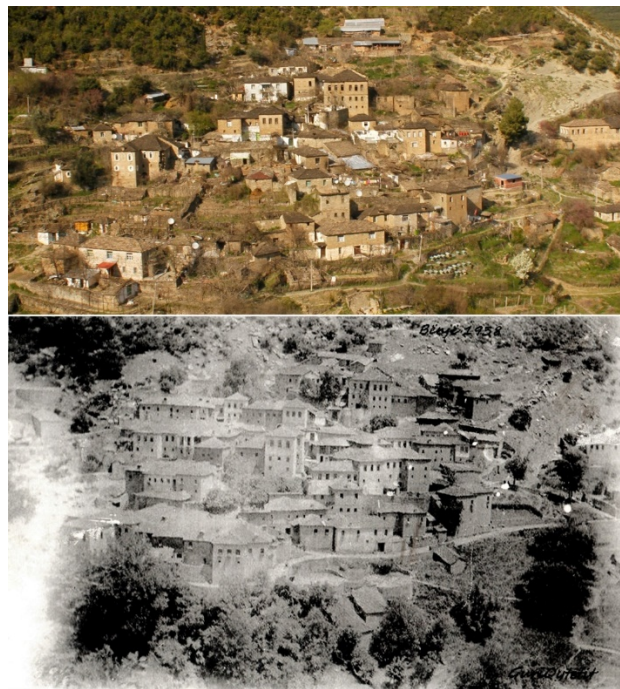
**Figure 38.** The image on the top displays the village nowadays, while the bottom image shows the village in 1930

village's founders, the family of Dona, family of Anastas, family of Llukani, family of Kici Spiros, and the family of Josif Tikos, family of Theofanise, etc. Locals also refer to other families as autochthonous, such as the Nasko, Budo, and Xhaje families. There is no certain information concerning the date of foundation of the current village. The only available ‘documentation’ consists of the inscriptions on the cornerstones and entrances of dwellings, all dated between 1860 and 1910. During this span of time, the South of Albania underwent substantial socio-economic changes, as well as wars and local conflicts. In this scenario the transformation of peasant houses into more complex configurations, similar to city dwellings, is frequent. Two-three storey fortified dwellings were built, sometimes giving rise to authentic fortified villages. The fortified houses of Bënjë, with aesthetic and typological features inspired on the stately homes of Gjirokastër, belong to this phenomenon. The destiny of Bënjë was permanently marked by World War II, when a large section of the village was destroyed. The amount of damage and the alteration of the original urban fabric can be seen by comparing the current state with a historical photograph from the Thirties.

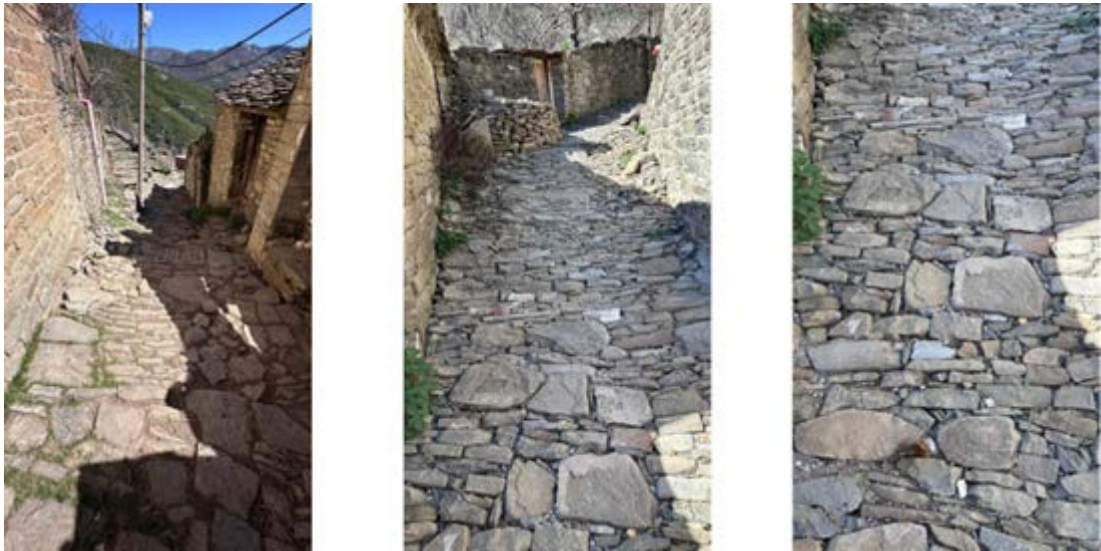
*Figure 49.* Cobbled pavements in the village

It is not known exactly when the cobblestones were built, but according to the data collected from the stories of the residents of the area as well as old photographs, the village was paved with cobblestones during the construction of the houses. Black river stone was used for the construction of the cobblestones. According to the data obtained from the interview with *Jorgji Kreci* (who is one of the only construction workers in the village as well as from the old families of Bënjë) but also from the traces that have remained, we understand that the cobblestones that are still today used to go all the way to the village of *Petrani*. Also, other residents testify that the cobblestones reached the lower area of the village until around 2000.

Based on the urban measurements and analyses I conducted, it appears that the width of the cobbled streets varies from 1.5 - 3m. Nowadays, the situation is not very good, many roads in the village are damaged or non-existent.

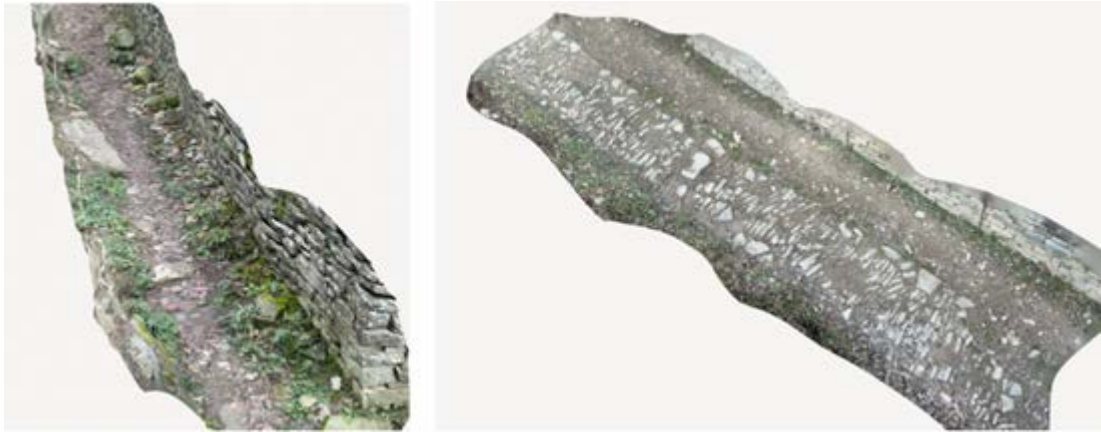
*Figure 50.* A 3D view of a section of road where the cobblestone pavement is severely damaged

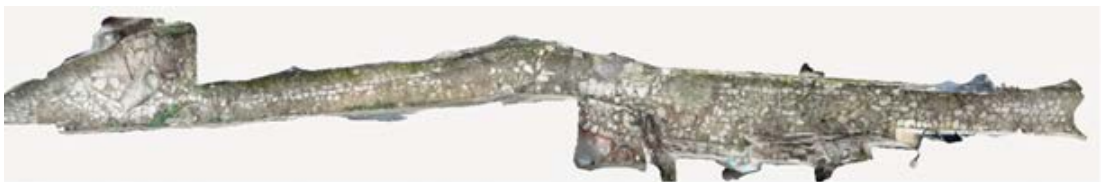
*Figure 51.* A 3D view of a section of road where the cobblestone pavement partly damaged

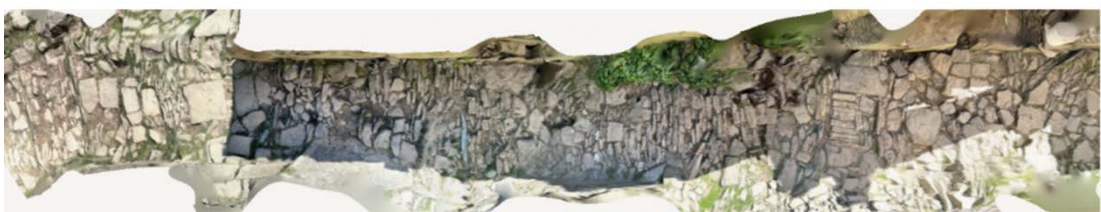
*Figure 52.* A 3D view of a section of road where the cobblestone pavement is in good state

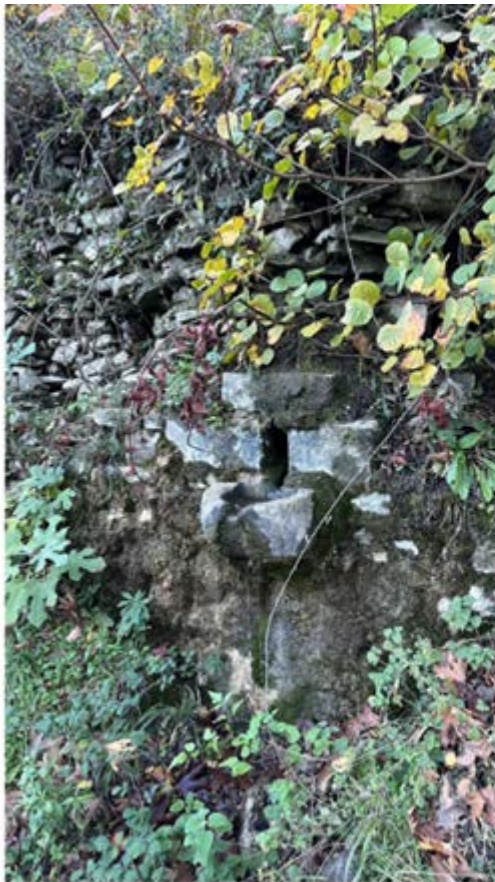
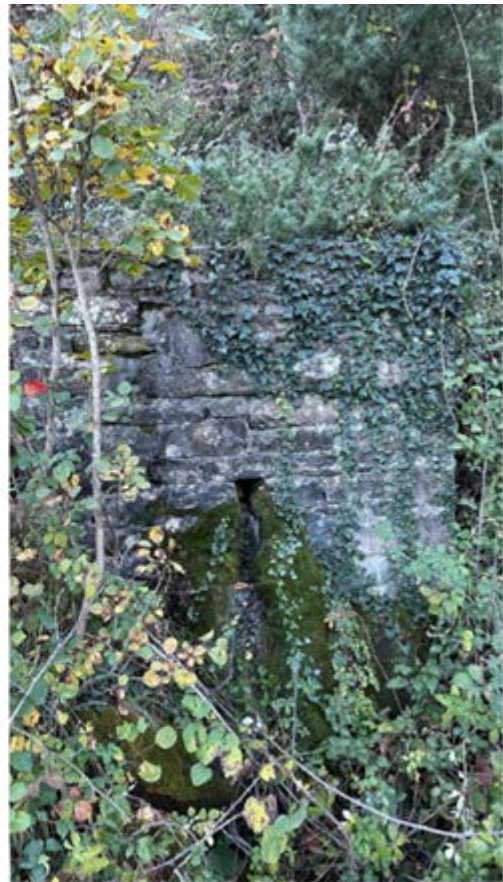
***Figure 53.*** Gurrëza of the village

It used to be the village's only drinking water source. *Gurrëza* is built with a high stone wall about 2m long and 3-4m wide that forms on a flat slope. Below it, in the middle of the wall, a stone basin has been placed for water drainage. On both sides, two elevated stone benches have been constructed, which once served for sitting and placing “*bucelat*”. This cistern collects water from the sources in Novoselë and maintains water throughout the year except for the months of July and August when the village experiences drought.

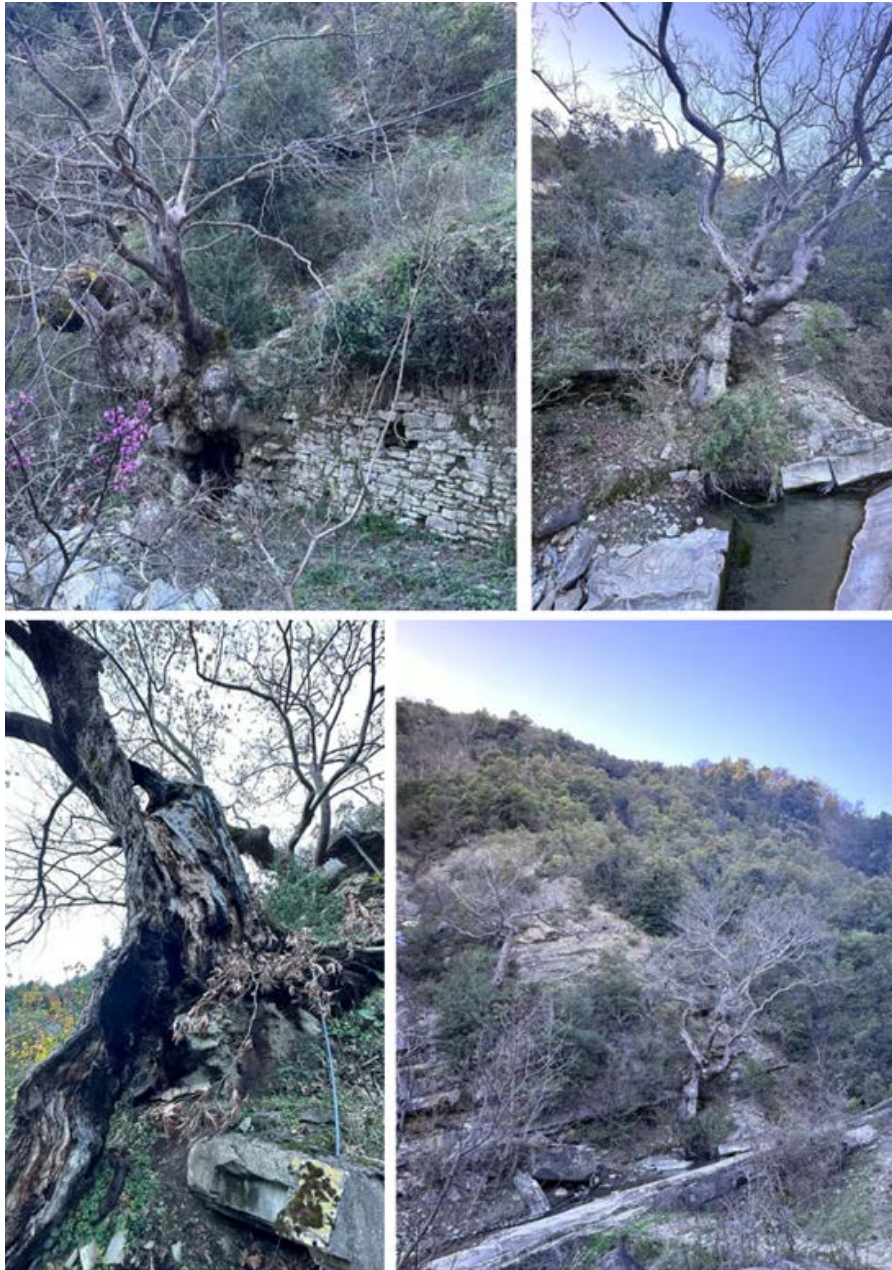
**Figure 54.** Centuries-old tree, "*Rrap*"

Near the fountain lies a centuries-old “*rrap*”, which has a large hearth stained by smoke. It was once used to place cauldrons for boiling water and for washing clothes by the womens of the village.

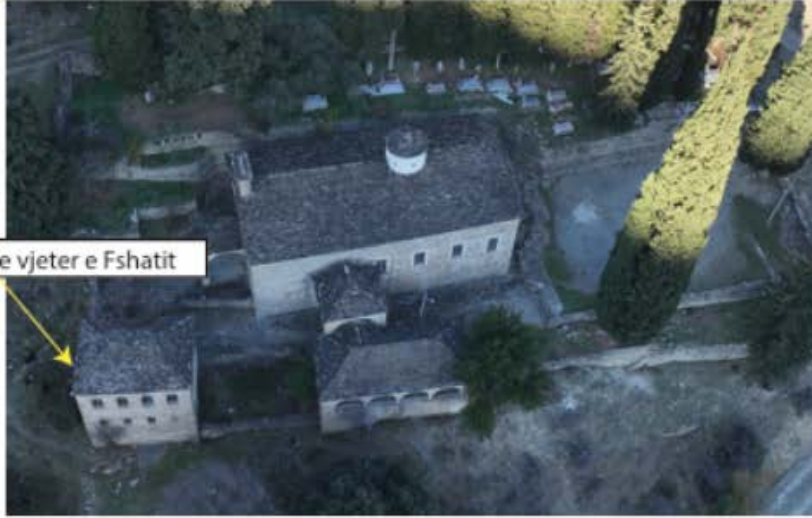
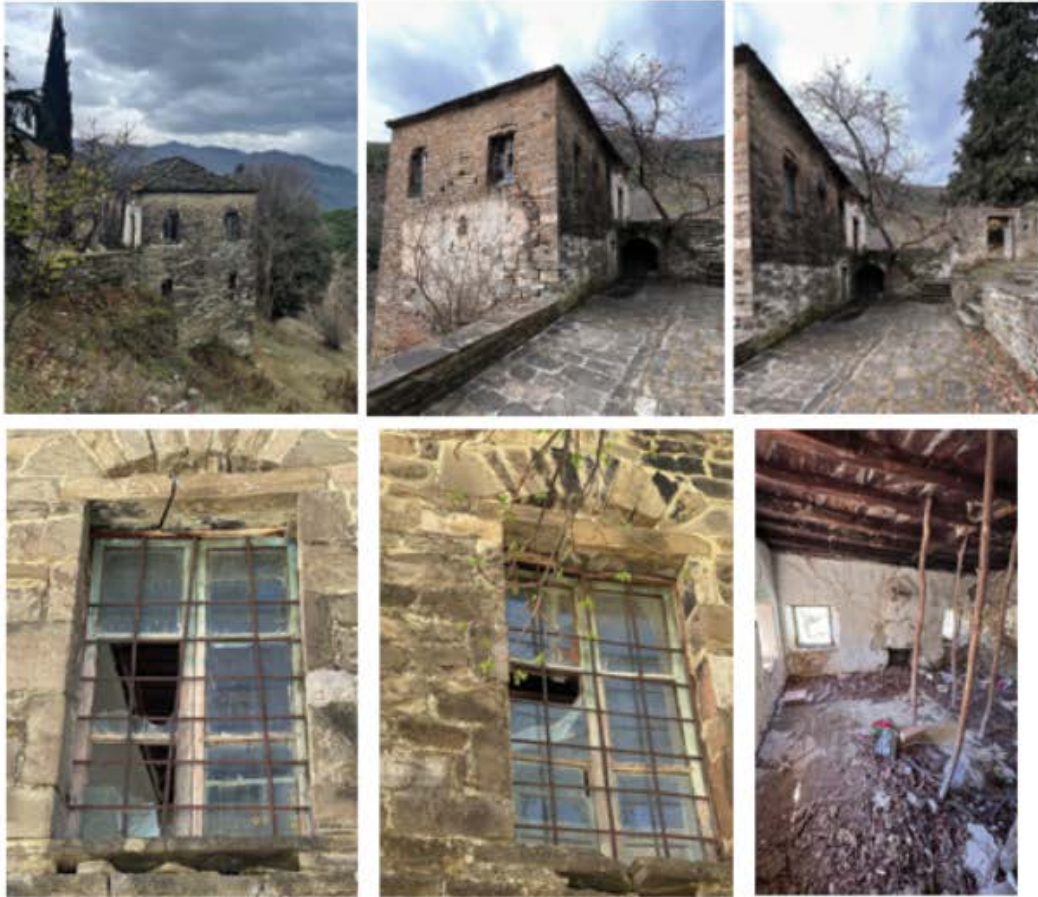
DOKUMENTACIONI FOTOGRAFIK

The **Cultural Heritage Card** for the Former School of the Village of Benje, established in the mid-18th century, provides essential information about this historically significant educational building. Classified as a Category II protected site, the school is located in the Permet district, within a designated protected area, and currently remains abandoned. The structure reflects traditional architectural styles characteristic of the region and plays a vital role in the local cultural heritage. Although its condition is described as partially good, the site is enclosed and maintains a connection to the community's educational history. The card emphasizes the importance of preserving this landmark as a symbol of the village's past and its educational legacy

NDËRHYRJET KONSERVUESE /  
RESTAURUESE  
QË PROPOZOHEN

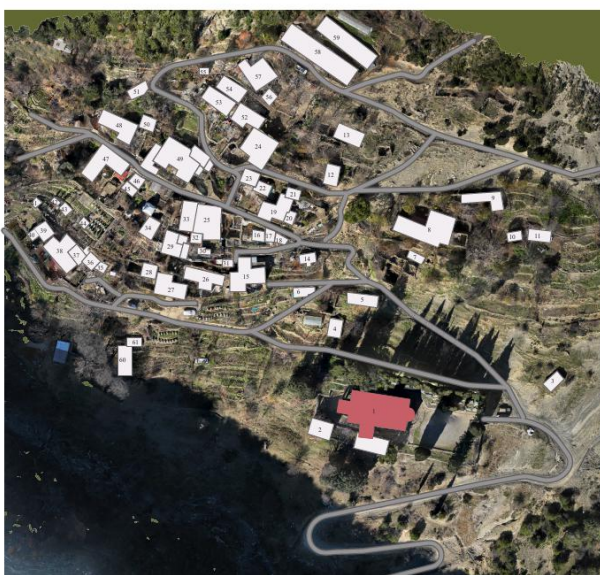
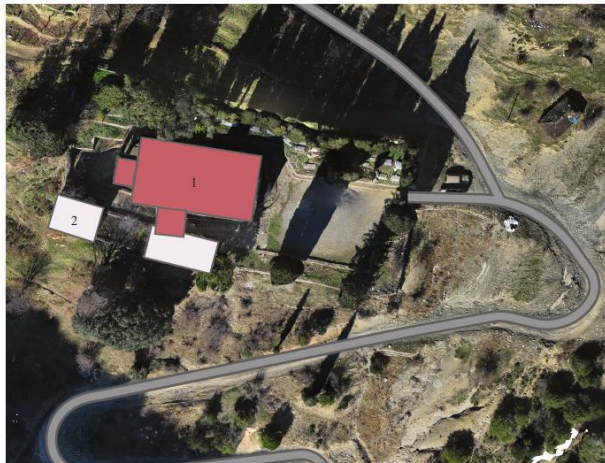
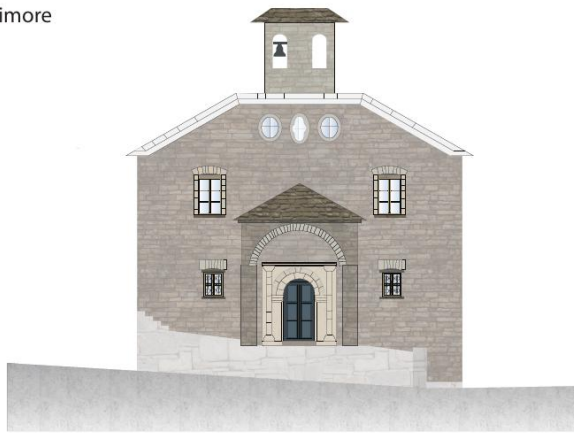
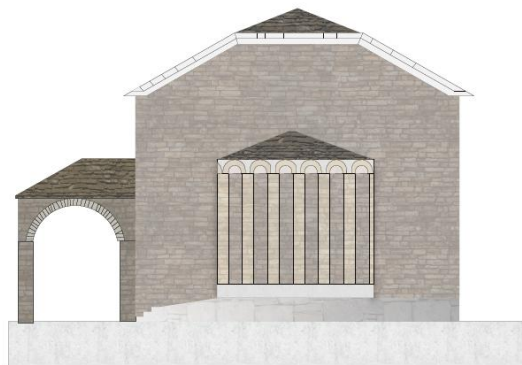
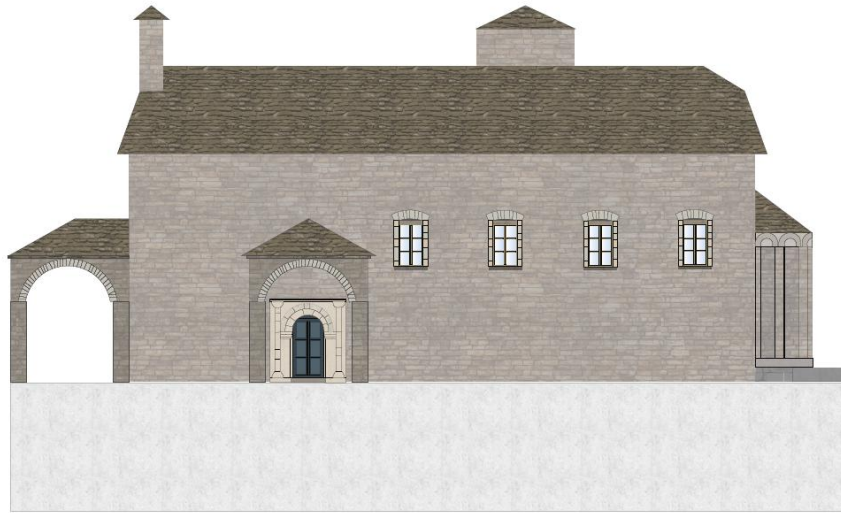
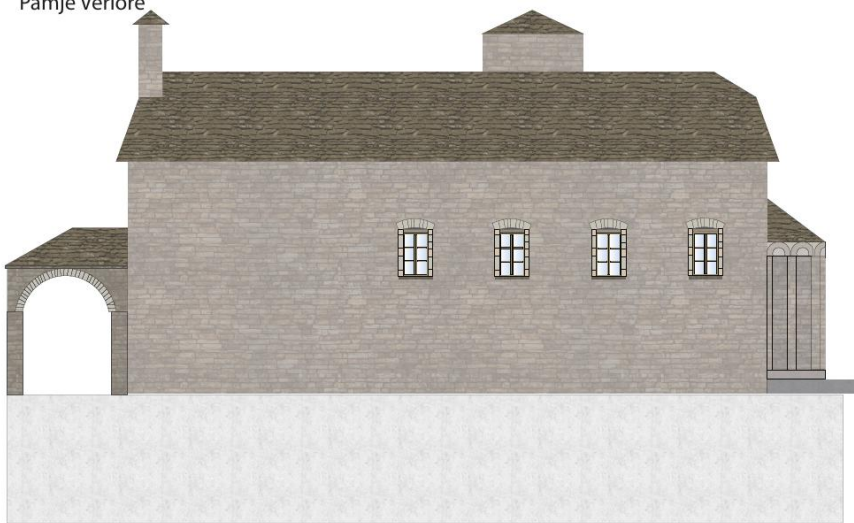
**DOKUMENTACIONI GRAFIK DHE HARTOGRAFIK**

The **Cultural Heritage Card** for the church in the village of Benje details this important architectural site, classified as a Category I protected monument. Dating back to the mid-18th century, the church is a vital symbol of the region's religious heritage and continues to function as a place of worship. Located in the Permet district and situated within a designated protected area, the structure is in good condition and showcases traditional stone masonry and distinctive architectural features characteristic of local ecclesiastical buildings. The card emphasizes the church's historical significance and its integral role in the community's cultural identity, highlighting the importance of its preservation for future generations

Propozohet:  
-Restaurim dysheme ne katin e dyt  
-Rikuperim i shkalleve qe te cojne ne katin e dyte  
-Pastrim i tavanit dhe mureve te kishes nga  
lageshtira myku dhe faktore te tjere natyror qe e  
demtojne

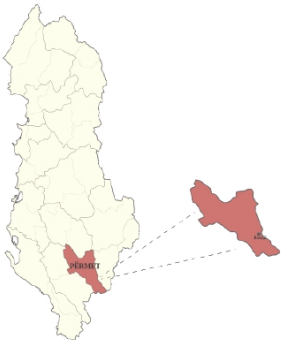
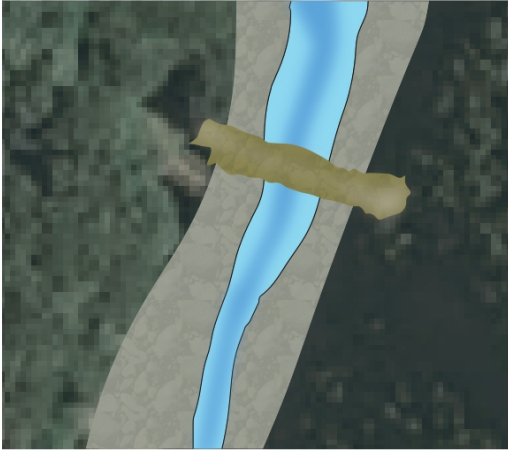
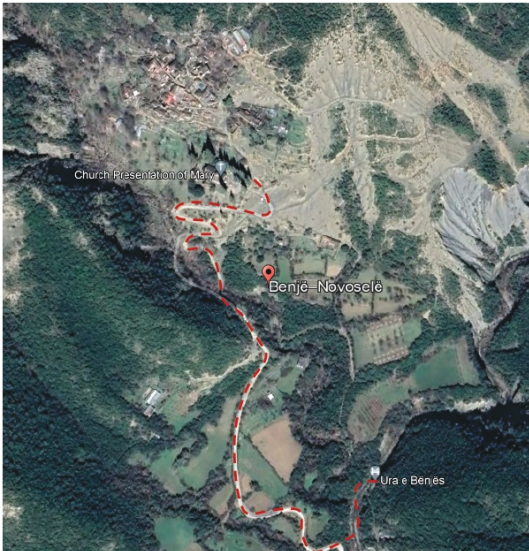
The **Cultural Heritage Card** for the bridge in the village of Benje details this important Category I protected site, dating back to the mid-18th century. As a vital engineering structure, the bridge exemplifies traditional construction techniques and serves a crucial role in facilitating transportation in the region. It is in good condition and remains functional, reflecting the historical significance and ingenuity of its builders. Enclosed within a protected area, the bridge not only represents a key piece of local infrastructure but also underscores the rich cultural heritage of the Permet district, highlighting its importance for future generations.

<p><b>NDËRHYRJET KONSERVUESE / RESTAURUESE QË PROPOZOHEN</b></p>	<ul style="list-style-type: none"> <li>-Riforcim i kembazeve,</li> <li>-Pastrim i siperfaqes nga barishtet bimet si dhe faktoret e tjere natyrore qe cojne ne demtimin e ures</li> <li>-Restaurim i kalldremit</li> </ul>
<p><b>DOKUMENTACIONI GRAFIK DHE HARTOGRAFIK</b></p>

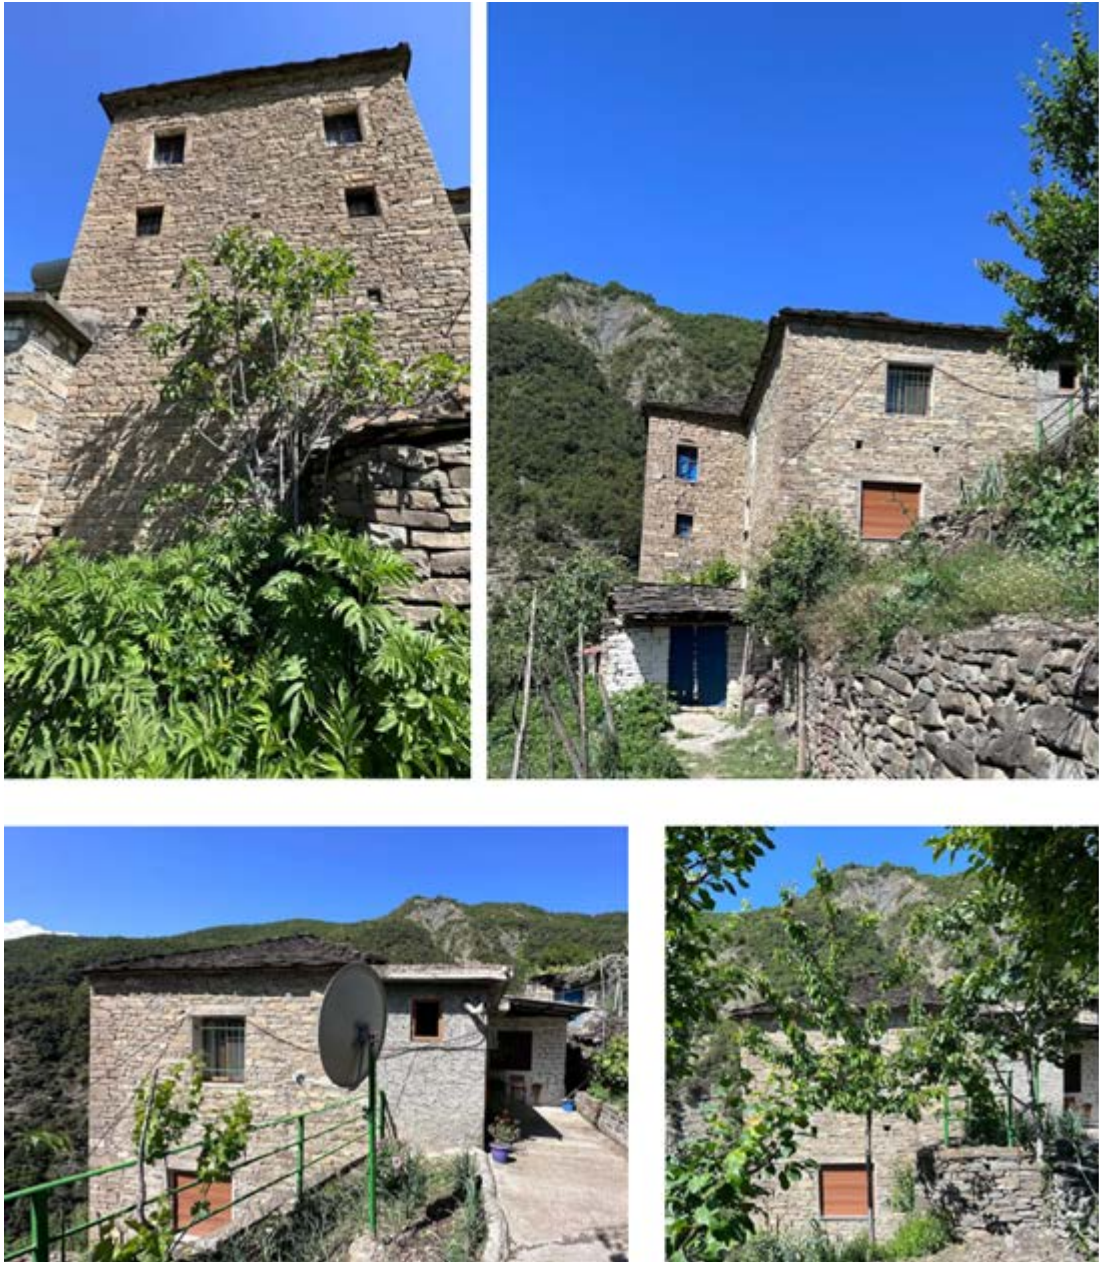
*Figure 65.* Front and internal view of the building of Pandeli Stefo

original construction. However, on the left side, modifications have been made to both the facade and the interior partitions of the dwelling.

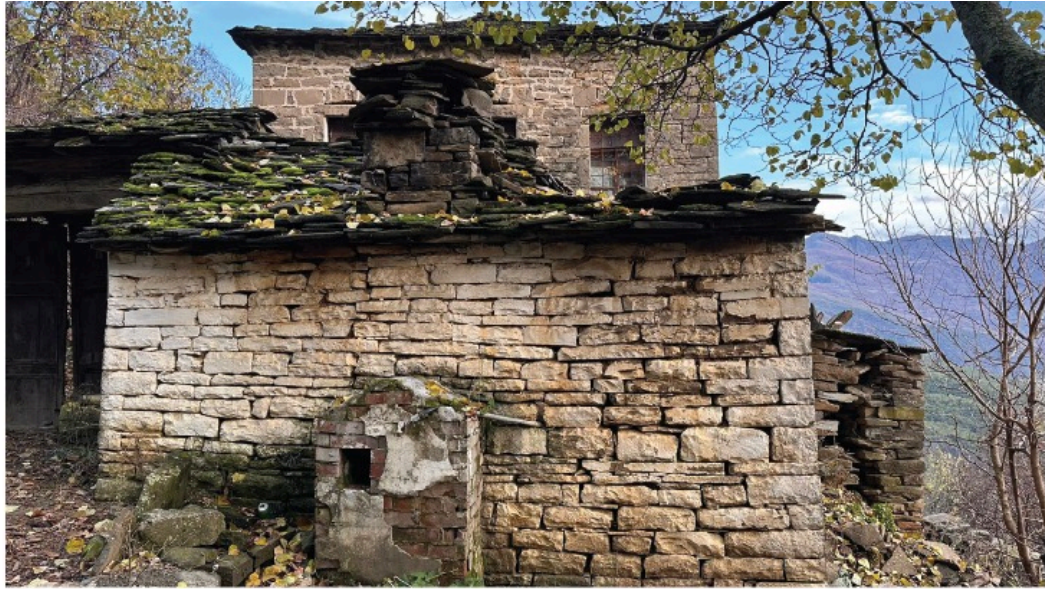
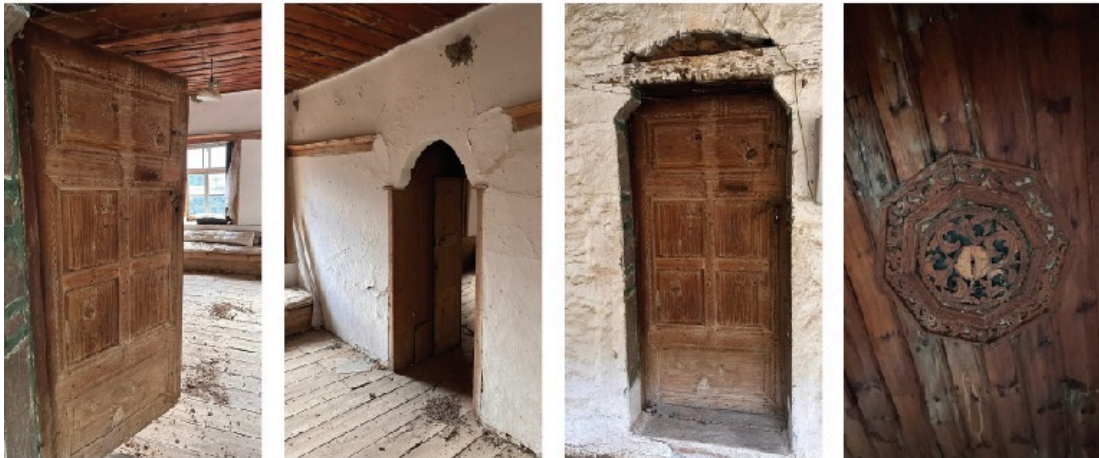
*Figure 78.* The top image shows the front view of Giorgio Ponti's house, while the bottom shots reveal internal doors and ceiling features.

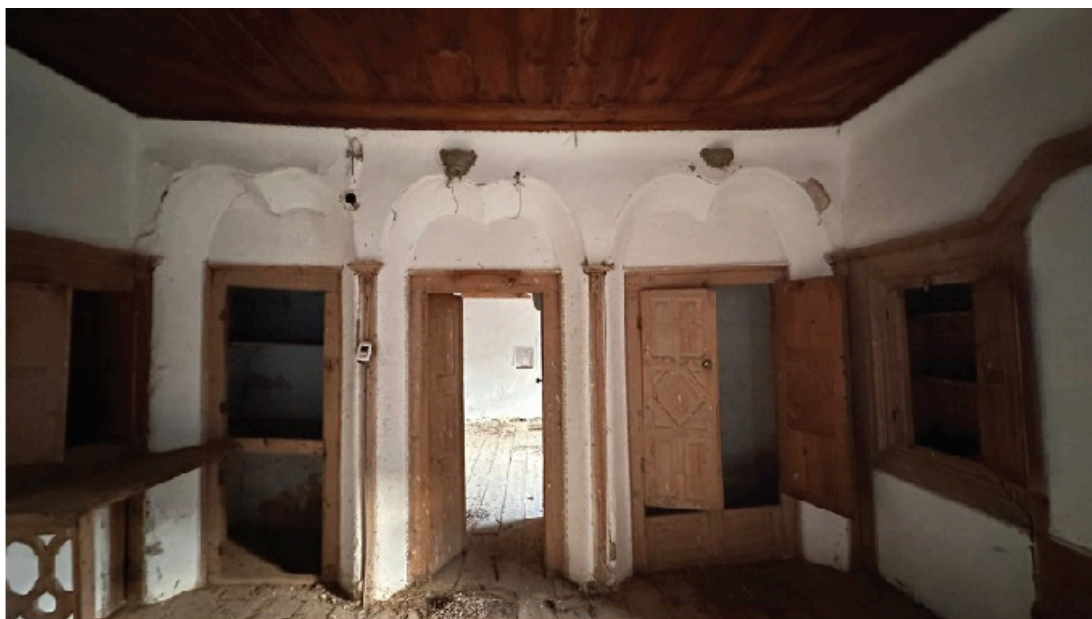
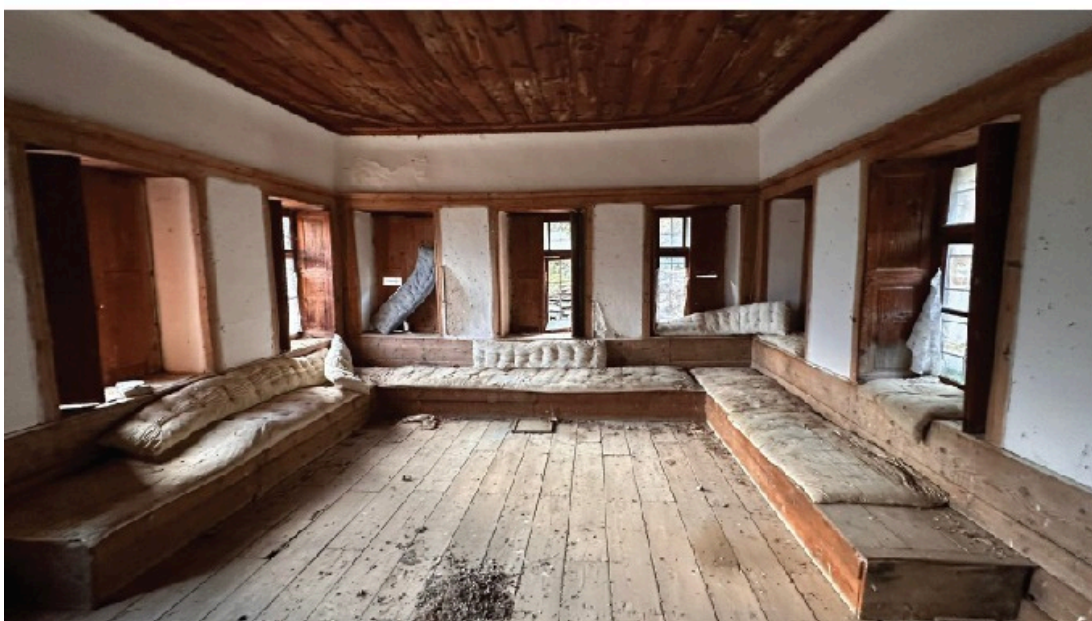
*Figure 79.* The internal view demonstrates "Oda"

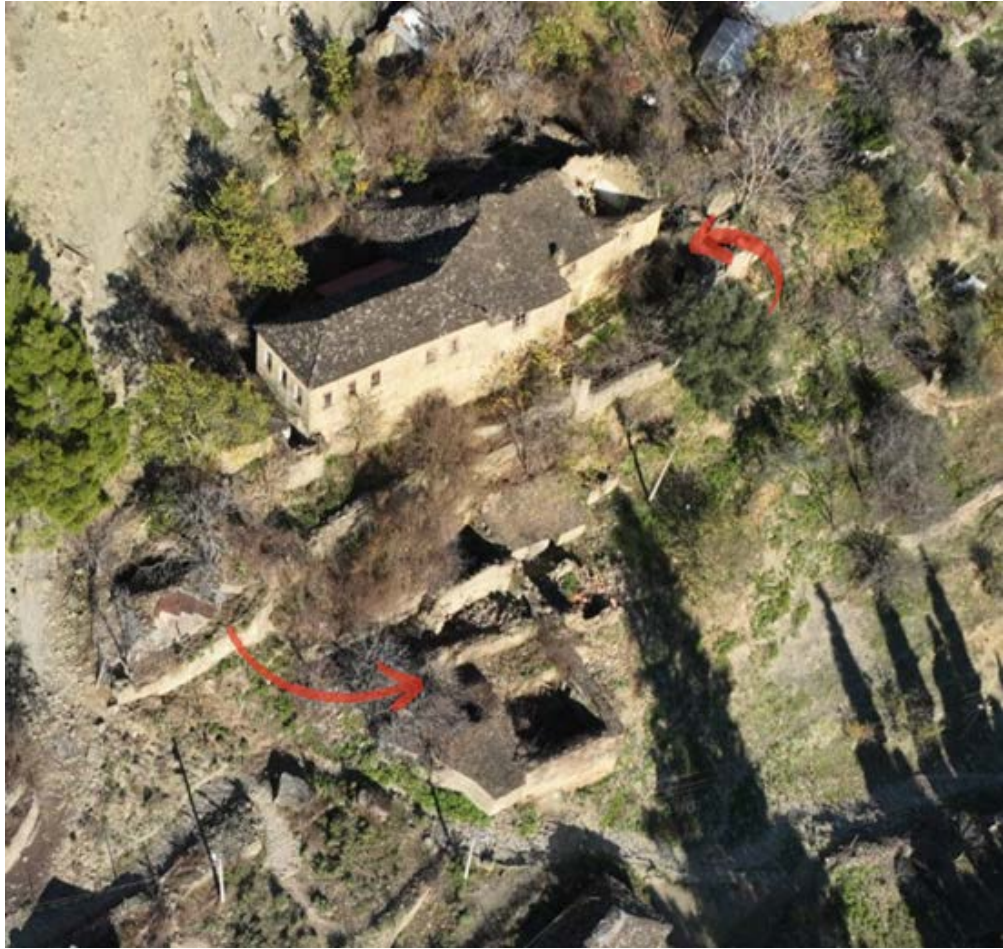
*Figure 101.* Ruins of burnt house

Although there are not many autochthonous families in the village, I have relied on spoken testimony gathered during visits to the village for this phase. The residents told me where and how the houses were before they were burned by the German invaders in the second world war. Aerial photos taken with a drone, but also photos and measurements I took during the visits, helped me to identify the remaining ruins.
