DOCUMENTING RURAL ARCHITECTURE IN BËNJA VILLAGE:  
RECONSTRUCTION SCENARIOS FOR HOUSES DESTROYED IN WWII

A THESIS SUBMITTED TO  
THE FACULTY OF ARCHITECTURE AND ENGINEERING  
OF  
EPOKA UNIVERSITY

JUNE, 2024

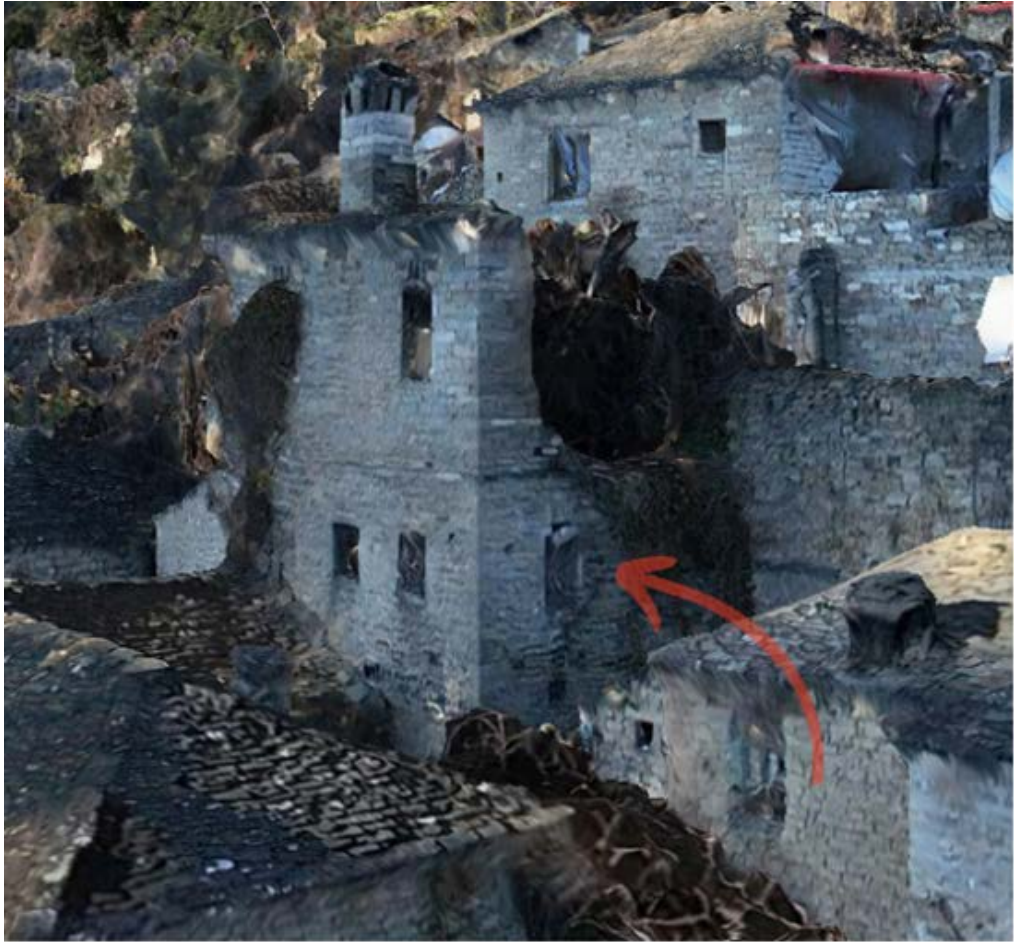
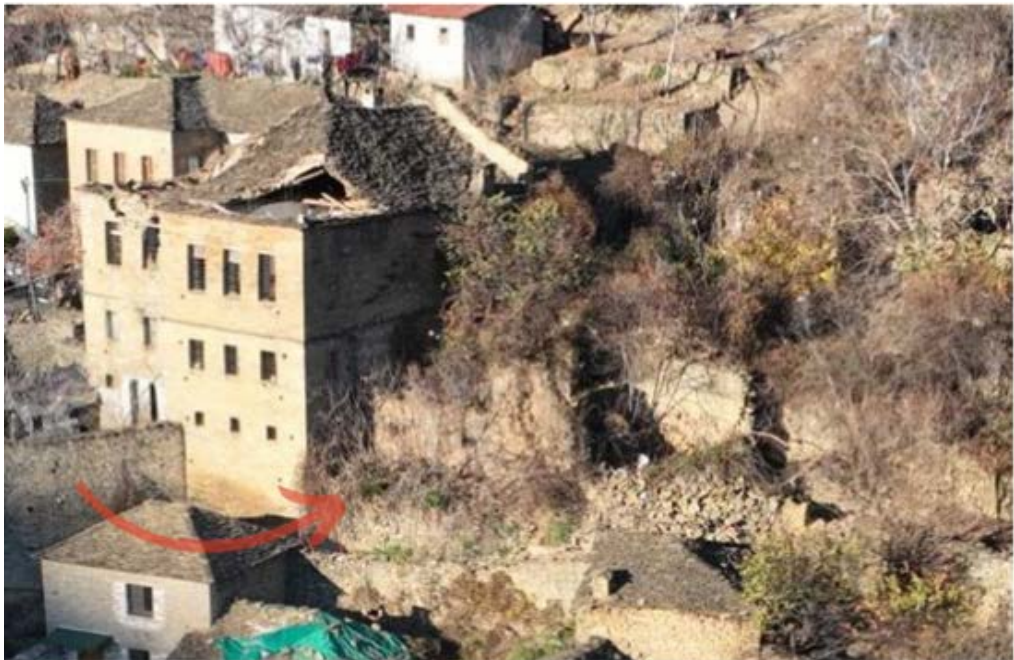
*Figure 102.* Ruins of burnt house

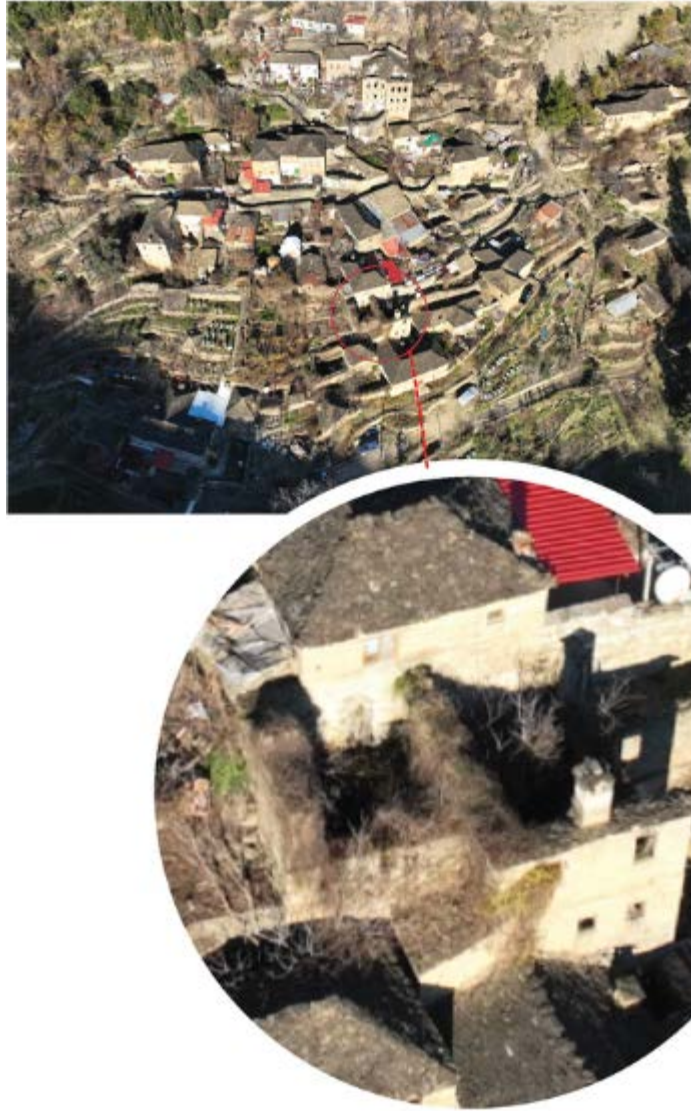
*Figure 110.* Identification of the existing conditions

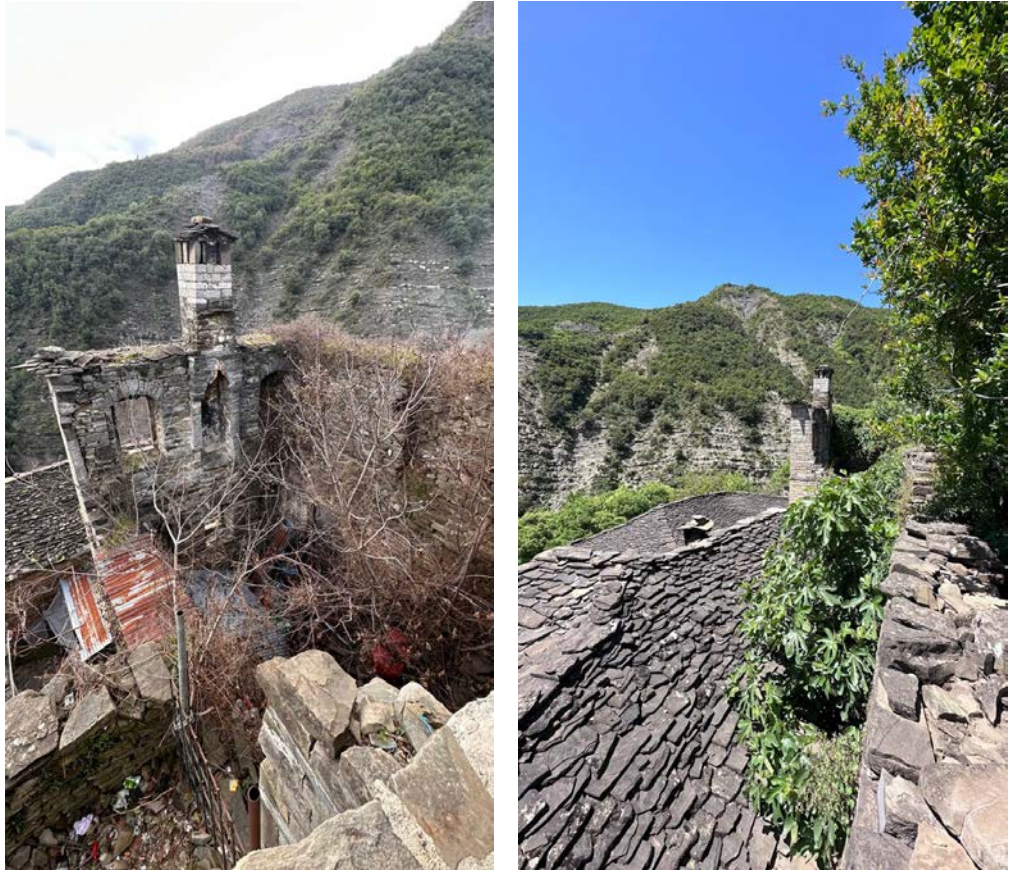
*Figure 112.* The current state of ruins
