TRENDS OF ENVIRONMENTAL TECHNOLOGY IN ART MUSEUMS:  
OBSERVATIONS ON HOW NATIONAL MUSEUM OF FINE ARTS IN TIRANA  
USES MICROCLIMATE TO CONSERVE DISTINCTIVE ARTIFACTS.

A THESIS SUBMITTED TO  
THE FACULTY OF ARCHITECTURE AND ENGINEERING  
OF  
EPOKA UNIVERSITY

SERVIO AVDYLI

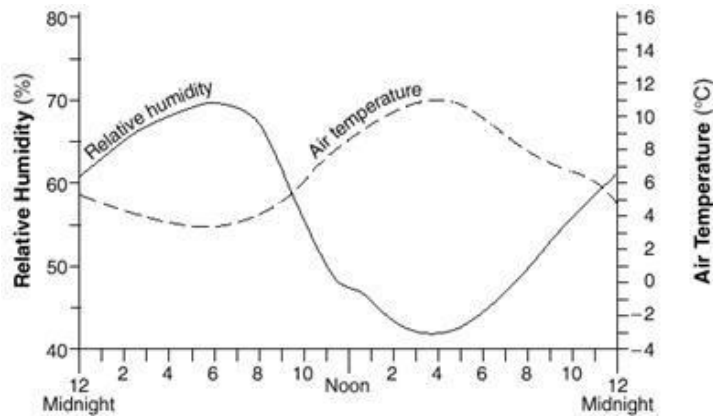
As the air temperature increases, its capacity to hold water vapor increases. At 0°C air can hold 6g of water for every m<sup>3</sup> of air. If the temperature rises to 10°C the water vapor holding capacity increases to 10g/m<sup>3</sup>, at 20°C increases to 17g/m<sup>3</sup> and at 30°C increases to 30g/m<sup>3</sup>. Thus, the capacity of air to hold water vapor varies according to air temperature (Thomson, The museum environment, 1986).

**Figure 3. 1.** The graphical relationship of T and RH (Thomson, 1986).

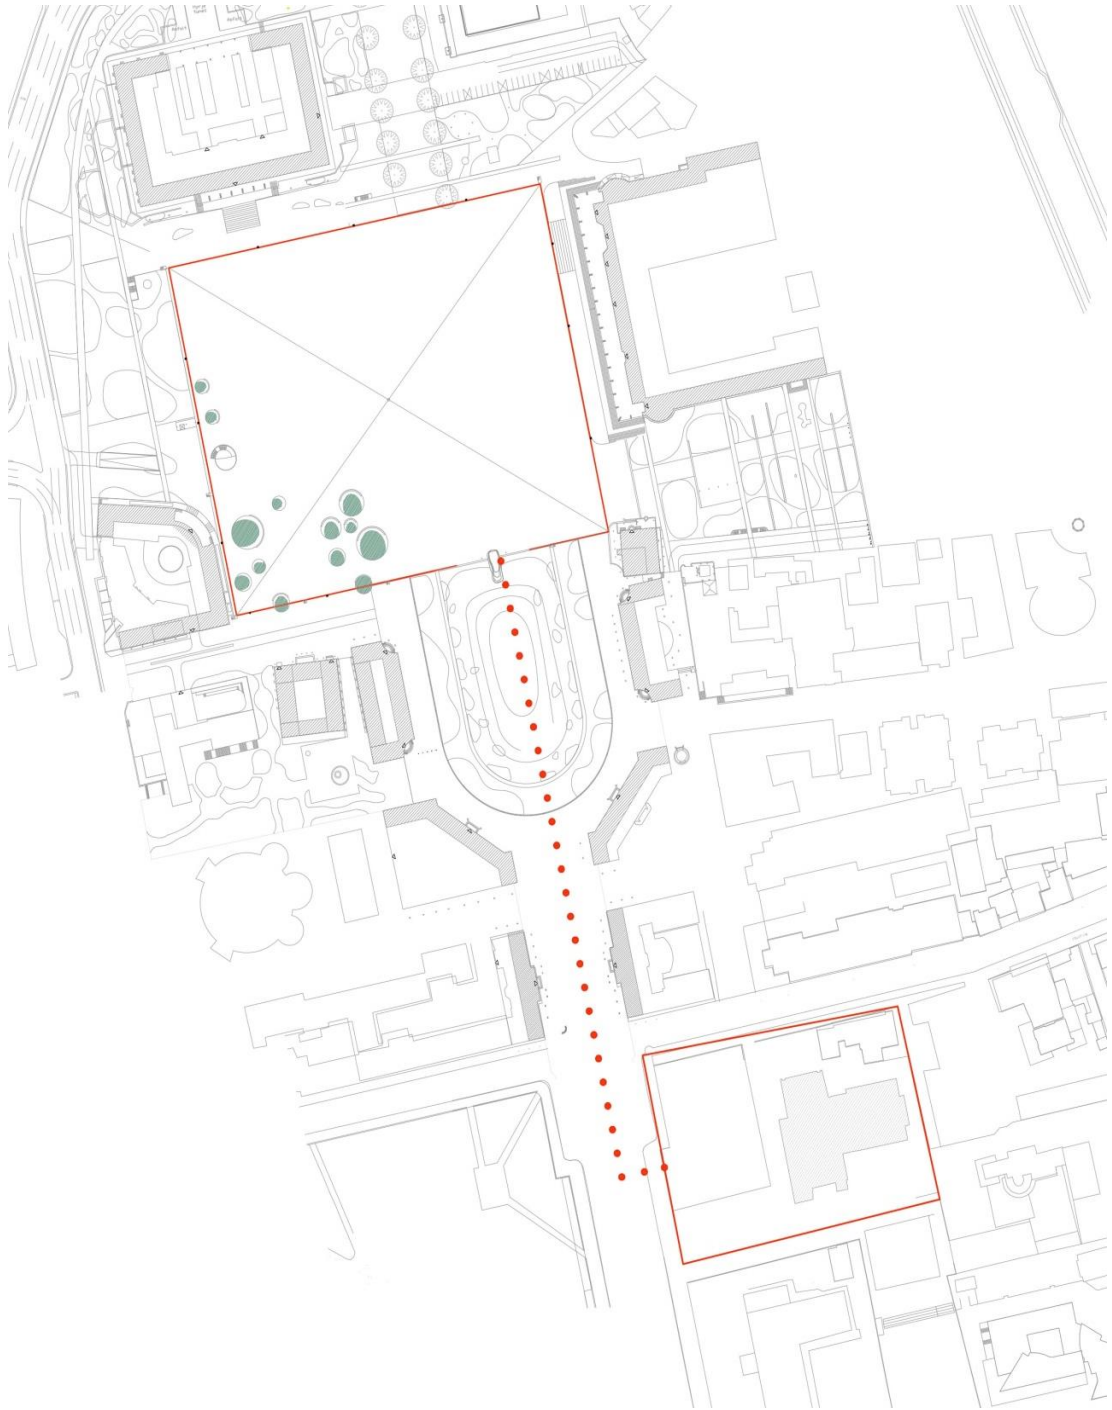
*Figure 5. 2.* Masterplan of the Museum.

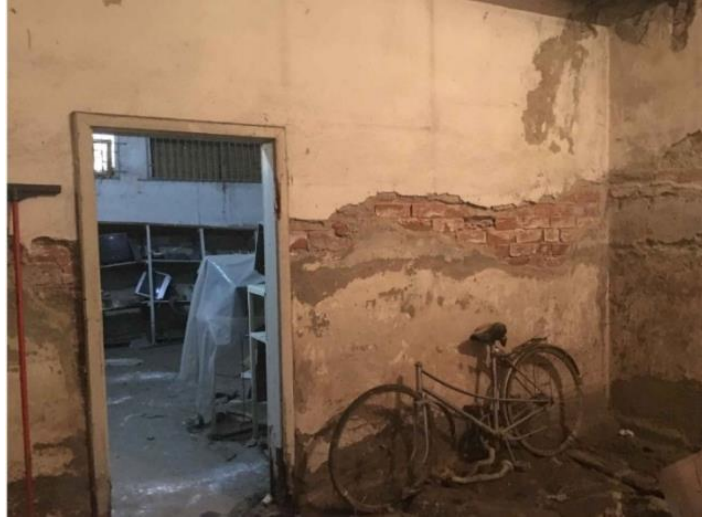
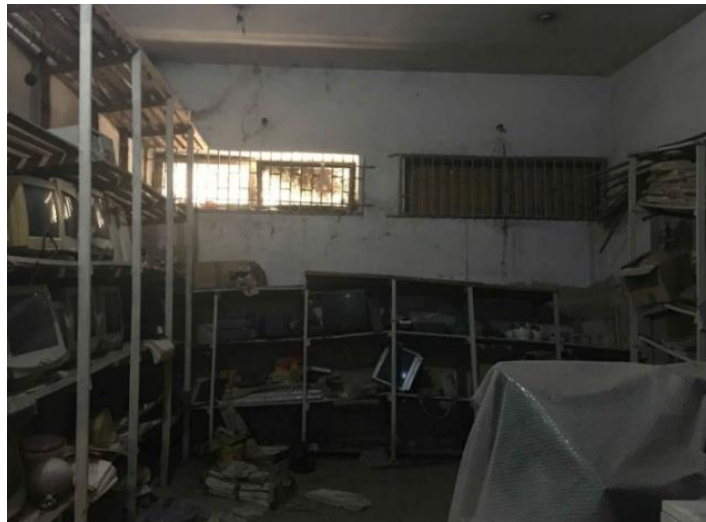
Humidity displayed on the walls, lack of plaster, paving slabs and lack of maintenance has led to severe degradation of this space. The following images show the current condition of the basement of the National Museum of Arts.

*Figure 5. 5/a/b.* Pictures from the basement.

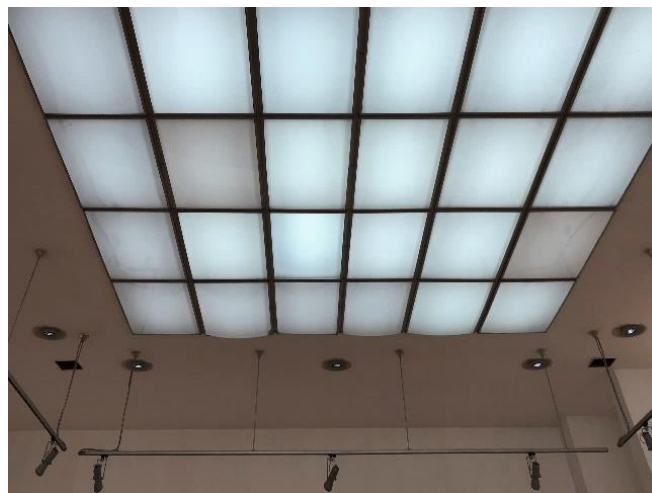
*Figure 5. 12/b* The state of the ceiling now.

As shown in *Fig. 5.12/a/b* and *Fig. 5.13 a/b/c*, the initial ceiling plan contains quite simple engineering details and conditioned solutions, but they go very well with the rest of the building.

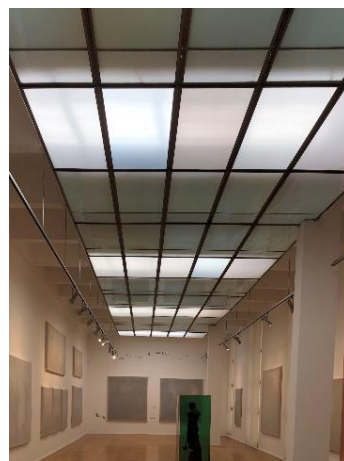
*Figure 5. 13/b* The state of the ceiling now.

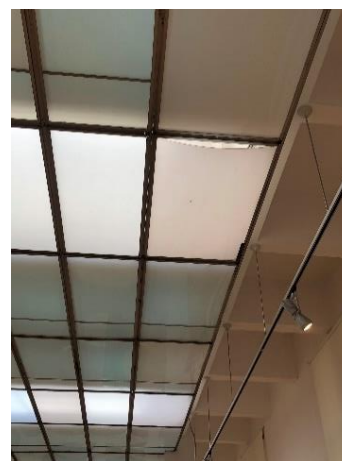
*Figure 5. 13/c* A detailed view of the covering.

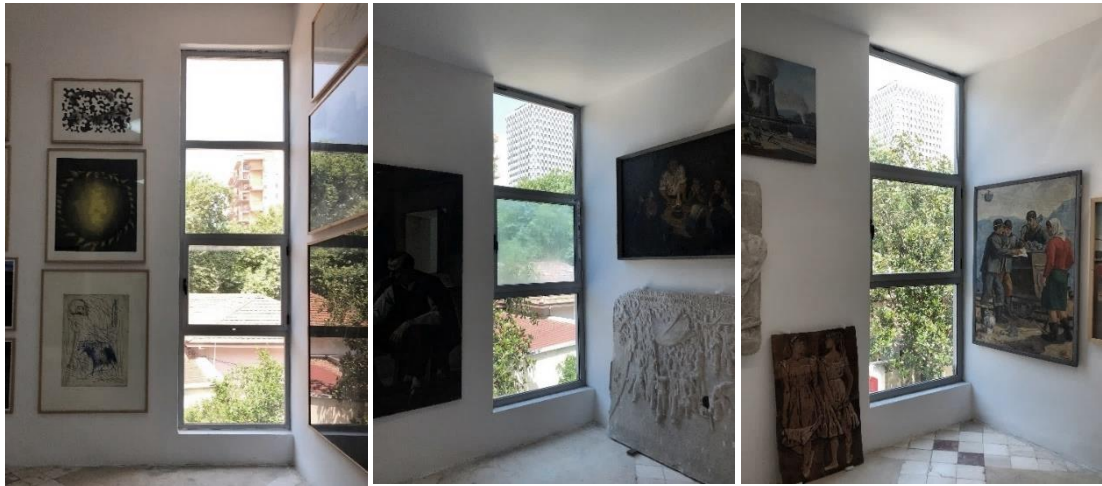
While in the later addition, from the presence of longitudinal windows is noticed on its upper floor. Although not so influential in the overall lighting, the presence of these openings creates more efficient ventilation in relation to the entire surface of the additional building, the ground floor of which stands gloomily under the artificial neon lighting under the plexiglass.

**Figure 5. 15/a/b/c** Openings on the West side of the added volume from the East.

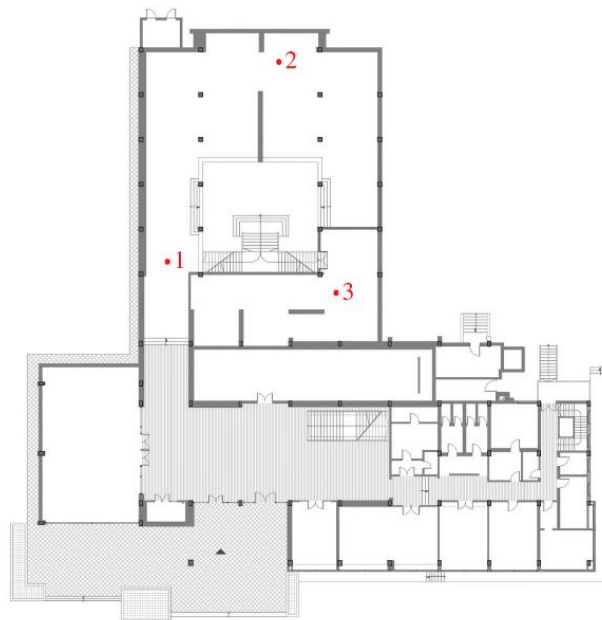
At the National Museum of Fine Arts, measurements were made for each exhibition space. The measurement period aimed at a long period of time in order to have the most stable data, but in the case of this study the strategy of simultaneous measurement was followed. To measure the values of T and RH in the interior of the museum were followed the basic rules of thermo-hygrometric measurements with the "testo 605i" tool. 12 different points were monitored in the exhibition spaces of the museum (Fig. 5.16/a, Fig. 5.16/b).

*Figure 5. 17/a* Points of Measurements for Ground Floor.

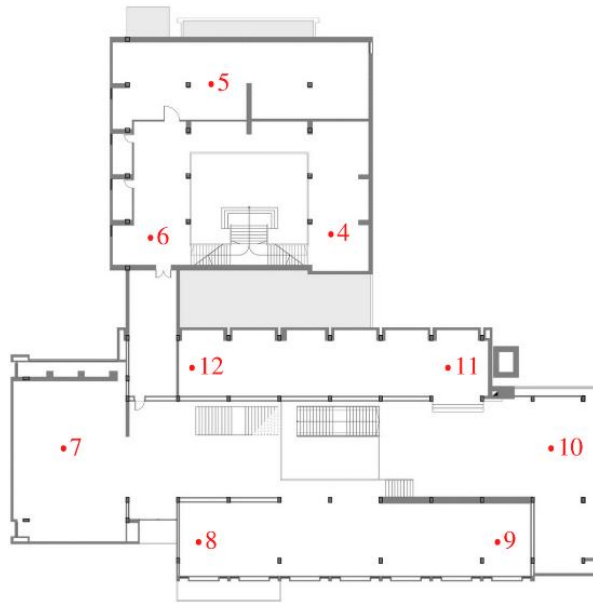
**Figure 5. 14/b** Points of Measurements for First Floor.

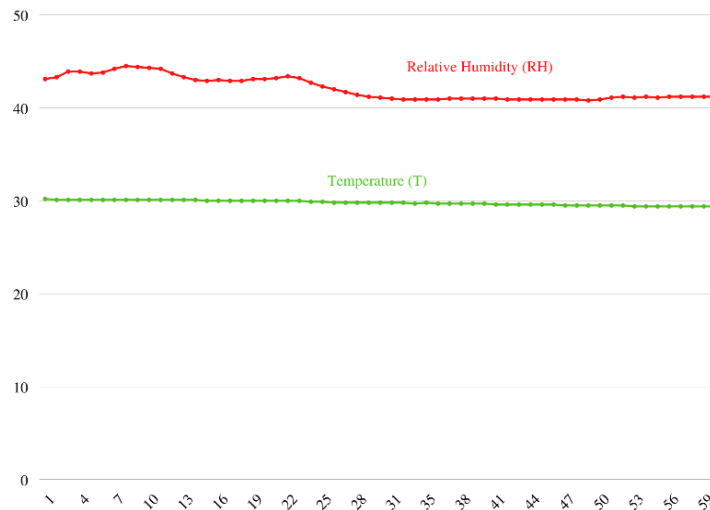
*The values recorded and graphically processed are presented in detail for each position, according to the measurement schedule, in Appendix 2 of this study. This chapter presents the general graphs for each position as well as the total measurement graph for the whole museum.*

**Graphic 5. 1.** Values of T and RH for Point 1

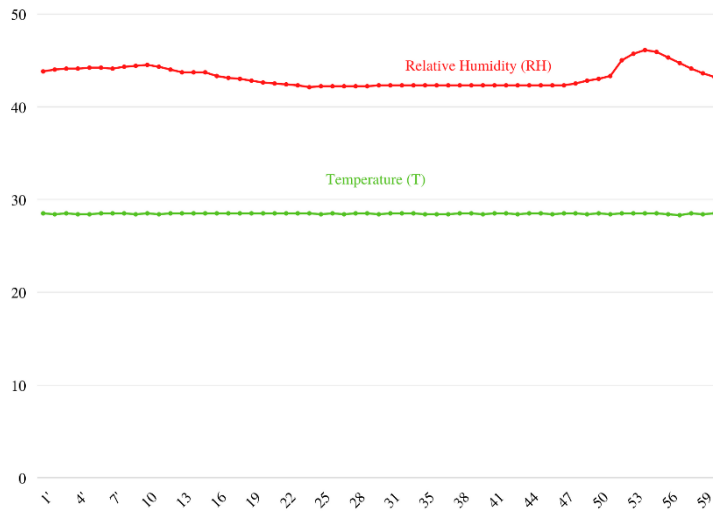
**Graphic 5. 2.** Values of T and RH for Point 2

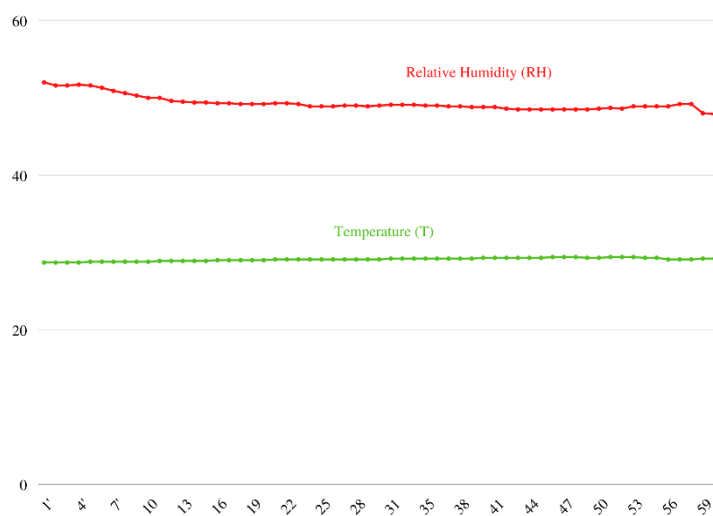
**Graphic 5. 4.** Values of T and RH for Point 4

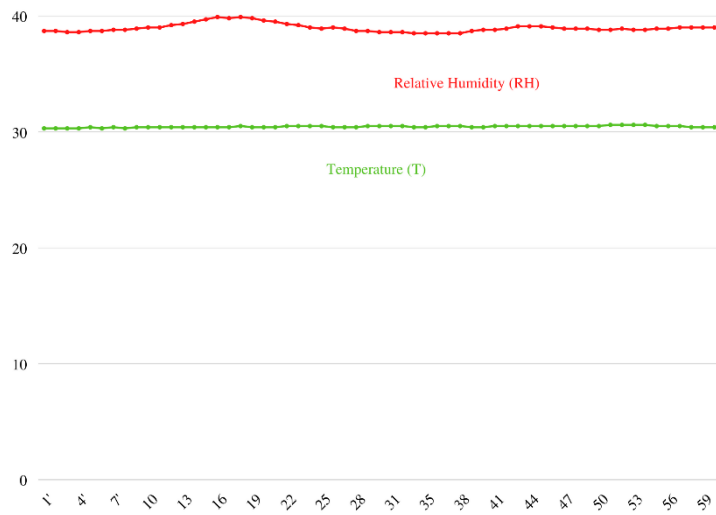
**Graphic 5. 12.** Values of T and RH for Point 12

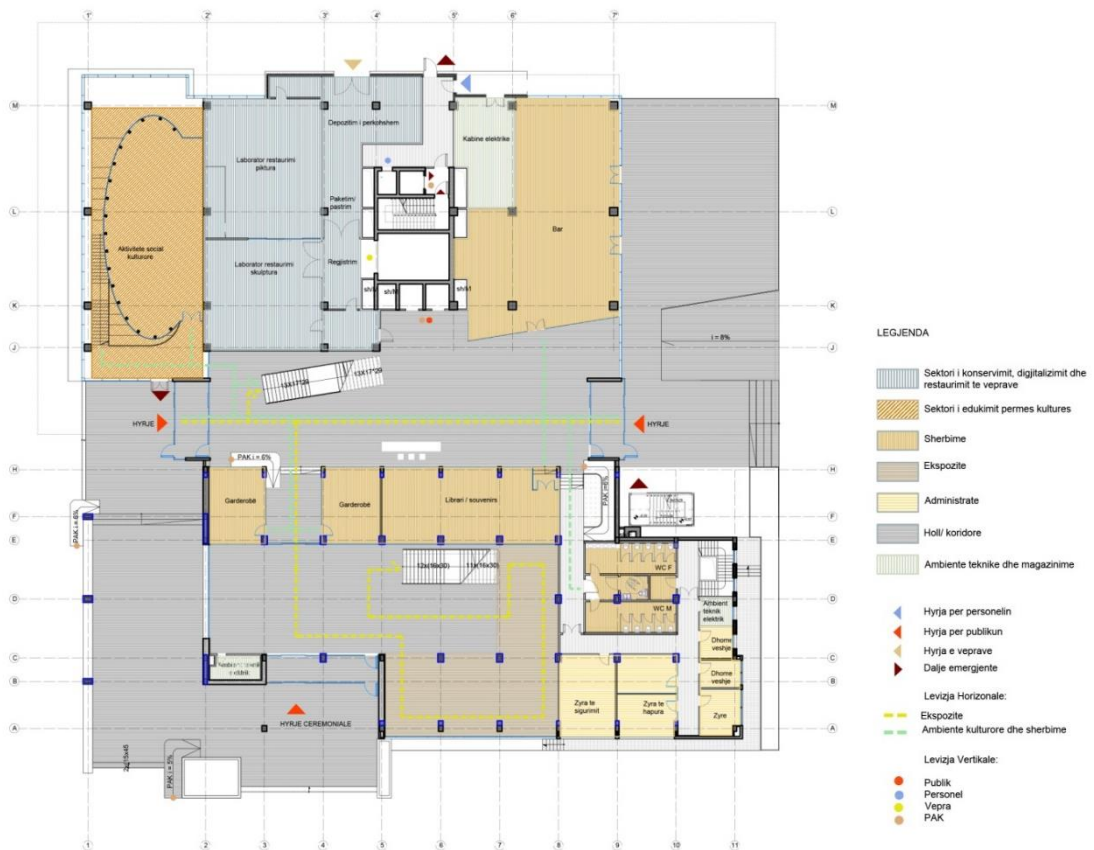
This project is conceived as an urban lounge, in the heart of museum life. According to the responsible architects, it will serve as an interface in the urban context for many public functions of the museum.

*Figure 6. 1060.* The proposed Ground Floor plan for the new Museum.
