REVEALING THE EXTERIOR TRANSFORMATION OF GJIROKASTRA
DWELLING UNDER ITALIAN INFLUENCE .

A THESIS SUBMITTED TO
THE FACULTY OF ARCHITECTURE AND ENGINEERING
OF
EPOKA UNIVERSITY

BY
MIRSADA AHMATI

JULY 2021

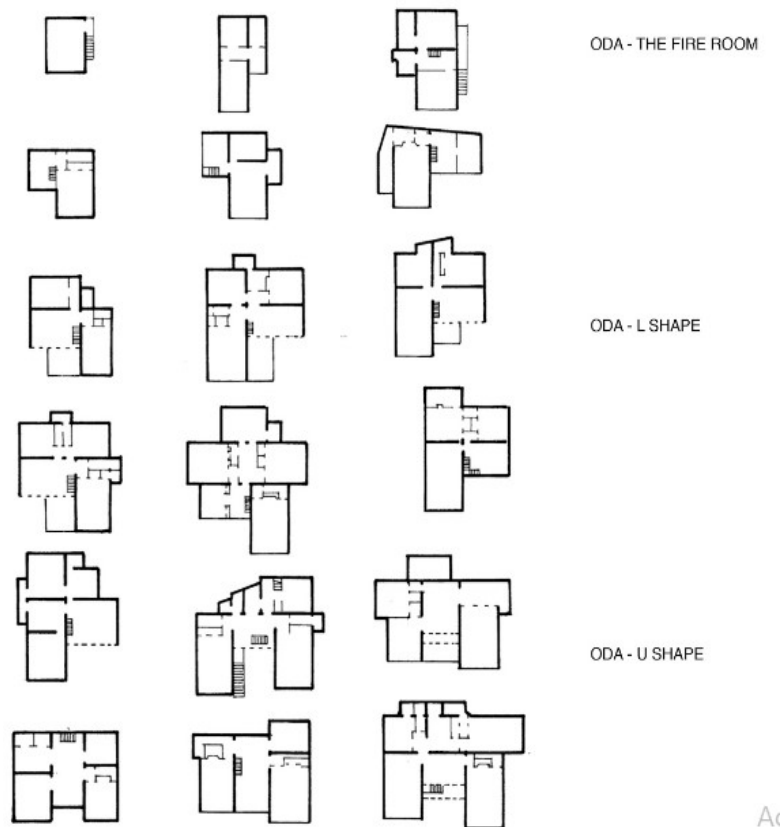
Figure 1: Development of Gjirokastra house , Emin Riza.

While the city fell under the leadership of Ali Pashe Tepelena in the city underwent great developments not only economic and social aspects but also architectural ones. Construction of the bazaar , water supply , schools , bridges were some of developments during this period. The most significant work on the dwelling typology of Gjirokastra's buildings was conducted in the 1980s. It is well analyzed on this monograph of *Riza.E(1981) Museum-City of Gjirokastra*, when he describes the element of traditional houses , materials and construction techniques. In Gjirokastër you immediately notice the frequent use of stone , that why it is called city of stone . Dwelling had character of “kulla” , fortified –tower houses. Main material used were limestone for foundation ,walls timber floor and roofs , clay mortar. Famous for its stone roofs , Gjirokastra is certainly a treasure in Albanian architecture .In this book Riza mention and analyses the development of Gjirokastra houses plan as below : (Figure.1)

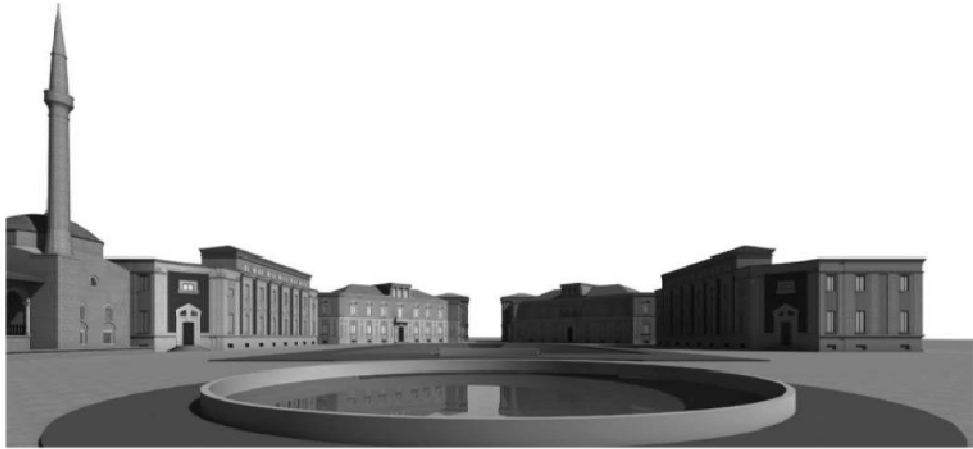
Figure 3: Proposal of boulevard in 1925, Armando Brasini.

In 1925, Armando Brasini came to Albania to offer his professionalism regarding city projects. Brasini proposed a plan that envisioned an intervention in the city center, which consisted of a group of six administrative buildings, with a central boulevard. Then the plan would be simplified by Florestano Di Fausto , which consisted of the realization of a wide boulevard which would separate the existing city from its periphery and which was proposed as the monumental and governing center of a new city and a new autonomous city.

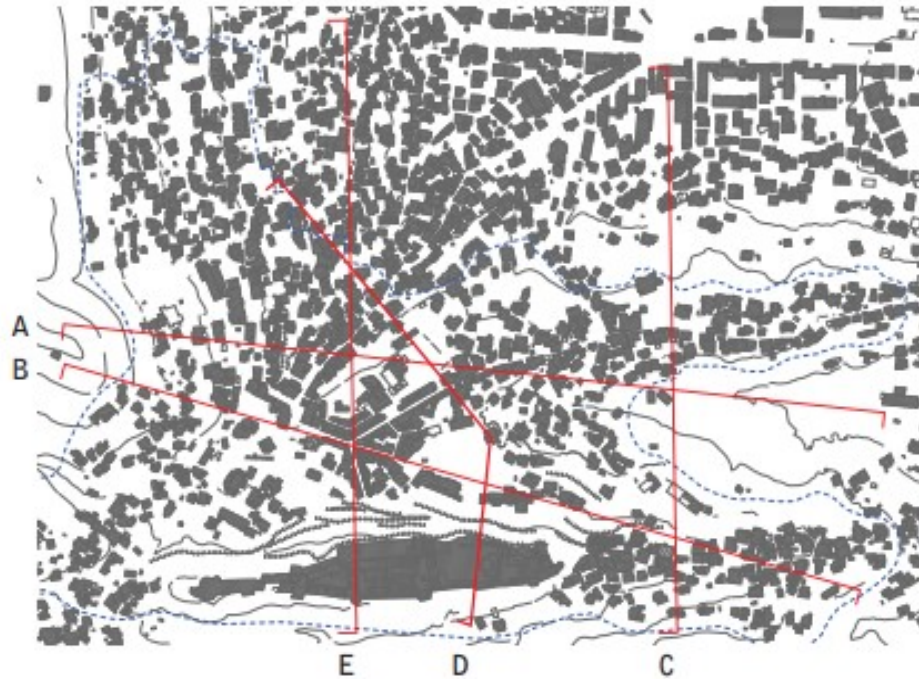
Figure 6 : Top view map of sections

Gjirokastra represents a wide range of the orthographic features , and intertwines with a diversity of urban elements which reveal a dramatic natural landform. The geographical position of the castle is situated in a post that shows the commanding role on the city ,looking over the valley. Here is a longitudinal section to understand better the terrain.

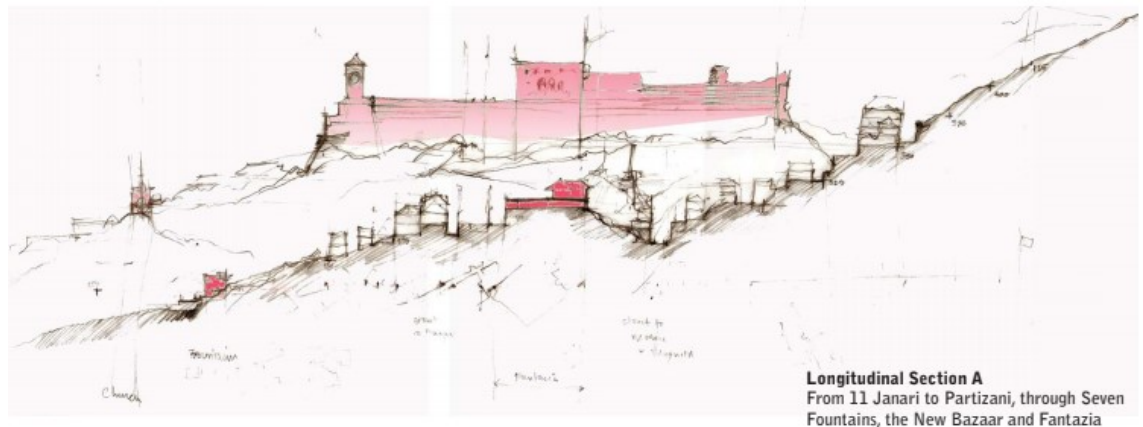
Figure 7. Section A

Sections below , shows the relationship of the town with topography , when the reveal proximities and separations between places in the city, created by the dramatic changes in elevation.

Longitudinal Section A
From 11 Janari to Partizani, through Seven Fountains, the New Bazaar and Fantazia

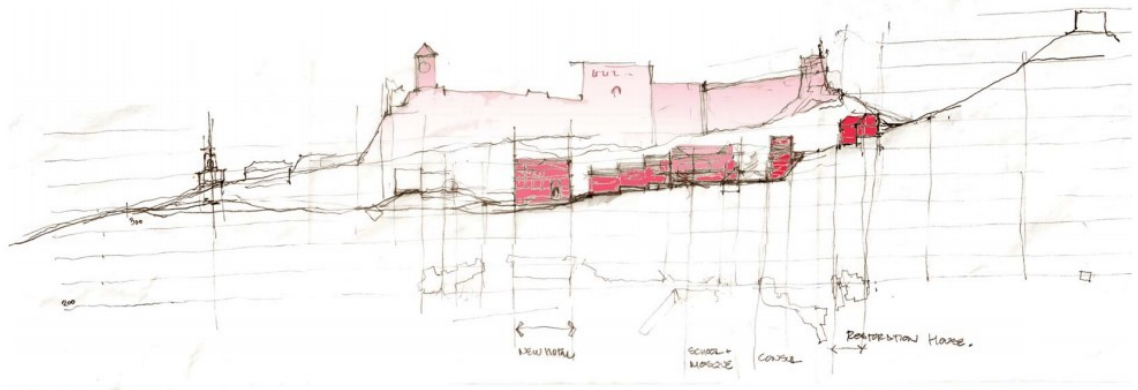
Figure 8. Section B

Longitudinal Section B
From Old Bazaar to Pazari i Vjeter, through Orthodox Church, Cerciz Topulli Square, Mosque and Regional Council Building

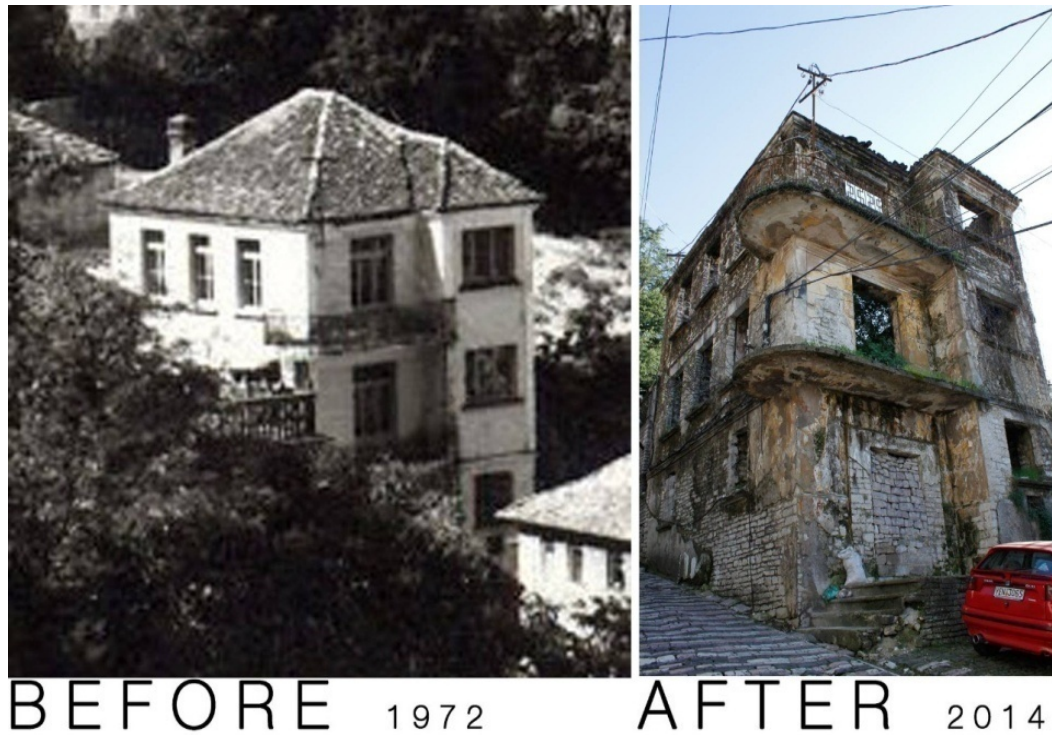
Figure 9 . Cici dwelling before/after

This house which belonged to Cici family is another example of abandoned building , there is a lack of interest from both the owners and by the authorities. Before 90' it has functioned as a Radio , but because of the fire which engulfed it which left considerable consequences, it was abandoned and neglected.

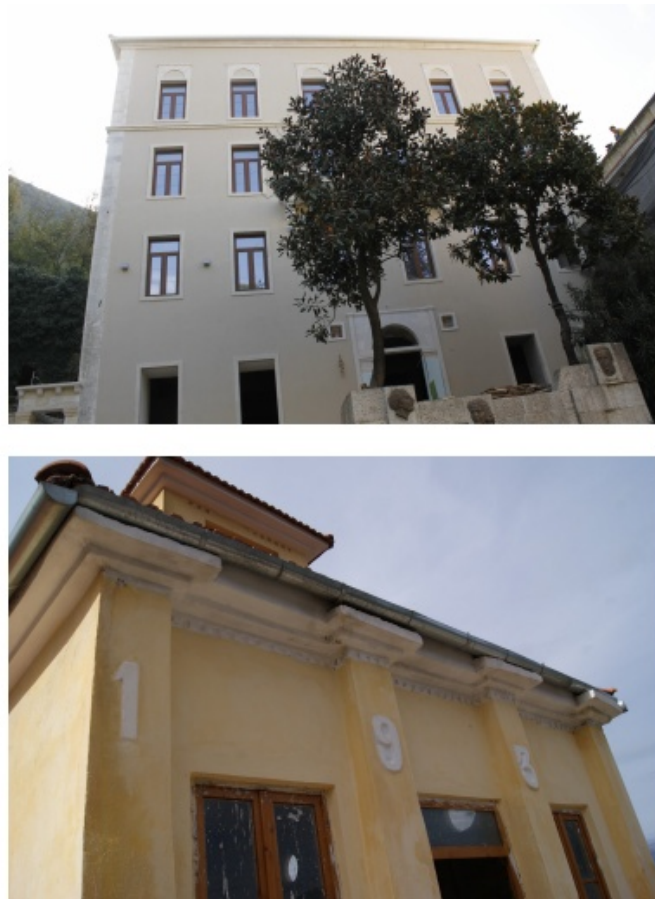
Figure 10 . Hotel Argjiro , Zigai.

In the first photo , it is the case of Argjiro-Hotel , a case of non –professional interventions are done , when we have to do with the replacement of windows with duralumin windows, a floor has been added, the roof has been eliminated and replaced with a new one. Those interventions have endangered the authenticity of the building where often these objects have been demolished and rebuilt again or in other forms replacing almost everything.

In the second case , there is another object , Zigai building, one of the buildings in the center of Gjirokastra Bazaar. in this building, in addition to changing the color, we are also dealing with the replacement of other architectural elements, specifically the roof, stairs or interior. In Gjirokastra it is not difficult to distinguish in the historic area interventions without criteria that come as slight additions to the structures of historic dwellings with new elements, which conflict with the old style of construction.

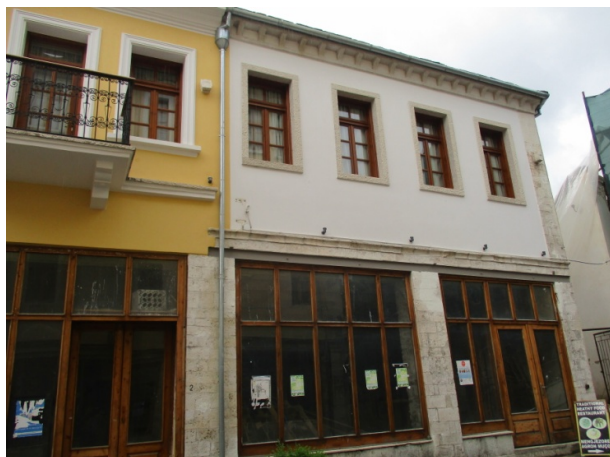
Figure 11. Hotel "Savoia".

Around the '30s, after some restructuring interventions, the building located at the entrance of the Bazaar in a part of it was used as a hotel“ Savoia ”, while in 1941, the rest was used by the Bank of Napoli.

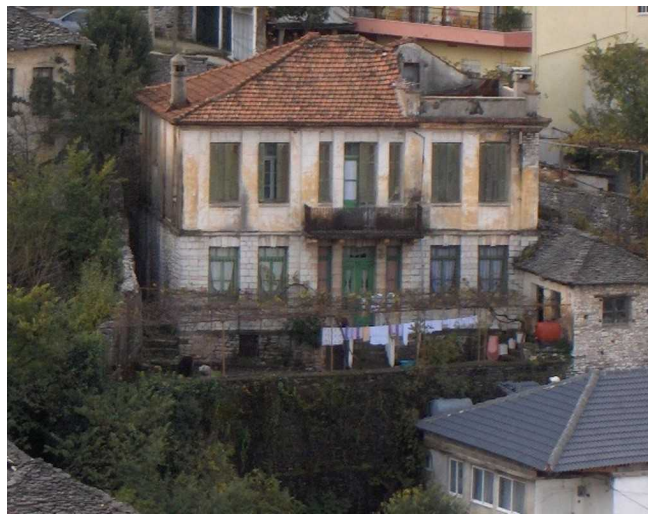
Figure 12. Vila Kokalari.

Villa "Kokalari", built in 1931-'33 according to the project of the ark. Vitaliano Poselli. This villa was owned by well-known lawyer Emin Kokalari. Characteristic for this villa from the architectural point of view are: balconies, verandas, shutters on the windows, railings with wrought iron on the balconies, cured courtyards, iron doors, etc. Structurally, the use of concrete and steel columns and beams is noticed, as well as the division of floors, often with concrete slabs. In the interior we have the use of tiles, stair marble and decorative tiles. Tiled roofs constitute another characteristic element in most of this period .

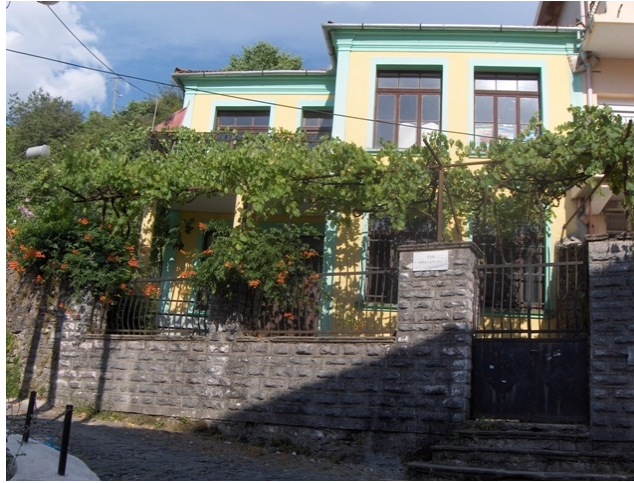
Figure 13. Vila Papavangeli

Villa "Papavangjeli", known as the villa of the "capitalist" of the leather factory in Gjirokastra. In the exterior of this villa stand out the balconies, verandas, railings with wrought iron on the balcony and the courtyard cured in detail, iron doors, etc. Structurally, the use of concrete columns and beams is noticed. In the spacious interiors we also use decorative tiles.

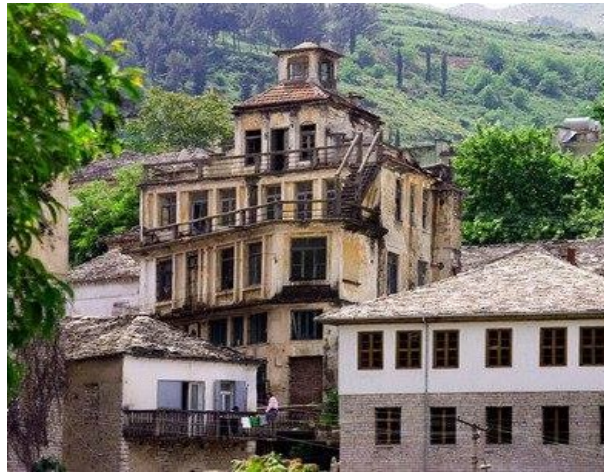
Figure 14. Kompleksi Zigai

Rapid developments in trade exchanges bring investments in shopping centers in Gjirokastra. One of the most prominent is the "Zigai" Shopping Complex in the characteristic Bazaar, owned by the merchant Aristidh Janneta. This building, dated as a building in 1937, from an architectural point of view, presents a unique model of functionality and architectural elegance. In a somewhat narrow place, the architect has skillfully developed the building in height. Here we encounter the use of concrete in columns, beams and slats, as well as decorative iron in the numerous railings and stairs from the outside of the building. In the lower part, in the premises that have served as warehouses, we have the use as a security element of metal terraces, while, on the first floor where there are trade areas with the public, the building has windows and large spaces. On the upper floors we have living quarters and at the top is a tower-type place for placing a clock.

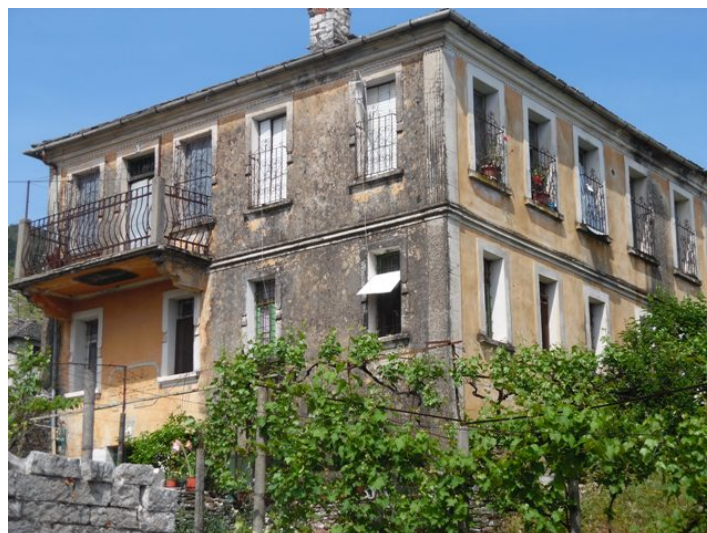
Figure 15. Kallaixhi Dwelling

This is a house with a special architectural style that can be called Italian-Albanian, in its facade the eye catches a type of plaque with the date 1937 of construction and the name of the owner Zija B. Kallaixhi , found in Palorto neighborhood . In the main facade of this apartment stand out the balcony with iron railings as well as the decorations and frames of different parts such as windows, corners, balcony, etc. The architect has been careful in introducing new elements and environments more functional for the time such as balconies, windows etc. has respected the surrounding environment by adapting the new elements with those of the buildings around it.

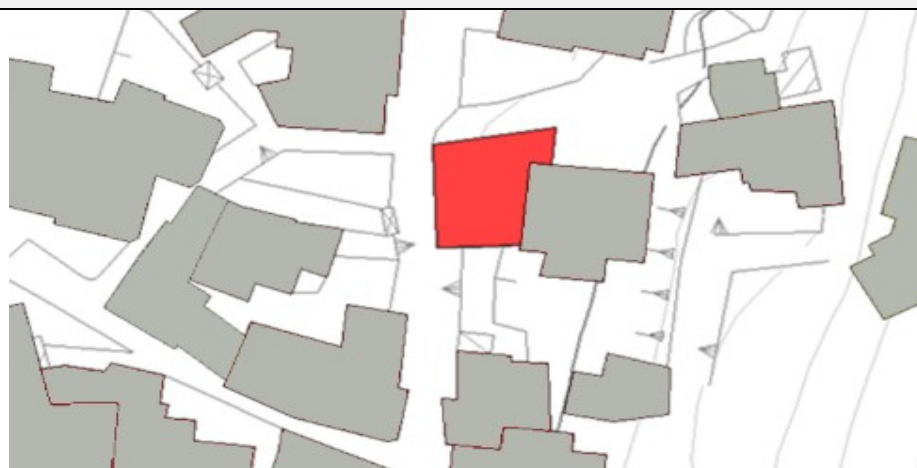
In the Varosh neighborhood, the “Qurku” dwelling represents an architectural example that combines new architectural influences with old commercial ones. The former house of Niko Toles, now inhabited by his nephew prof. Stefan Qurku, reconstructed with Italian project of the '30s. The coexistence of several architectural and structural elements stands out in this building: the balcony with concrete and iron railings, the windows with shutters and those of the medieval style of Gjirokastra, as well as the roof covering where one part is tiled and another part with stone cases.

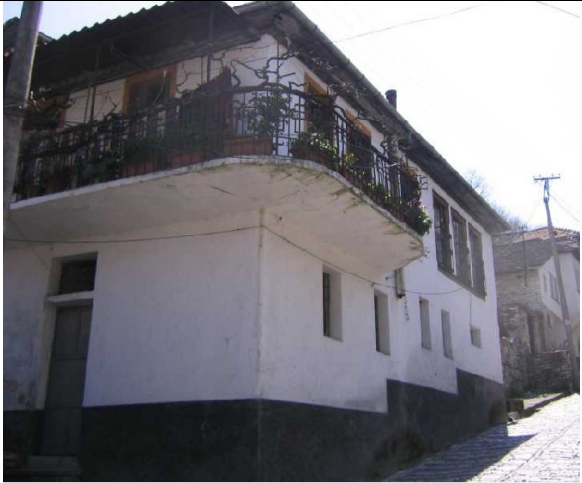
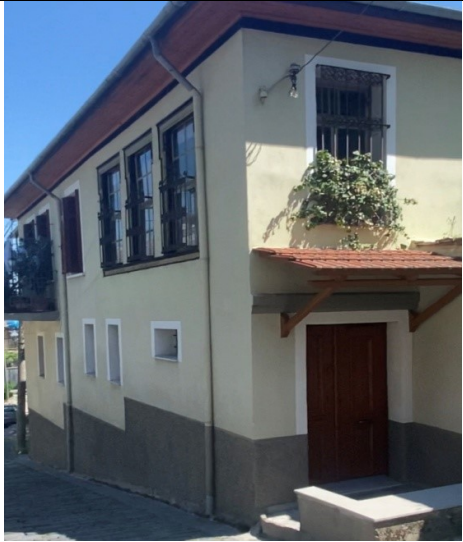
Table 6. Technical file for Gjirokastra monument

BUILDING COLOUR	-White -Yellow -Brown -Occra -Pink -Mixed -Pea colour	<input type="checkbox"/> <input type="checkbox"/> <input type="checkbox"/> <input type="checkbox"/> <input type="checkbox"/> <input type="checkbox"/> <input checked="" type="checkbox"/>		
BUILDING DIMENSIONS				
RESTORATION INTERVATIONS <i>/1/2/3/4/5/ (FROM EASIEST TO DEEPEST INTERVATIONS</i>	YEAR 1968	YEAR	YEAR	YEAR
	4	---	---	---
CONSERVATION CONDITION <i>CONDITION DEGREES /1/2/3/4/5/ (FROM BEST TO WORST CONDITION)</i>	ROOF / COVERING	DOOR	WINDOW	COLUMN
	1	1	2	---
	MURALS	BALCONY	FACADE	FLOOR
	---	2	1	2
PHOTOS				
2006		2021

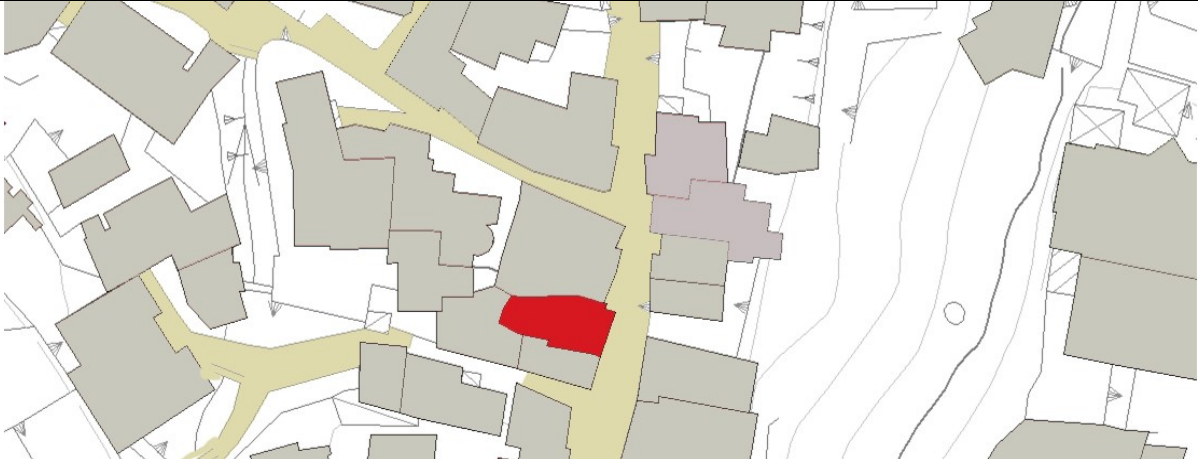
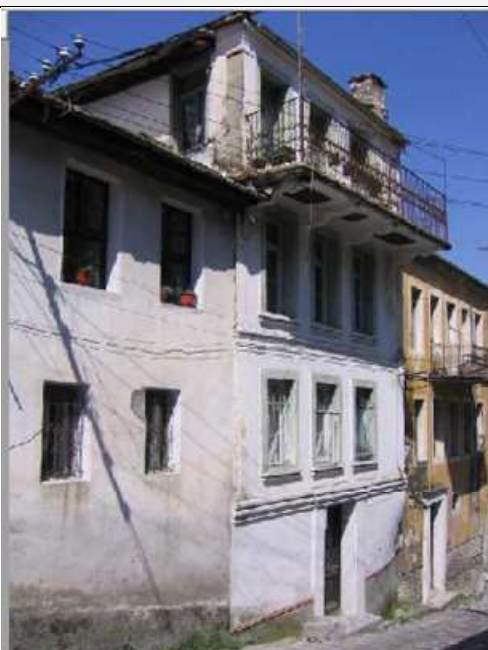
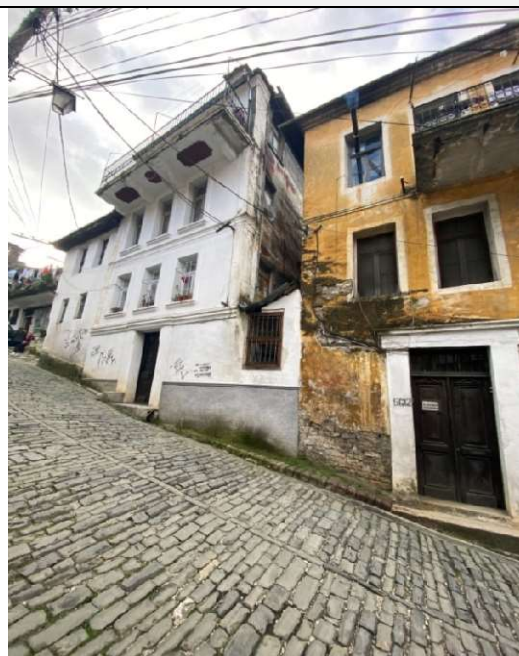
Table 7. Technical file

GENERAL ARCHITECTURAL DESCRIPTION	
<p>Four storey dwelling , built in 1934, with access to the main street, decorated window frames , surrounded by iron railings. The building has a concrete balcony and iron railings. Floor partition with decorative elements of Italian style .Plastered –decorated white façade.</p>	
BUILDING STRUCTURAL ELEMENTS	
<ul style="list-style-type: none"> • FLOOR 	<ul style="list-style-type: none"> -Wooden <input checked="" type="checkbox"/> -Brick/Cement <input checked="" type="checkbox"/> -Stone (Dome,Volte) <input type="checkbox"/> -Ceramic +Iron <input type="checkbox"/> -Brick +Iron <input type="checkbox"/>
<ul style="list-style-type: none"> • COLUMNS 	<ul style="list-style-type: none"> -Wooden <input type="checkbox"/> -Stone <input checked="" type="checkbox"/> -Iron <input type="checkbox"/> -Concrete <input type="checkbox"/>

CONSERVATION CONDITION <i>CONDITION DEGREES</i> <i>/1/2/3/4/5/</i> <i>(FROM BEST TO WORST CONDITION)</i>	ROOF / COVERING	DOOR	WINDOW	COLUMN
	2	1	2	---
	MURALS	BALCONY	FACADE	FLOOR
	---	3	1	2

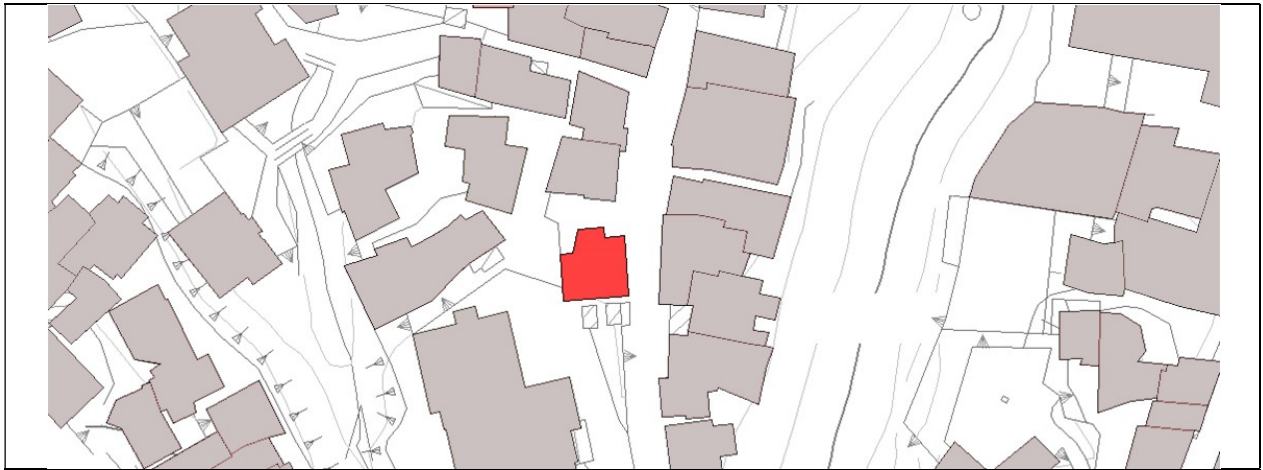
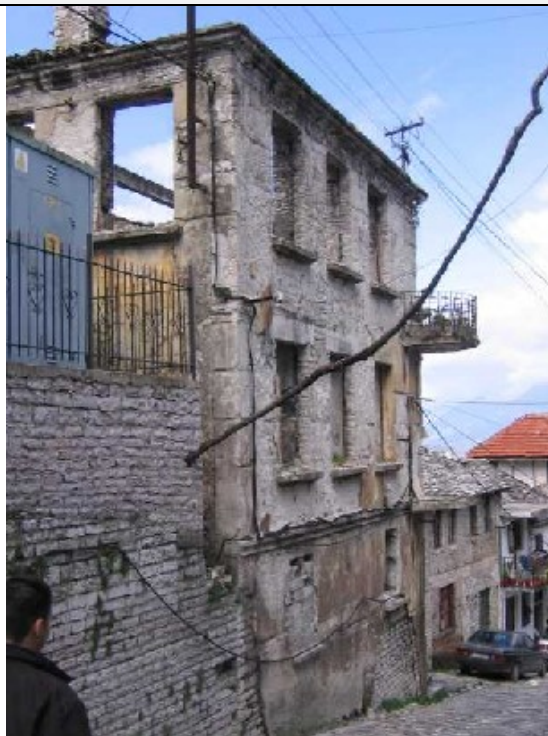
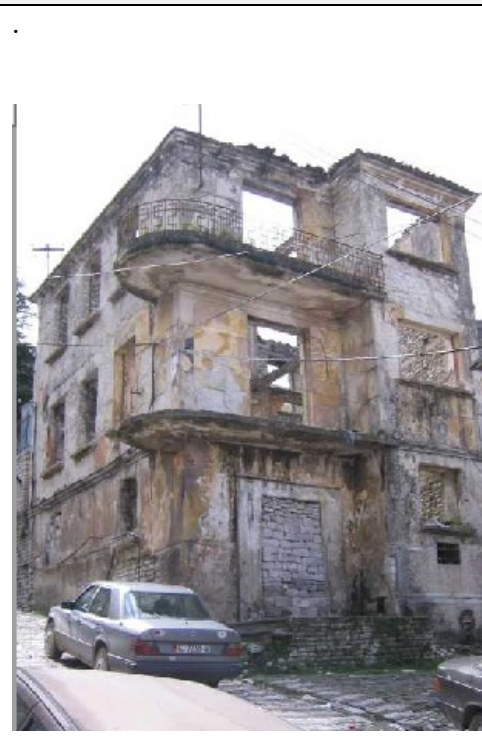
Three-storey building on the cobblestone side. It is already abandoned and in a state that is degrading. The roof and ceilings have completely collapsed. Stone masonry placed in a row and connected with lime mortar. We distinguish the presence of concrete balconies. There was an arched gate in the steam room, which is now enclosed by a wall. Maintains the rhythm of windows.

CONSERVATION CONDITION	4	5	5	4
<i>CONDITION DEGREES /1/2/3/4/5/ (FROM BEST TO WORST CONDITION)</i>	MURALS	BALCONY	FACADE	FLOOR
	---	4	4	4

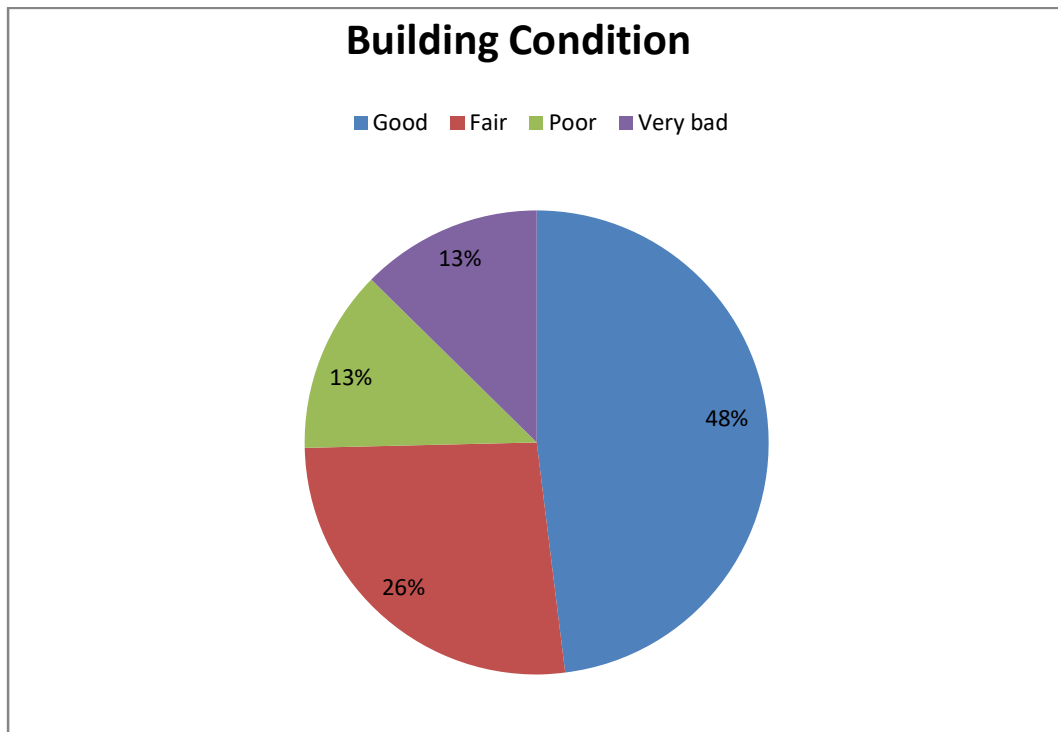
Table 8 . Building Condition

It resulted that from 658 monuments of first and second category , 316 of them are in good condition , 175 fair condition , 84 are in poor condition and 83 in a very bad condition . The study has taken into consideration exterior and interior elements of the building to reach the conclusions .

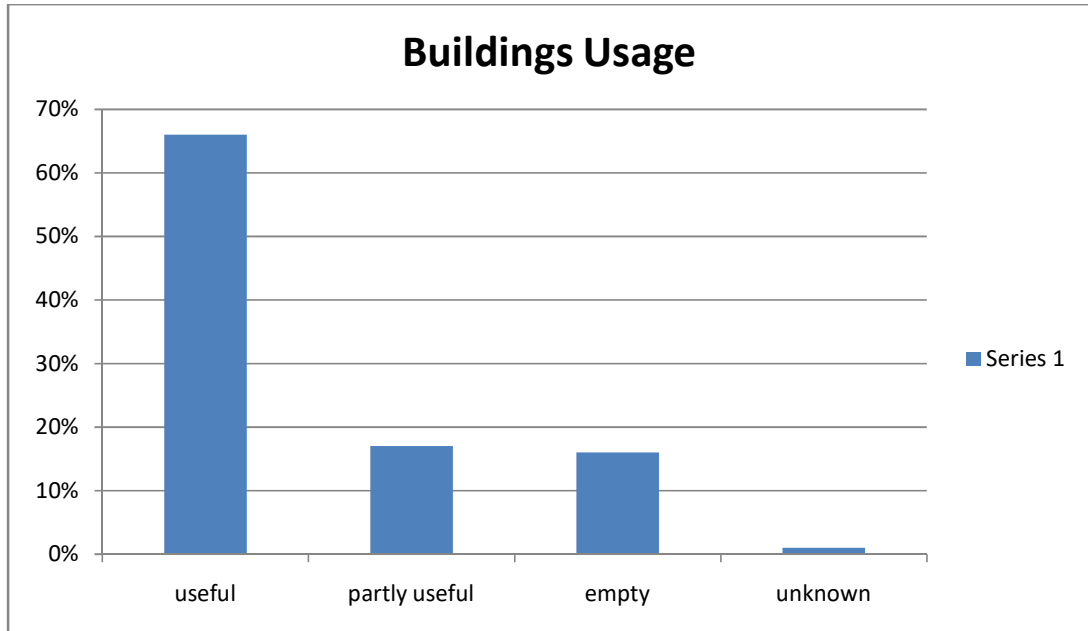
Table 9. Building Usage

According to the graphic it shows that the largest percentage of buildings are useful , 17% are partly useful , only on the ground floor , 16% are abandoned and the houses are empty , 1% is unknown.

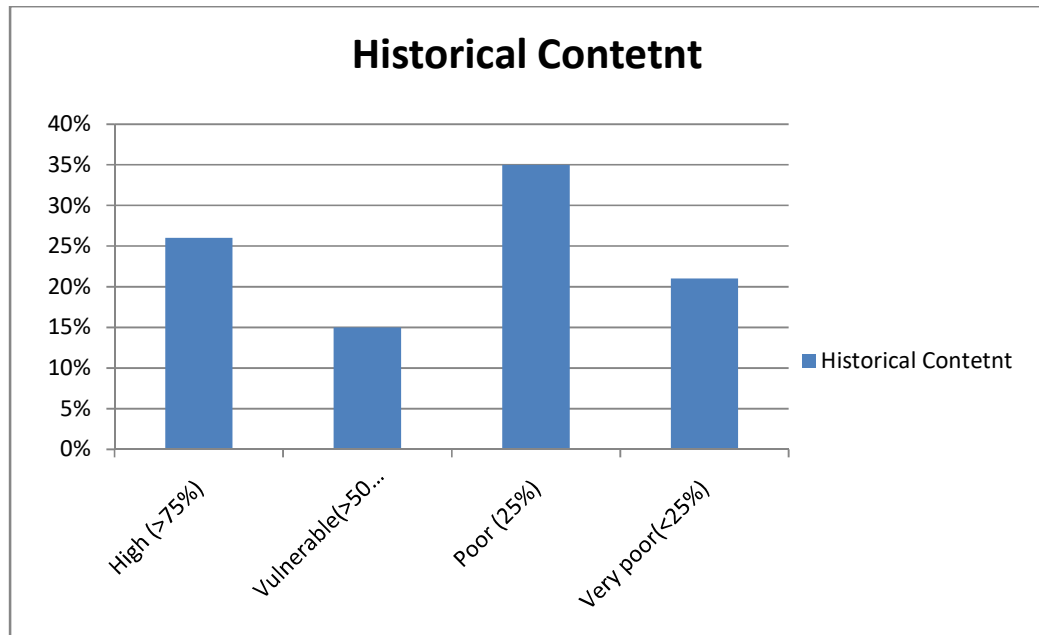
Table 10. Historical Content

26 % of the buildings with high historical contents , which means , all elements of the buildings including interior and exterior , that have been preserved by the owners . High historical content means the content of 75% or more of traditional elements that building had since beginning .

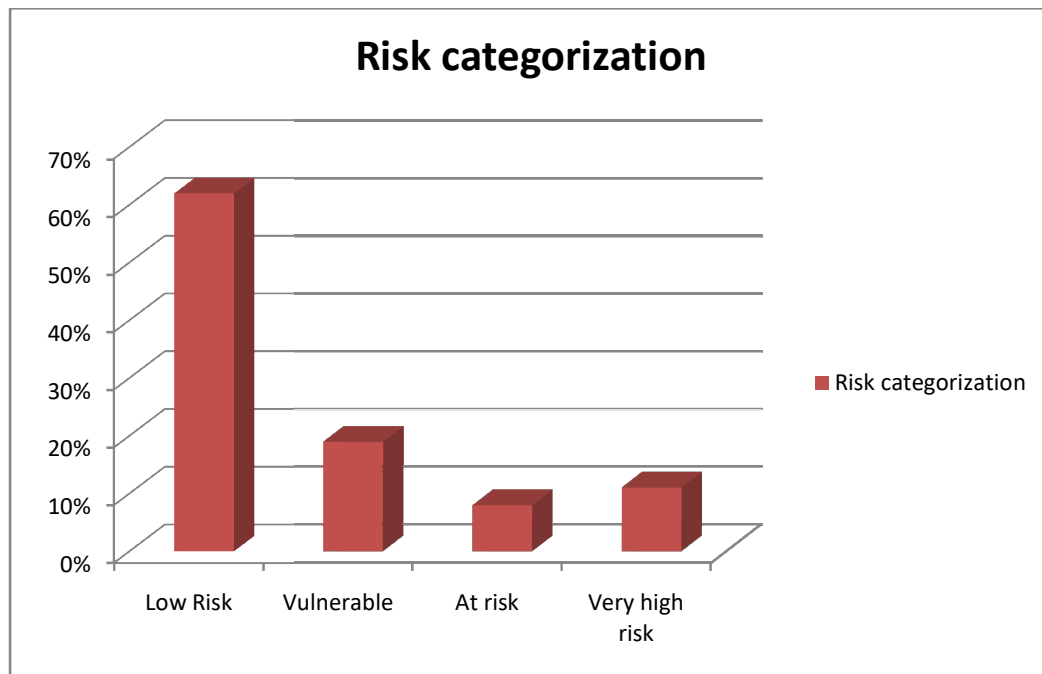
Table. 11 Risk Categorization .

62 % of historical building monuments , are at low risk of categorization , which means that the major number of buildings have major low risk for their category that currently are , as their condition is not bad to risk them .

11 % of the building are at a very high risk ,since their historical elements are being lost , and their condition is not as good as it should.

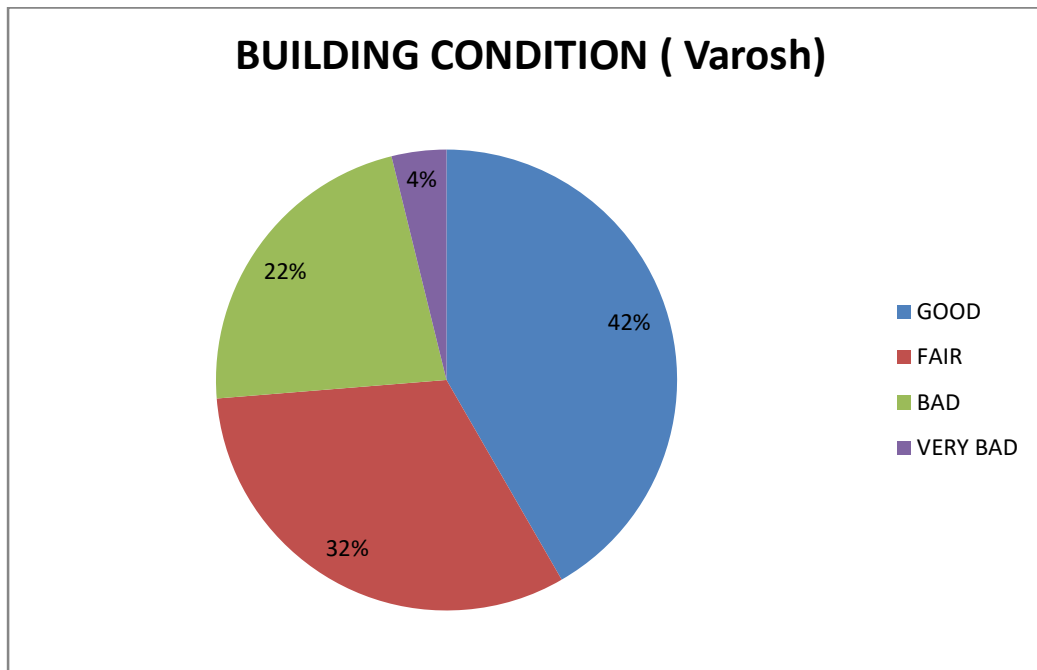
Table 12. Building Condition Varosh

From 35 dwellings in Varosh , the neighborhood that has most of Italian constructions , 42% of them are In good condition, 32% have a fair condition , 22% bad condition and only 4 % in a very bad condition.

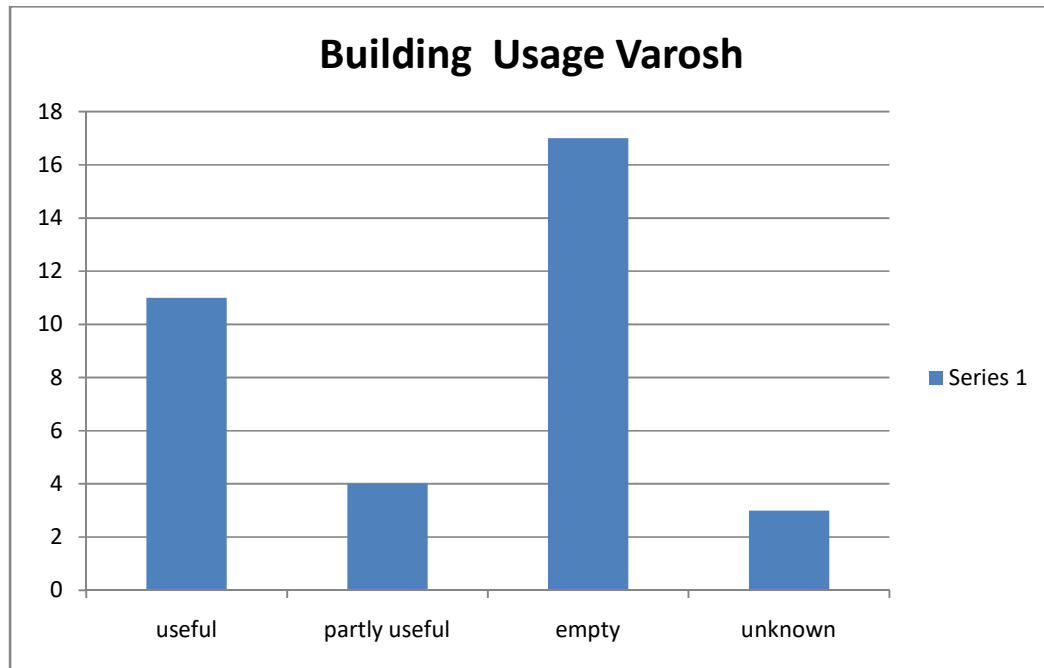
Table 13. Building Usage Varosh .

In the graphic shown above , it has been resulted that in 35 dwellings , only 11 of them were useful , 4 of them partly useful , 17 of them were empty and 3 of them unknown . The largest number of buildings are abandoned from owner from different reasons , where the most common one is immigration .

Partly Useful- were only 4 , and this means that not all the building is in use but , commonly only the ground floor which has commercial function and the upper ones are dwellings .

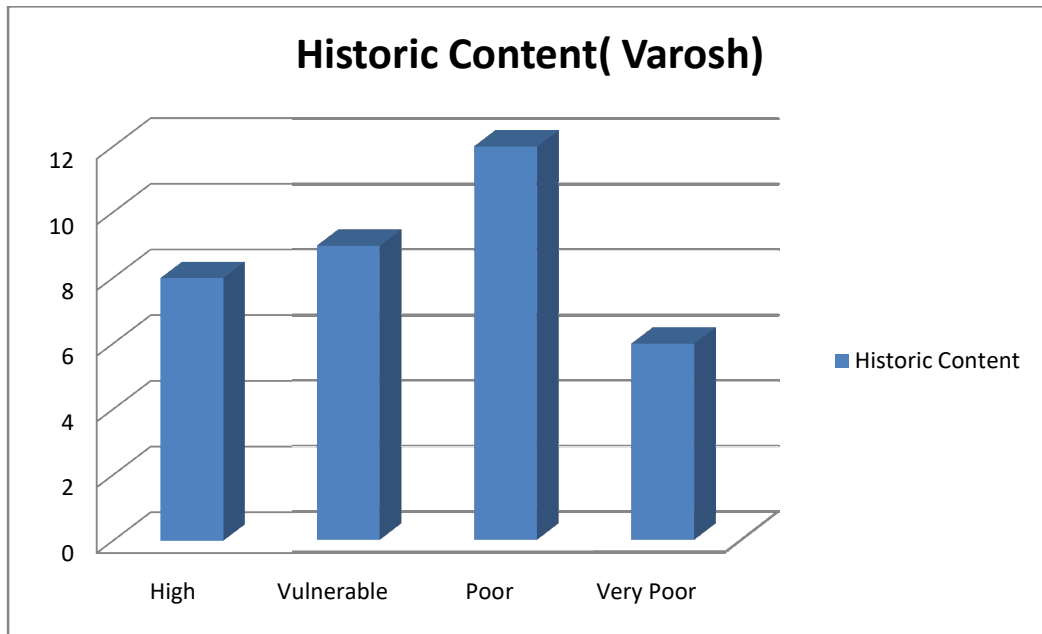
Table 14. Historic Content Varosh .

-8 buildings in Varosh from 35 of Italian period , have high historical content ,

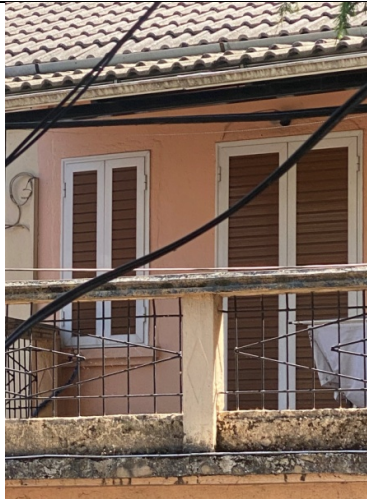
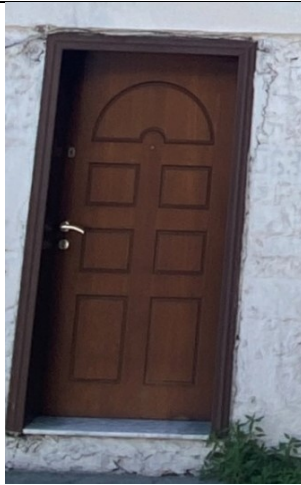
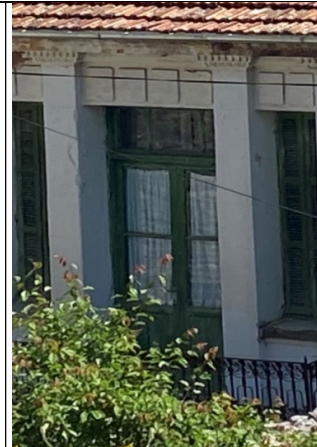
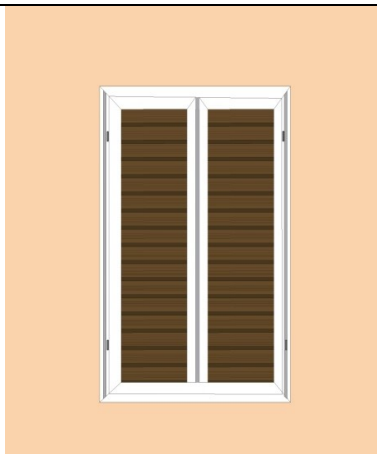
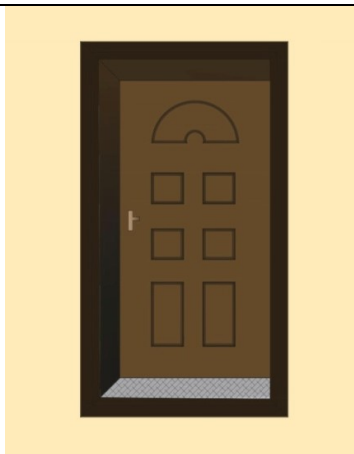
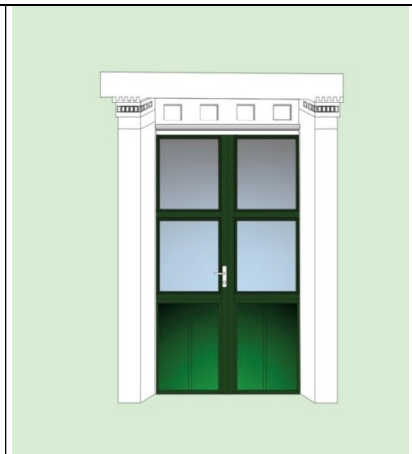
- Door with wooden shutters characteristic of Italian architecture.

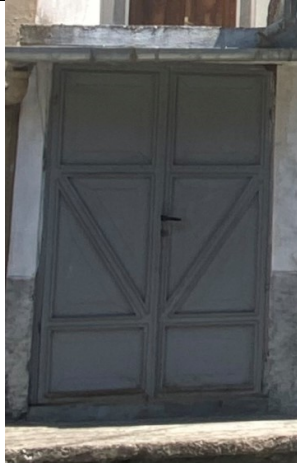
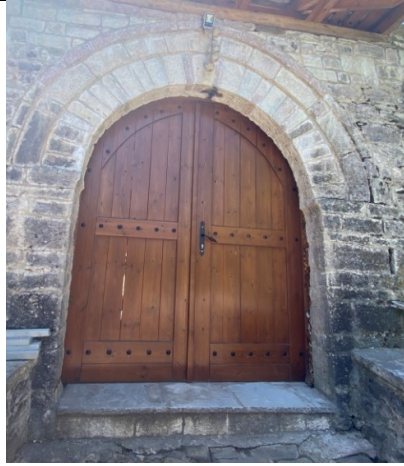
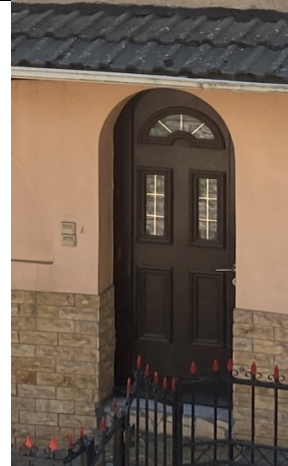
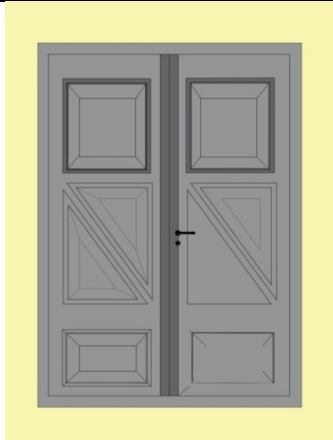
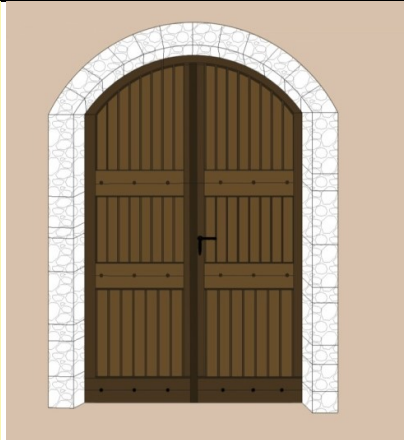
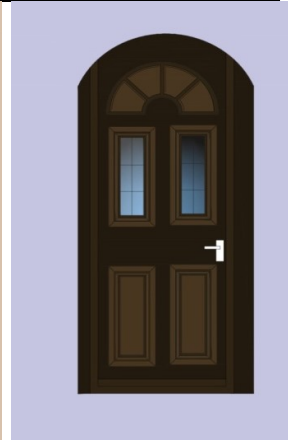
- Simple Steel door

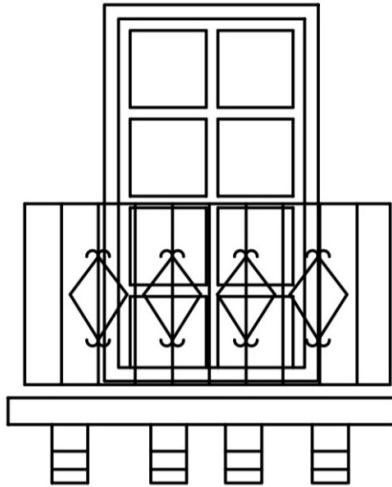
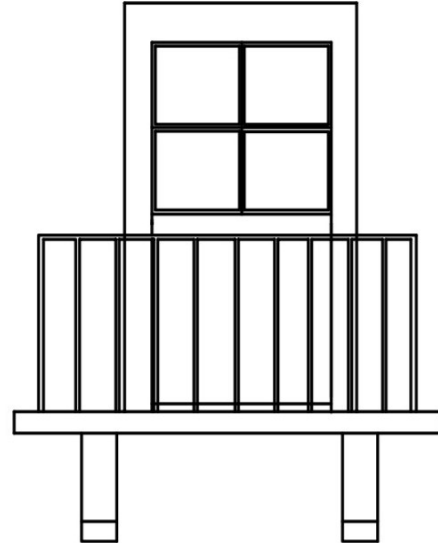
SKETCHES OF BALCONY

- Concrete balcony , with decorative steel railings .
- With concrete retaining elements .

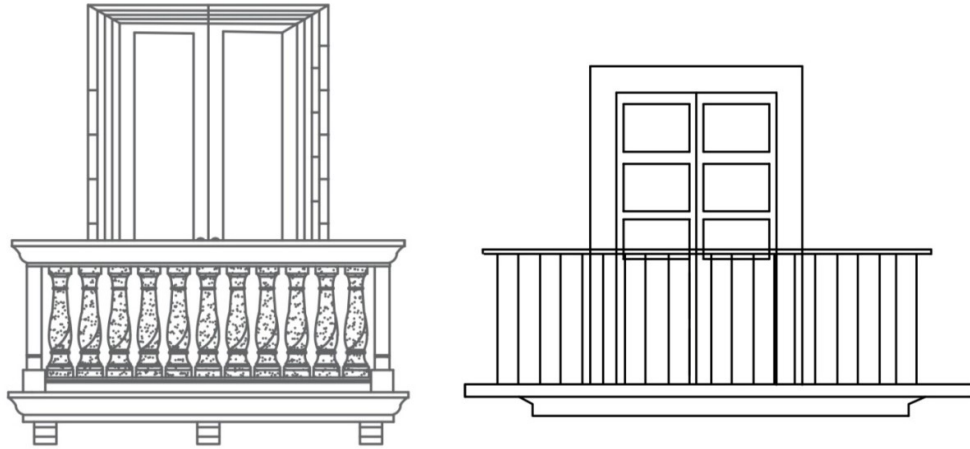
- Concrete balcony , with concrete parapet , and decorative columns on the side , as well as decorative elements above and below
- Supportive elements

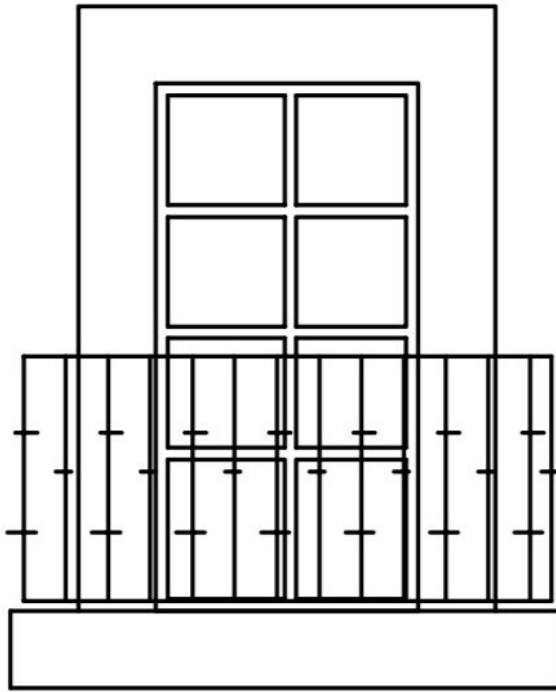
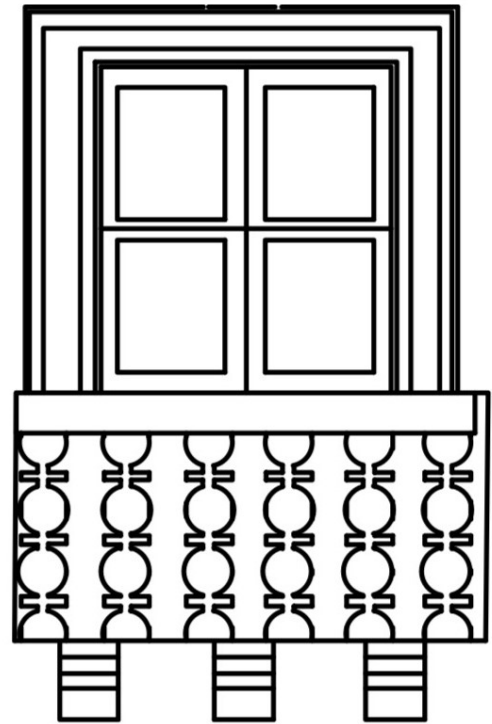
- Simple Concrete balcony , with steel decorative railings , without supported structures, as it is part of the building , being supported on the floor below.
