REVEALING THE EXTERIOR TRANSFORMATION OF GJIROKASTRA
DWELLING UNDER ITALIAN INFLUENCE .

A THESIS SUBMITTED TO
THE FACULTY OF ARCHITECTURE AND ENGINEERING
OF
EPOKA UNIVERSITY

BY
MIRSADA AHMATI

JULY 2021

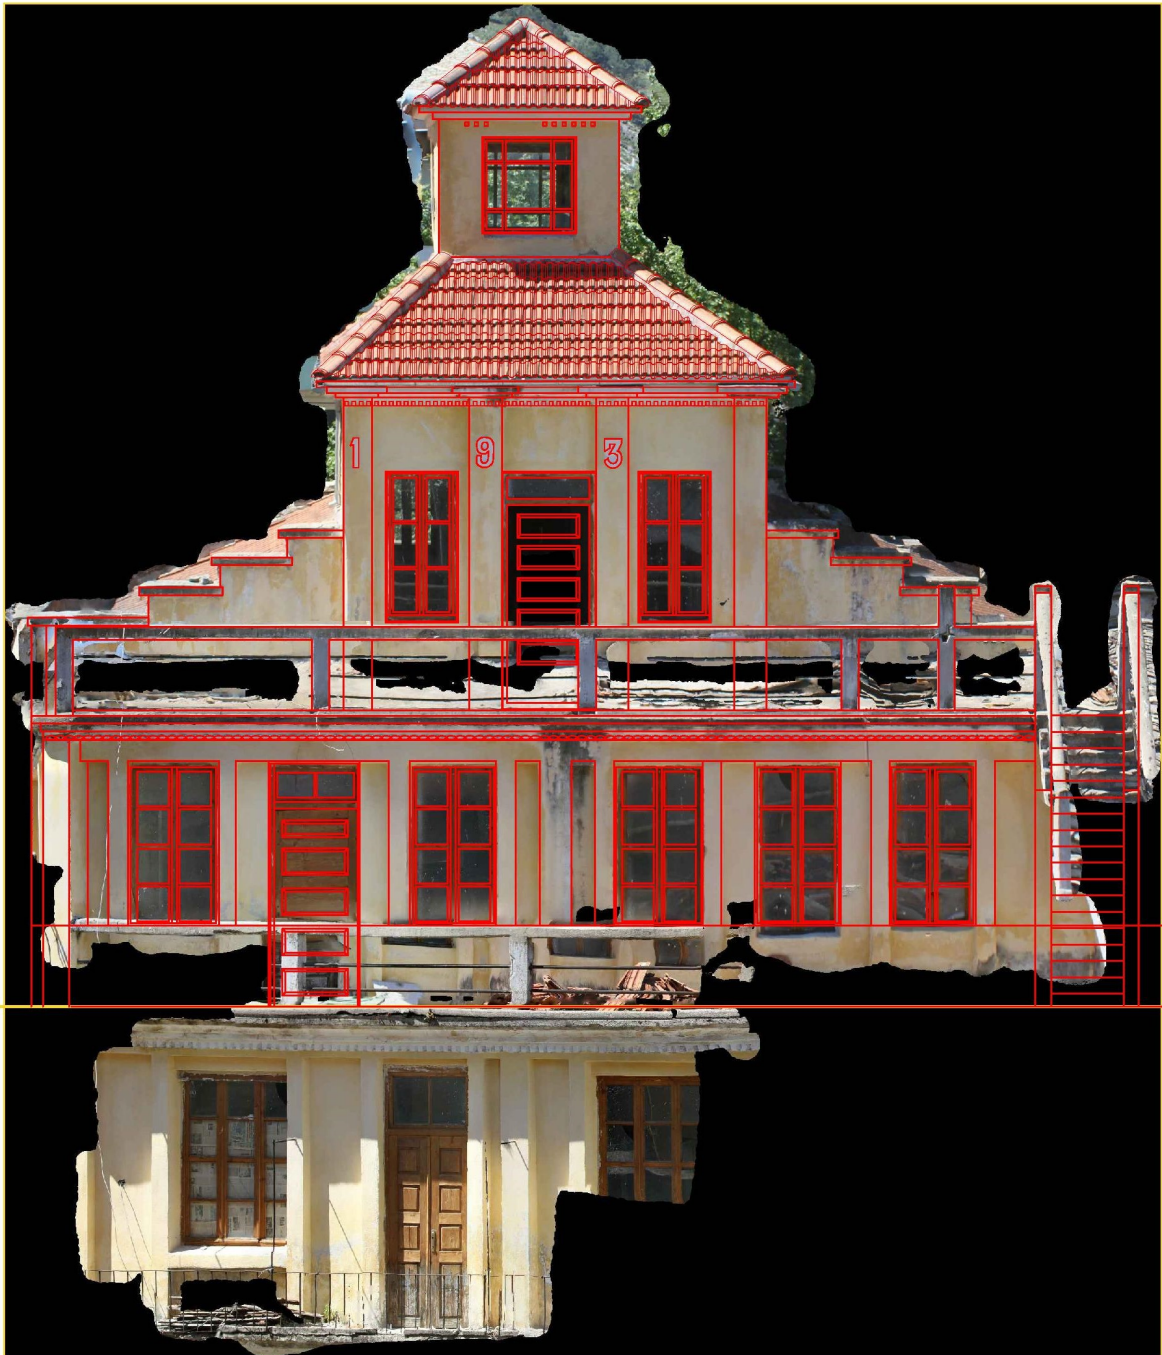
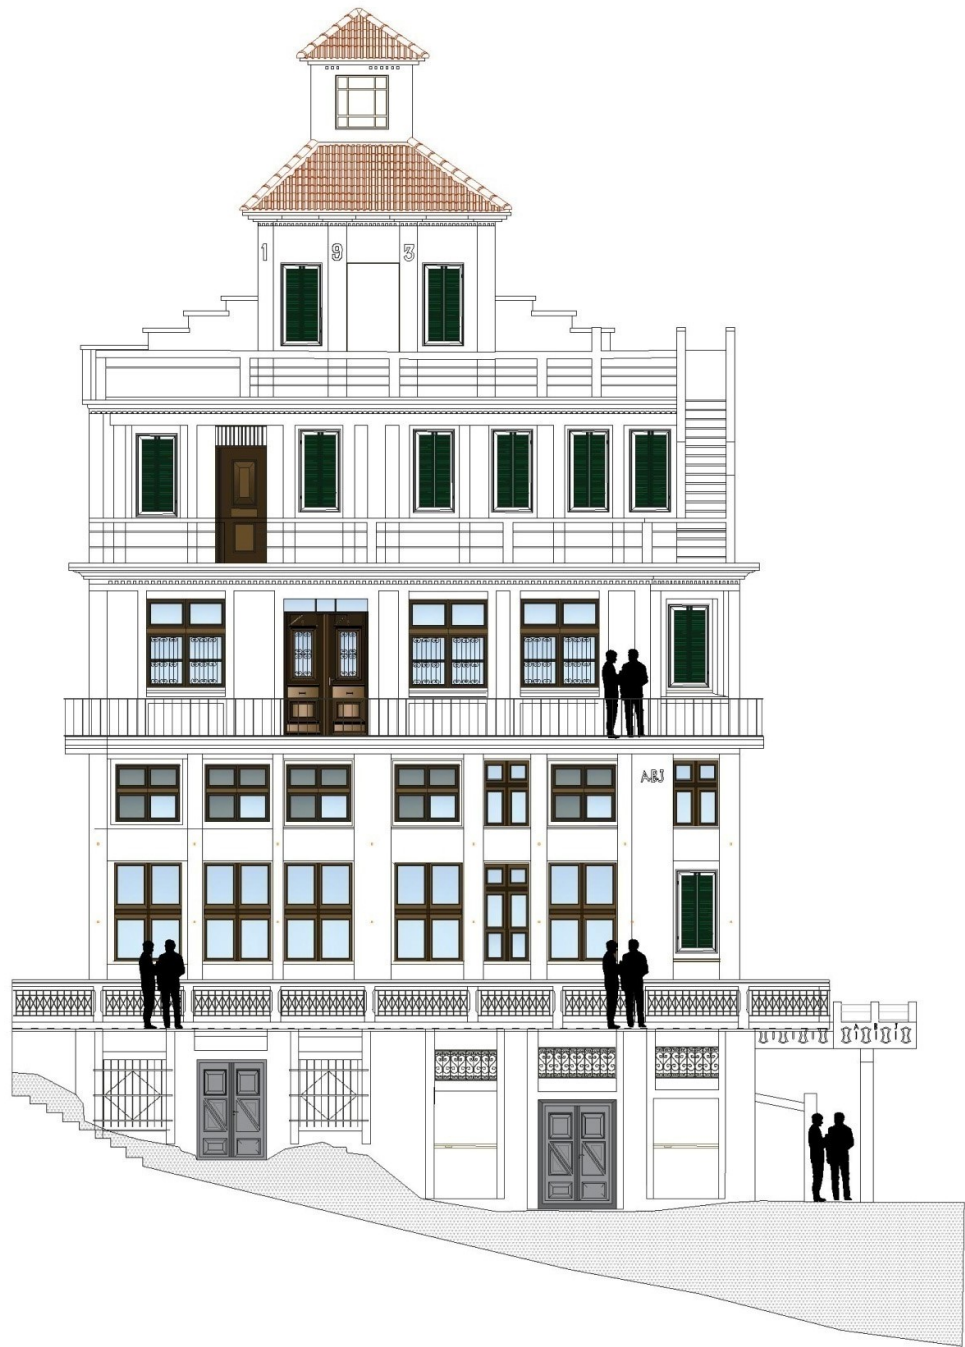
5.2 Proposal on restoration of Zigai building

Zigai façade : Kreshnik Merxhani

Restoration proposal : Mirsada Ahmati
