## Repairing and Seismic Strengthening of Damaged Reinforced Concrete Structures with External Steel Shear Walls

### ABSTRACT

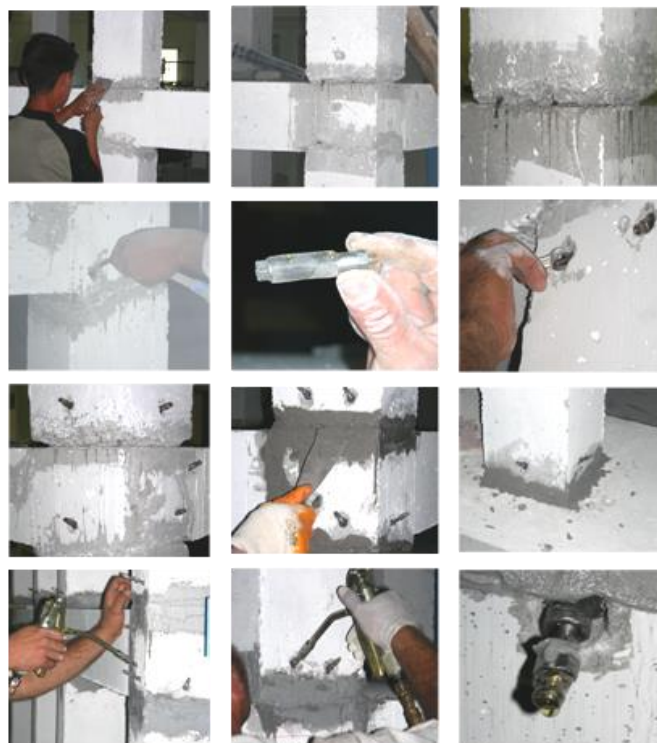
Figure 7 Repairing of the damaged RC reference model with epoxy injection

In order to repair the deformed model, initially, damaged zones were immobilized and all the cracks including micro fissures were enlarged and cleaned by oil-free dry compressor. Then, packers were placed into the holes which were perforated to the lower and upper parts of the cracks forming a 45° angle with the concrete surface for epoxy injection. Afterwards, cracks were closed completely with repair cement and epoxy material was pierced to the cracks under pressure (maximum with 5 bar pressure). This treatment continued to the point where the epoxy material goes out of the control packer. At this stage, it was understood that micro fissures were completely filled when epoxy left the control packers. Details of the repairing procedure for the reference model and the appearance of the repaired model are given in Fig.7 and Fig.8, respectively.
